CONSULTING STRUCTURAL ENGINEERS

**REPORT CONCERNING STRUCTURAL OF:**  
**NO 2 KILBURN VALE, LONDON NW6**

**Job No: 11074**

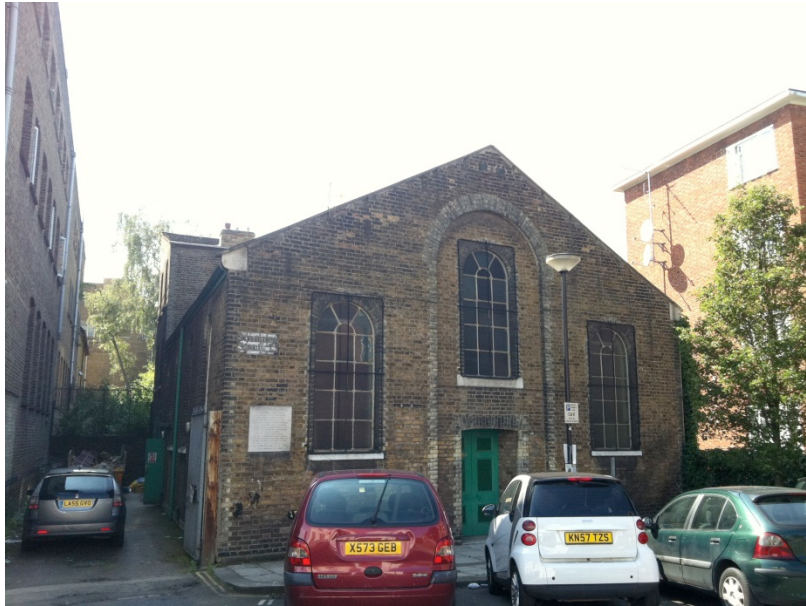
- .1 The front elevation is formed in 13½" Flemish bonded stock brickwork, originally laid in lime mortar. The window and door openings are recessed by 4½". The façade rises to a pediment shaped verge. The verge eaves are picked out in stone blocks. In general the pointing is currently adequate, although, repointing may be required in the near future.

- .1 The niches and window openings are spanned externally by semi-circular arches. The arches are in structurally sound condition without sign of horizontal movement at the skewbacks or over the span of the arches.

- .1 No signs of significant differential vertical movement were noted along the run of the elevation.

Photo No. 1 Front Elevation.

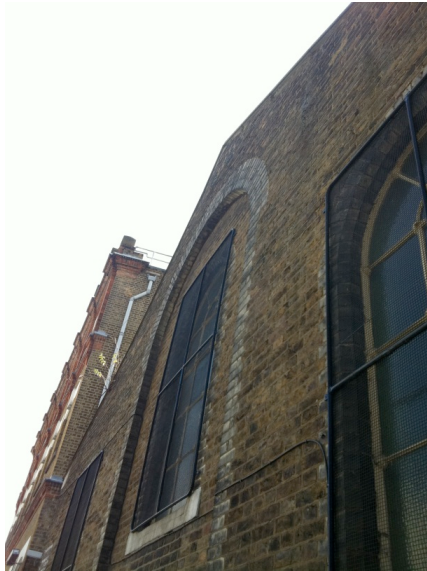
Photo No. 5 Front Elevation Detail.

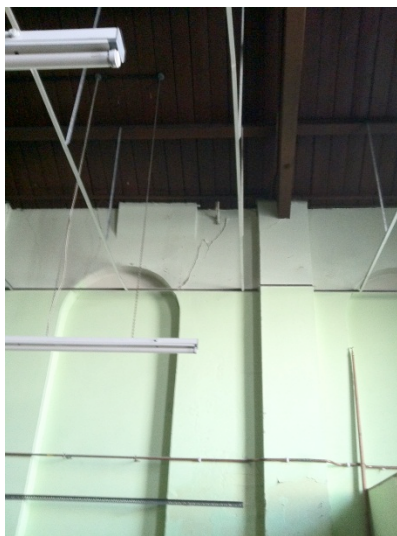
- 1 The most significant area of distress in the 'chapel' section is the cracking noted at the junction of the front wall and the north and south flank walls. The cracking appears to from a yield arch pattern around the corner of the junction with notionally diagonal cracking converging on the top corners. Additional cracking was noted on the apron panel below the window opening adjoining the front wall, on the south elevation. This cracking has been repaired in the past and has reopened. It is currently approximately 5-6mm in width. The weathered condition of the arising of the cracking suggests that the re-opened cracking is not recent. This cracking should be sealed in order to prevent progressive dilapidation resulting from the ingress of the elements.

- 1 The crack pattern is consistent with settlement of the front corners of the flank walls. It is somewhat unusual that there does not appear, on superficial inspection of the external condition of the front wall that there is no significant evidence of differential settlement of the front wall. A possible explanation for this condition is that the front and flank walls were constructed on differing foundations possibly at different times.

- 1 A possible contributory factor to instability in the south flank wall is the possibility of a leaking drain; there is a drain run parallel to the flank wall in the side alley. Leaking from the drain could possibly lead to softening the clay beneath shallowly founded period, rudimentary footings. The drain should be checked for leaking/perished joints and replaced if necessary.

Photo No. 6 Internal detail of South facing flank wall, at junction with front wall. Note crack in flank.

- 1 It is recommended that further investigation be carried into the sub-soil conditions at the junction off the front and flank walls. This would provide appropriate information which would allow an appropriate regime of underpinning remedial works to front wall. It is anticipated at this stage that the extent of the underpinning would be over the width of the front elevation, returning approximately 2-3m along the flank walls. The depth of the underpinning, pending testing of retrieved samples, would be of the order of 1.00m – 1.50m below ground level.

- 1 The superstructure brickwork should be stitch repaired and made good internally and externally.
- 1 The rear wall of the rear addition should be re-built from first floor level and tied into the floor and roof structure.

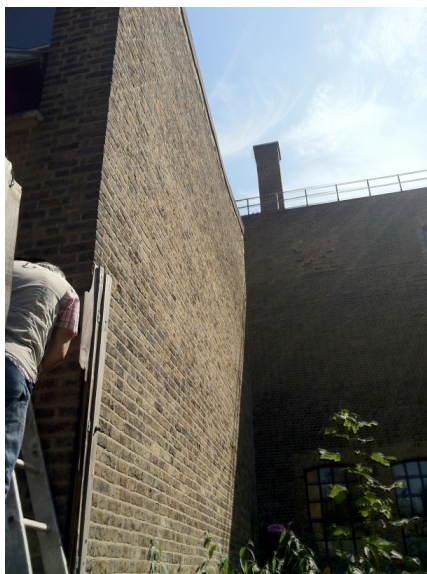
- 1 The rear wall of the accommodation, rear section of the building is currently exhibiting considerable out of plane distorted into the building. A rudimentary plumb survey indicated that at worst in the

Photo No. 8 View of rear elevation showing distortion inwards above first floor level.

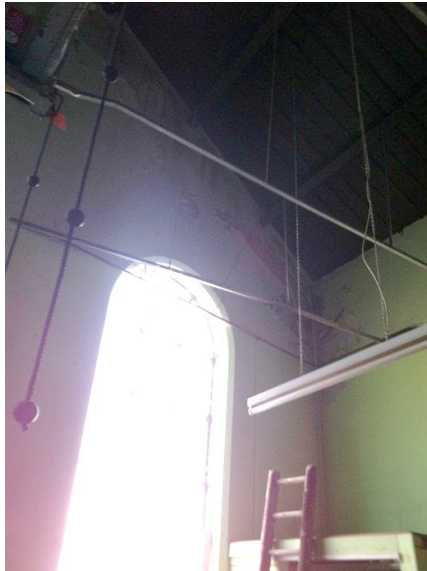
Photo No. 10 Cracking at front south wall junction.

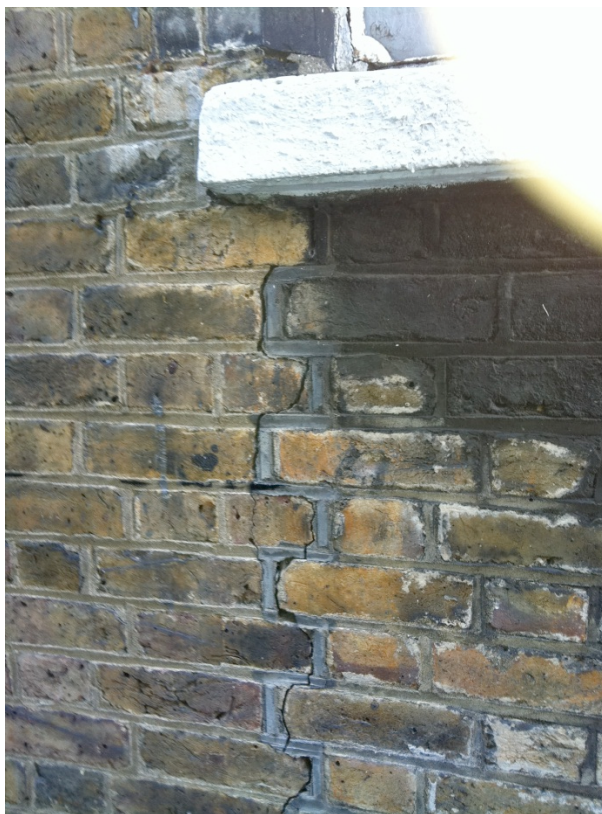
Photo No. 11 Repaired crack in flank wall apron adjacent to front wall.

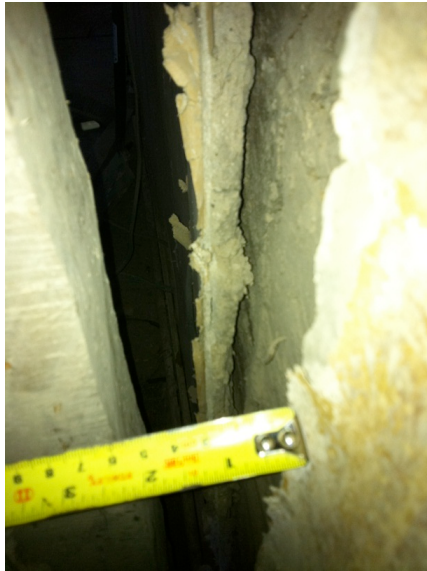
Photo No. 12 Movement of the internal face of the end gable wall and the final timber stun in the spine wall.
