Lawson Martin Long Consulting Engineers Ltd

28<sup>th</sup> October 2019

Ref: 19/0098

**Structural Inspection of Cracking at 116 Highgate Road, London NW5**

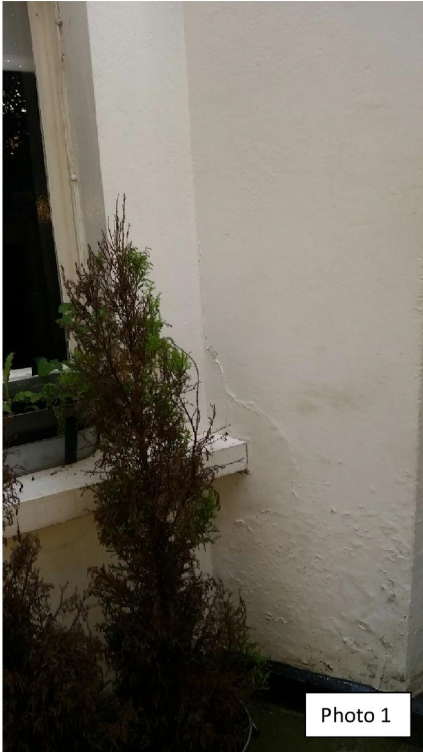
There is a crack at the bottom right corner of the right hand bay window (where it joins the front elevation) This turns to a diagonal crack just above the sill going downwards towards the ground in the front elevation; this crack starts as hairline (where it has broken through the paintwork and finishes as a slightly displaced subsurface crack (see photo 1).

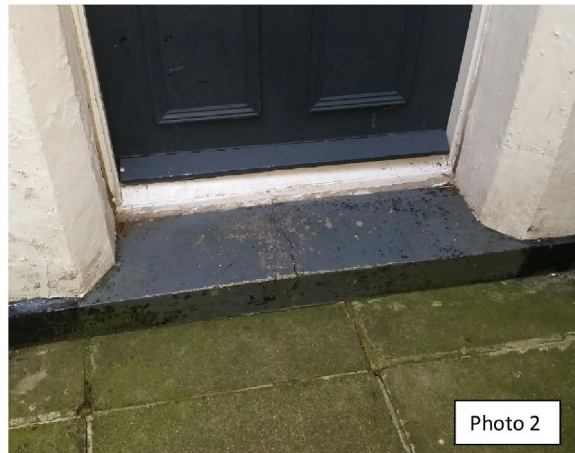
There is a crack through the front doorstep of No 116 (see photo 2).

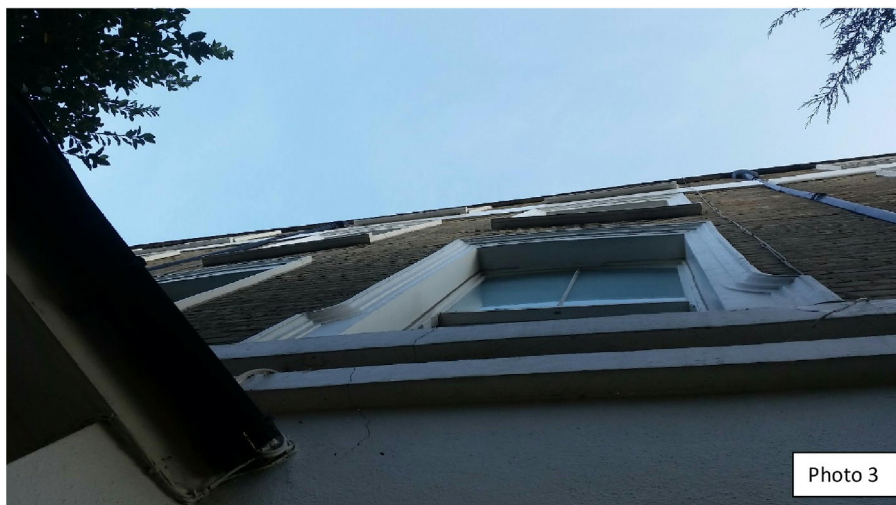
The front elevation of No 116 has a significant bow, with belly of bow being between first and second floor levels; there are signs of this having been repaired in the past with the installation of bowties and Helibars to arrest the bowing (see photo 3). We have been given sight of a report from a previous engineer recommending Helibar and Bow tie repair, along with receipts from contractors showing this work has been done. There is every reason, therefore, to anticipate that the bowing is historic, and the remedial work has arrested it. We saw no recent cracking which would suggest there has been no recent movement of the bowing.

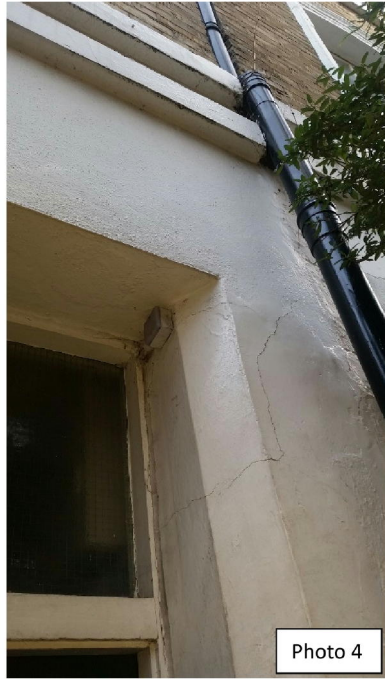
Photo 4

There is a crack to the right hand side of the front door at toplight level that rakes diagonally upwards (see photo 4 ).There is a vertical crack from the top right hand corner of the front bay of No. 116 rising up and through the window sill of the righthand first floor window (see photo 5). There is a crack above and to the left of the main entrance door when viewed externally (see photos 3 & 5). This crack tapers so that it is narrower at the bottom and wider at the top and it extends to the first-floor windowsill (as detailed below).

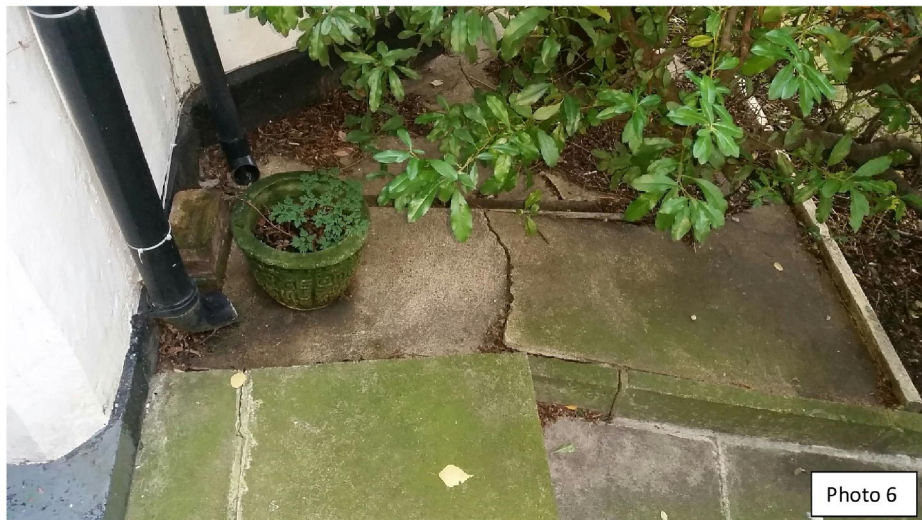
Photo 6

The downpipes to the right of the front door allow the water to discharge over the surface potentially adding to moisture content differentials (see photo 6). Ideally down pipes should discharge into the public sewer (possibly via the manhole in the front garden).

The slabs at the front of 116 Highgate Road adjacent to 114 are cracked, raised and uneven (see photo 6). There is a significant crack in the left-hand junction of the front and the left-hand side of the bay to No 114 (see photo 7) of width approaching 10mm; there is also a vertical stepped crack to the left-hand side of this window (see photo 7).

5. The downpipes on the front elevation between Nos 116 and 114 are connected to either a soakaway or the surface water sewer.

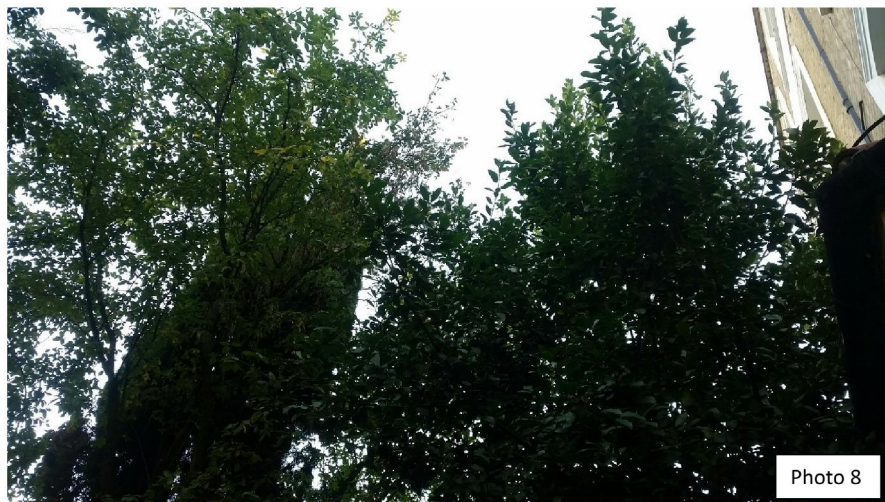
There are several mature trees in the front gardens of 114 – 118 Highgate Road, such that the buildings are within the zone of influence of these trees' roots (a number of these trees are of similar height to the four-storey building), see photo 8.

4. The trees in the immediate vicinity of the front of the house are pollarded to reduce their height by half and canopy volume to approximately 1/2 of the current volume and thus to reduce the zone of influence of their roots. If the trees are reduced, the ground can be expected to recover (heave) back to something approaching its original volume. This could mean that over the coming couple of years, more cracking damage could occur to all three buildings (114, 116 and 118) until the recovery is complete, at which point the cracks could be repaired and redecorated. If the recovery were monitored and not found to be excessively damaging to the existing structures, you may, at that point decide to completely remove the trees, subject to recommendations from a structural engineer and Arboriculturalist at that stage.

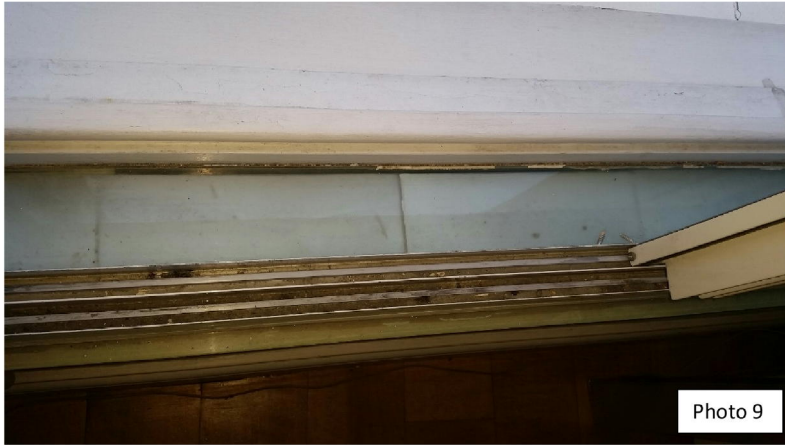
Photo 9

A windowsill tile has popped up on the left-hand windowsill (looking from within the room) (see photo 9). This is the same windowsill with external crack mention earlier. The bowing of the bay can be clearly seen in the tapering junction between the fitted wardrobes and the front elevation (see photo 10). The bow is also visible at the junction between the ceiling and the front elevation where there is also a hairline crack in the junction (see photo 11).

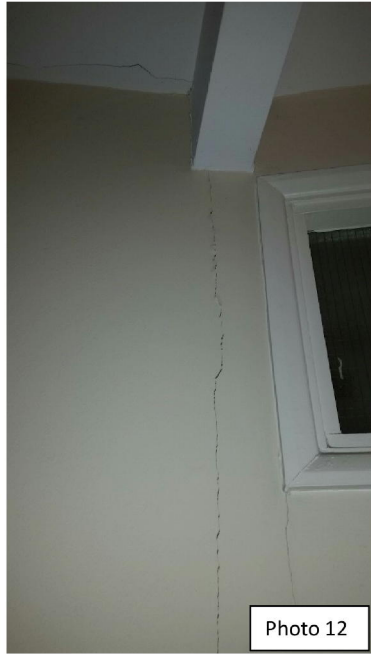
Photo 12

There is a vertical crack in the junction of the brick part of the internal hall flank wall to the front reception room and the studwork part, below the downstand beam. There is also a raking crack through the ceiling adjacent to the junction of this internal wall and ceiling (see photo 12 & 13).

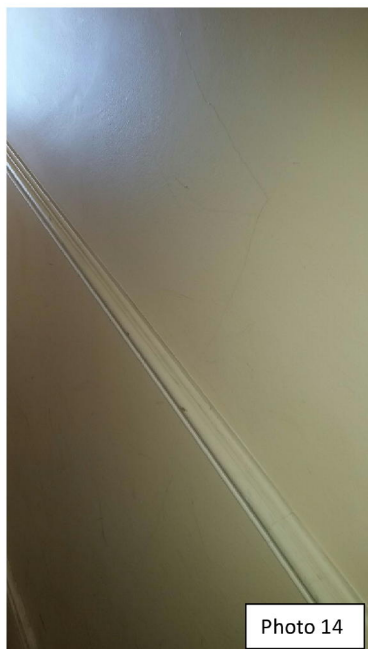
Photo 14

There is also a hairline vertical crack in the party wall with No 114 at the bottom of the stairs (see photo 14 & 15)

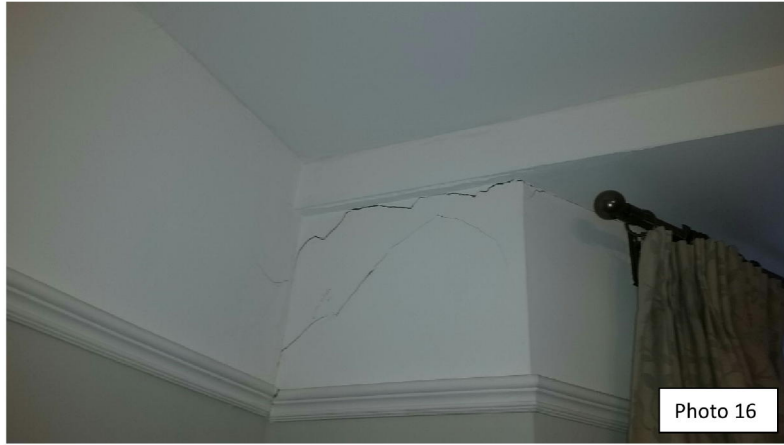
Photo 16

There are two significant cracks at the top of the front elevation between the junction with the hallway wall and the junction with the front bay (see photo 16). The large crack carries on into the bay in the junction with the bay ceiling (see photo 17). There

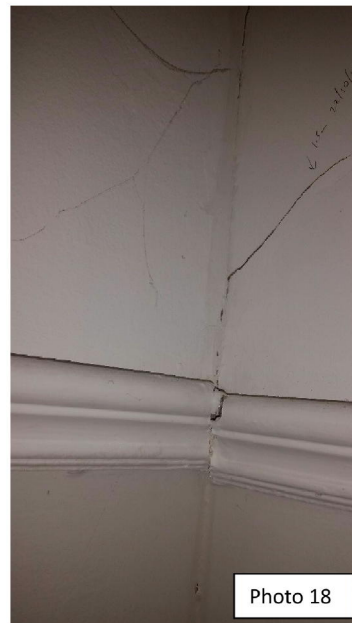
Photo 18

is also a vertical crack in the junction of the hallway wall and the front elevation and evidence the front elevation has dropped slightly in relation to the hallway wall (see photo 18).
