Barton Hyett Associates
Arboricultural Consultants

66 PARKHILL ROAD, CAMDEN, LONDON

TREE INSPECTION REPORT

Date: 13th February 2020

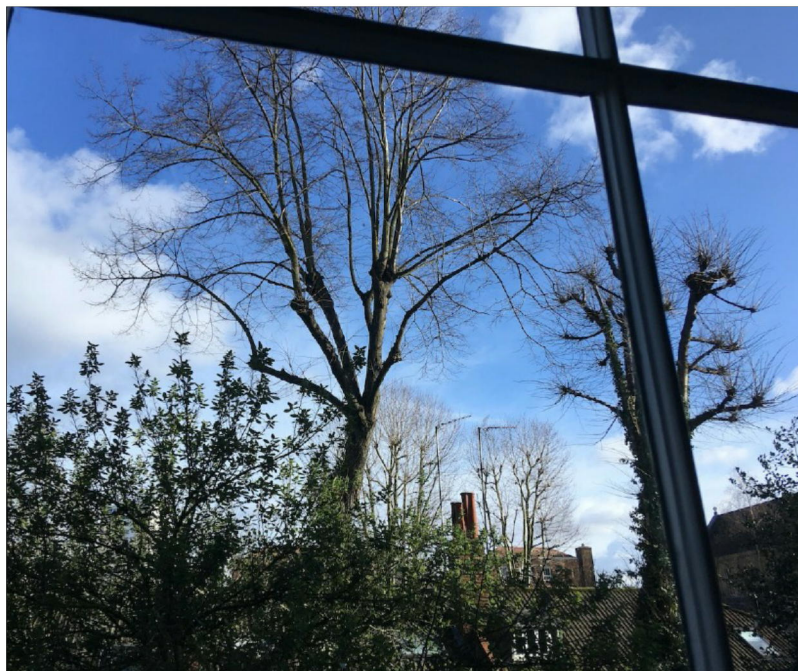
- 4.3. The crown of the tree overhangs the two gardens, private footpath and the roofs of two dwellings of Mall Studios. The tree's trunk is approximately 3 metres from the front elevation of the Mall Studios.
- 4.4. The tree has been pruned regularly to control the size of the crown. The form of the structural branches indicates that it was previously pollarded at approximately 12 metres height, but since then has been maintained as a secondary pollard by pruning the branches above the original pollard points.

Photo 1: the crown as viewed from the rear windows of no.66. The original pollard points roughly match the height of a pollarded lime in a garden to the south (right of frame).

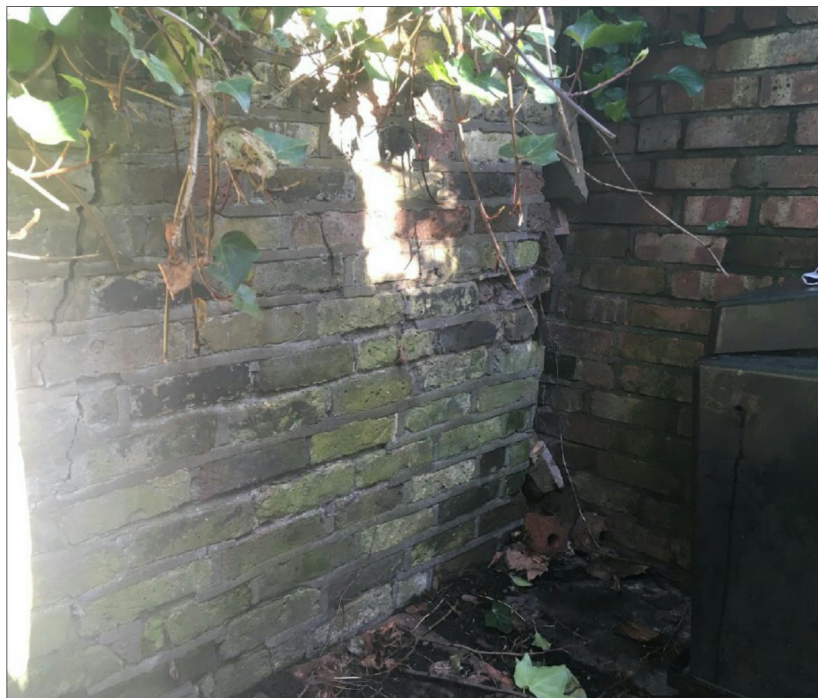
- 4.7. From within the garden of number 64, damage to the boundary wall between the two gardens is visible. The end of the wall does not tie in to the rear wall which spans the rear boundary of both gardens and there are loose bricks present in the gap between the walls. Close inspection of the gap between the two walls shows that trunk of the lime tree is touching both walls.
- 4.8. There are also numerous vertical cracks in the the south face of the garden party wall, and an outward bulge in the mid-height.

Photo 2: the south face of the garden party wall as viewed from within the garden of 64. The trunk of the lime is directly behind the wall on the left.

- 4.9. The rear boundary wall (on the right in the above photo) leans to the east (away from the garden) of 6 degrees.
- 4.10. Viewing the rear boundary wall from the private footpath (access for Mall Studios) reveals that the ground level behind the wall is approximately 1.2m lower than the gardens, therefore the wall is a retaining structure. The wall has been significantly damaged in line with the trunk of the lime; at the top the bricks have been displaced completely and there is a gap through which the trunk can

- 5.4. At the same time as providing numerous benefits, this lime is also having some negative impacts, or 'disbenefits'. My observations of the damage to the walls in relation to the tree's struck indicate that the tree is clearly the cause of the damage to both walls. This has been progressing for some time, and will only worsen over time unless extensive re-building of the walls is carried out.

- 6.2. Although a TPO was served in 2011, the tree has only moderate public visual amenity due to its location behind buildings and other trees.
- 6.3. I recommend that in order to enable repairs to the walls and prevent further damage occurring to them in the future, the lime tree should be removed and the stump ground down as far as possible with a stump grinder.

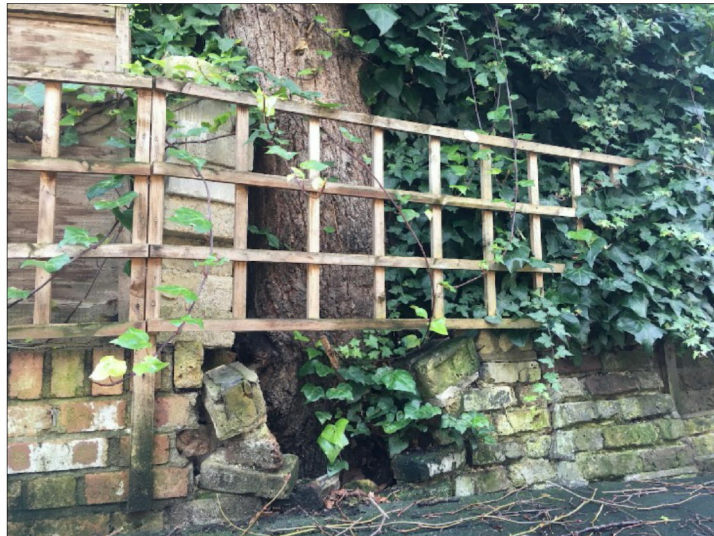
be seen. Lower down, below the ground level in the gardens, there is a pronounced bulge in the wall and numerous cracks in the mortar as the brick positions have been distorted.

Photo 3: the lime trunk and top of the retaining wall as viewed from the footpath.

- 5.8. In my opinion, the main consideration for this tree is the current damage to the walls and the potential for damage to worsen over time. The displacement of the walls is being caused by the annual, incremental thickening of the trunk and the direct pressure that it is placing on the walls. Even by regular and heavy pruning of the crown, this gradual enlargement of the trunk will

continue, and therefore more direct pressure will be applied. Therefore, future damage is inevitable and at some point, the retaining wall could collapse.

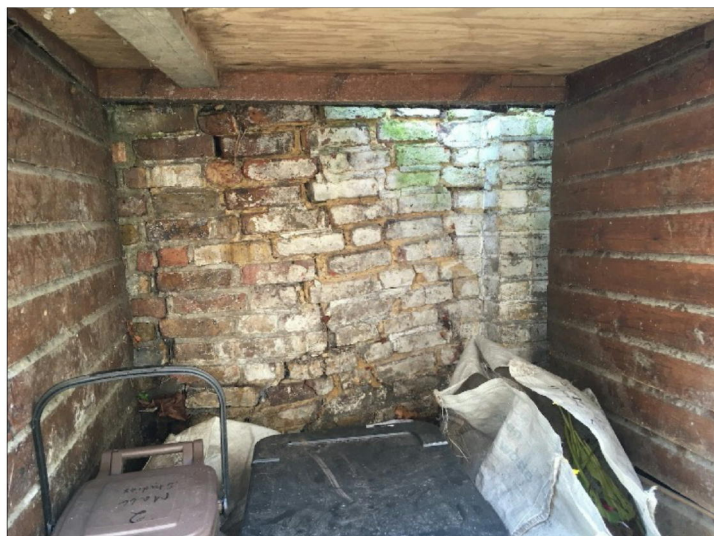
Photo 4: view of the below-ground section of the retaining wall, viewed through a timber storage shed on the footpath.
