MacIntyre Trees
Arboricultural Consultancy

Arboricultural Impact Assessment and Method Statement Report

for ADI Architects, in relation to
construction at rear of 140 Maida
Vale, London.

Date	Feb 2020
Report Ver.	1991_Fv1

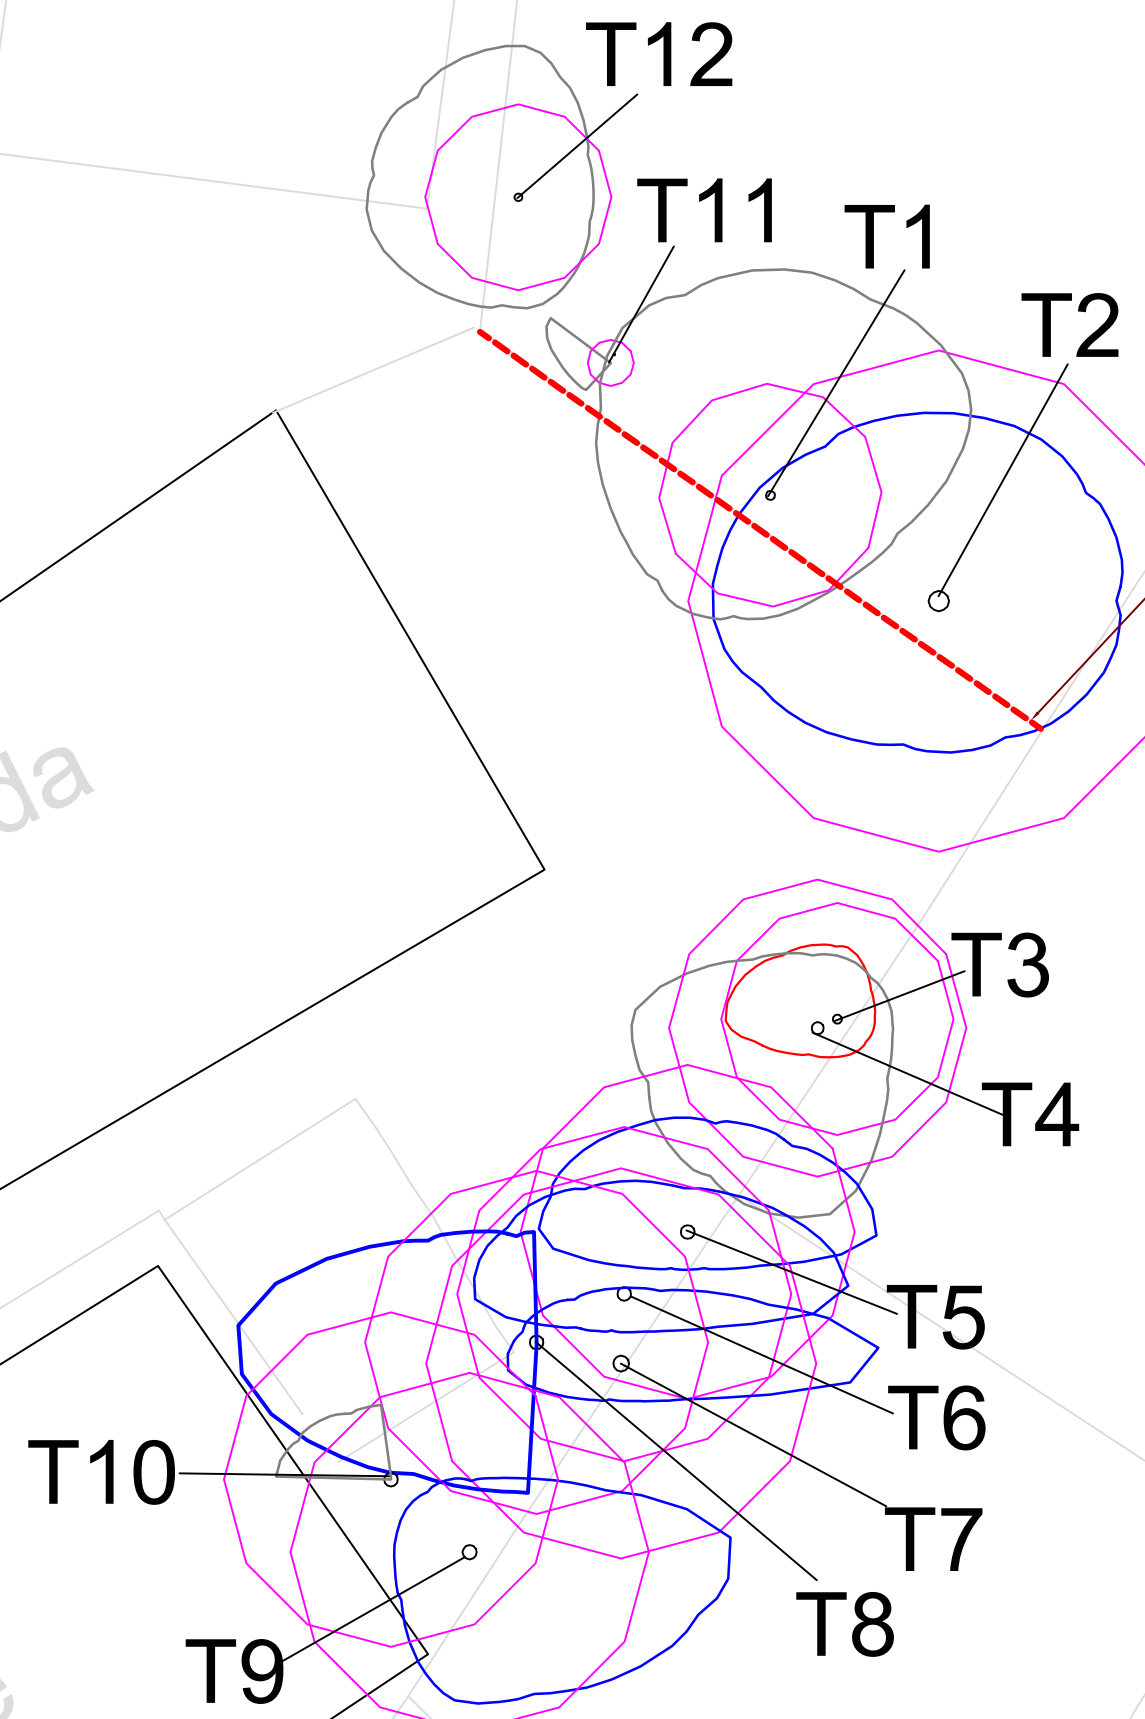
Drawing Title
 TREE_CONSTRAINTS_PLAN
 (EXISTING_LAYOUT)

Collapsed wall to be re-built on course shown with red dashed line.

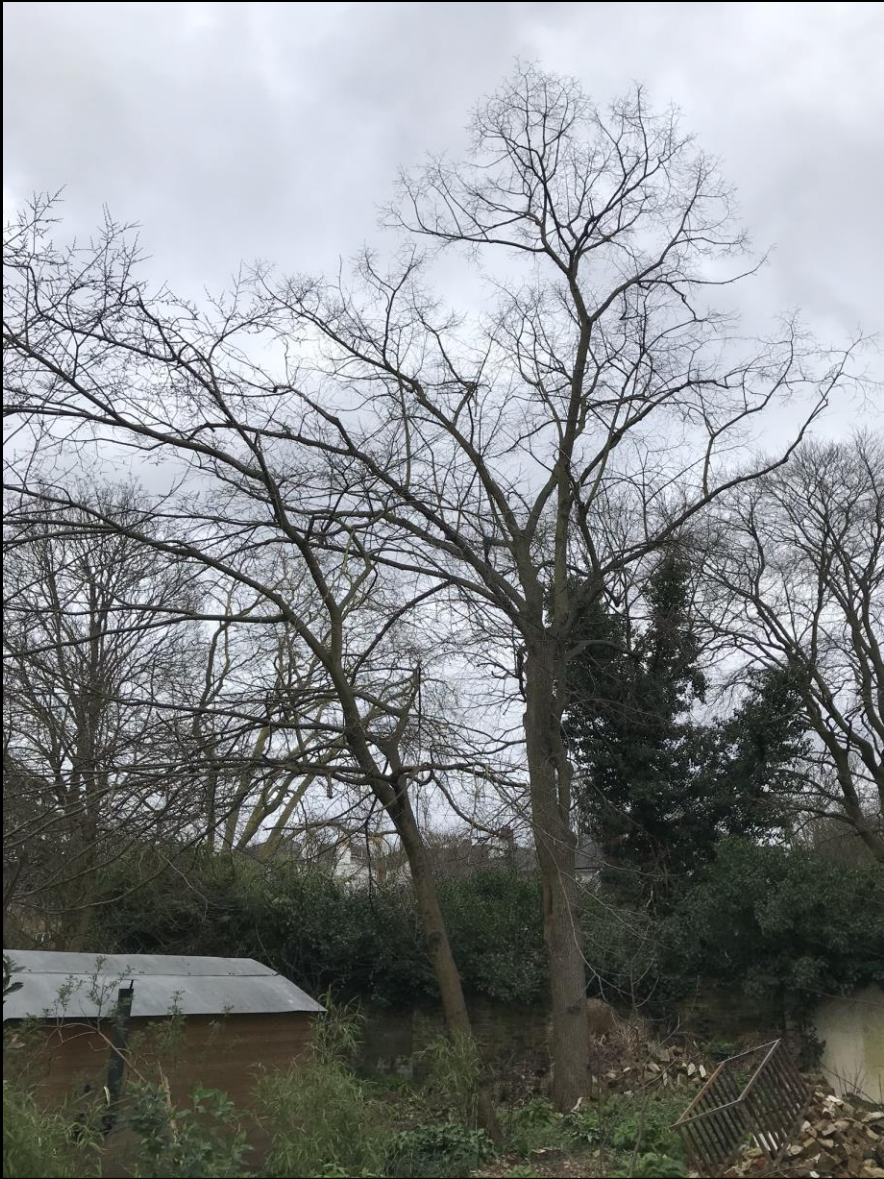
- 5.7. The two largest trees, T1 and T2 (a Lime and Sweet Gum), grow within 1 m of the boundary wall to be rebuilt and it was clear during my site inspection that at least one surface root from the young Sweet Gum (T1) tracks toward the foundations. Unfortunately, the existing foundations had been backfilled with soil and so I could make no assessment of their depth or if roots grow in close proximity. However, given the shrinkable nature of soils and the need to rebuild the wall to around 1.8m height, it is likely that substantial foundations will be required to avoid future ground movement. An engineer will be required to give further details on foundation design and depths.

Tree T1 (left) and T2 (right.)

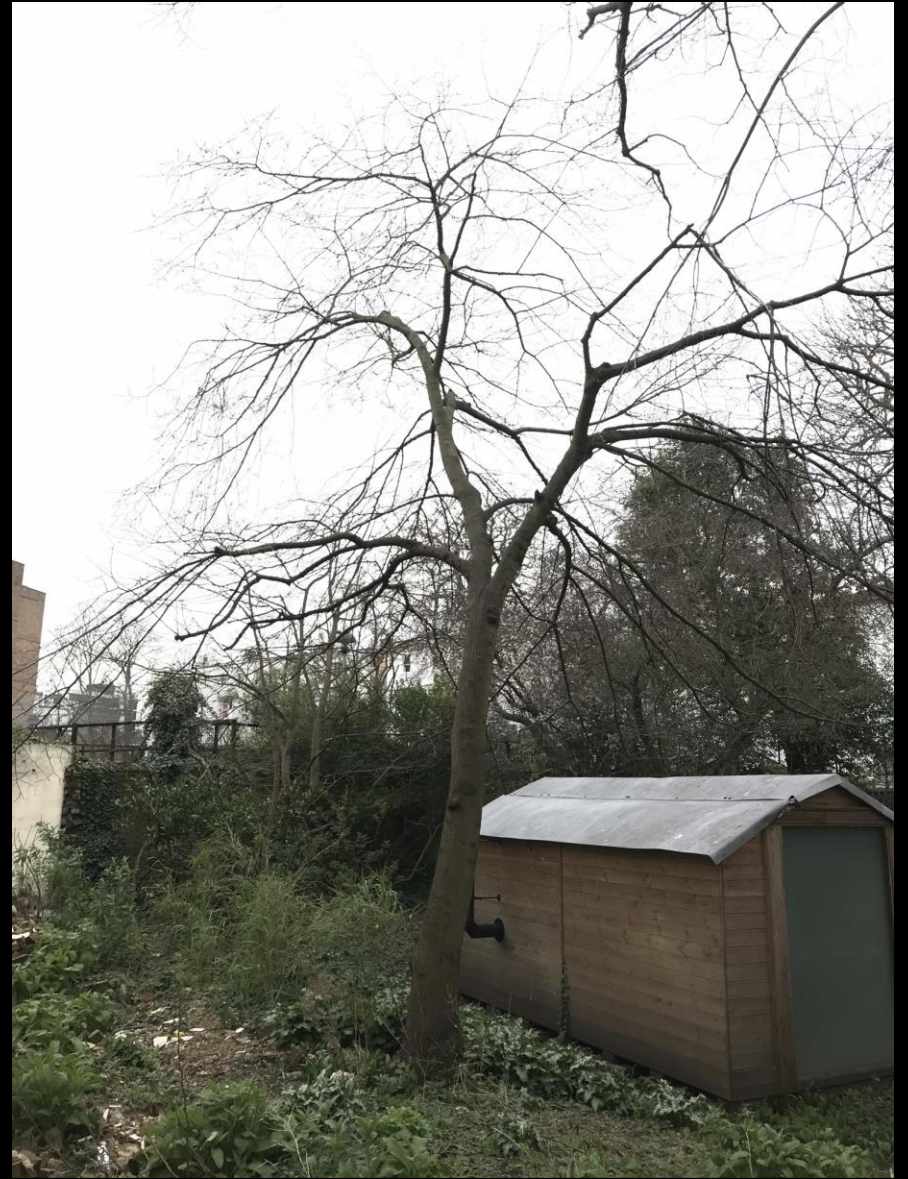
- 4.2. Tree T1 is a relatively young Sweet Gum which has developed a poorly formed, asymmetric crown due to suppression by the adjacent lime tree (T2). It has been classed as category C specimen because of its poor form, although it does offer some positive screening and landscape benefits for the property associated with the garden.

Tree T1, viewed from south east

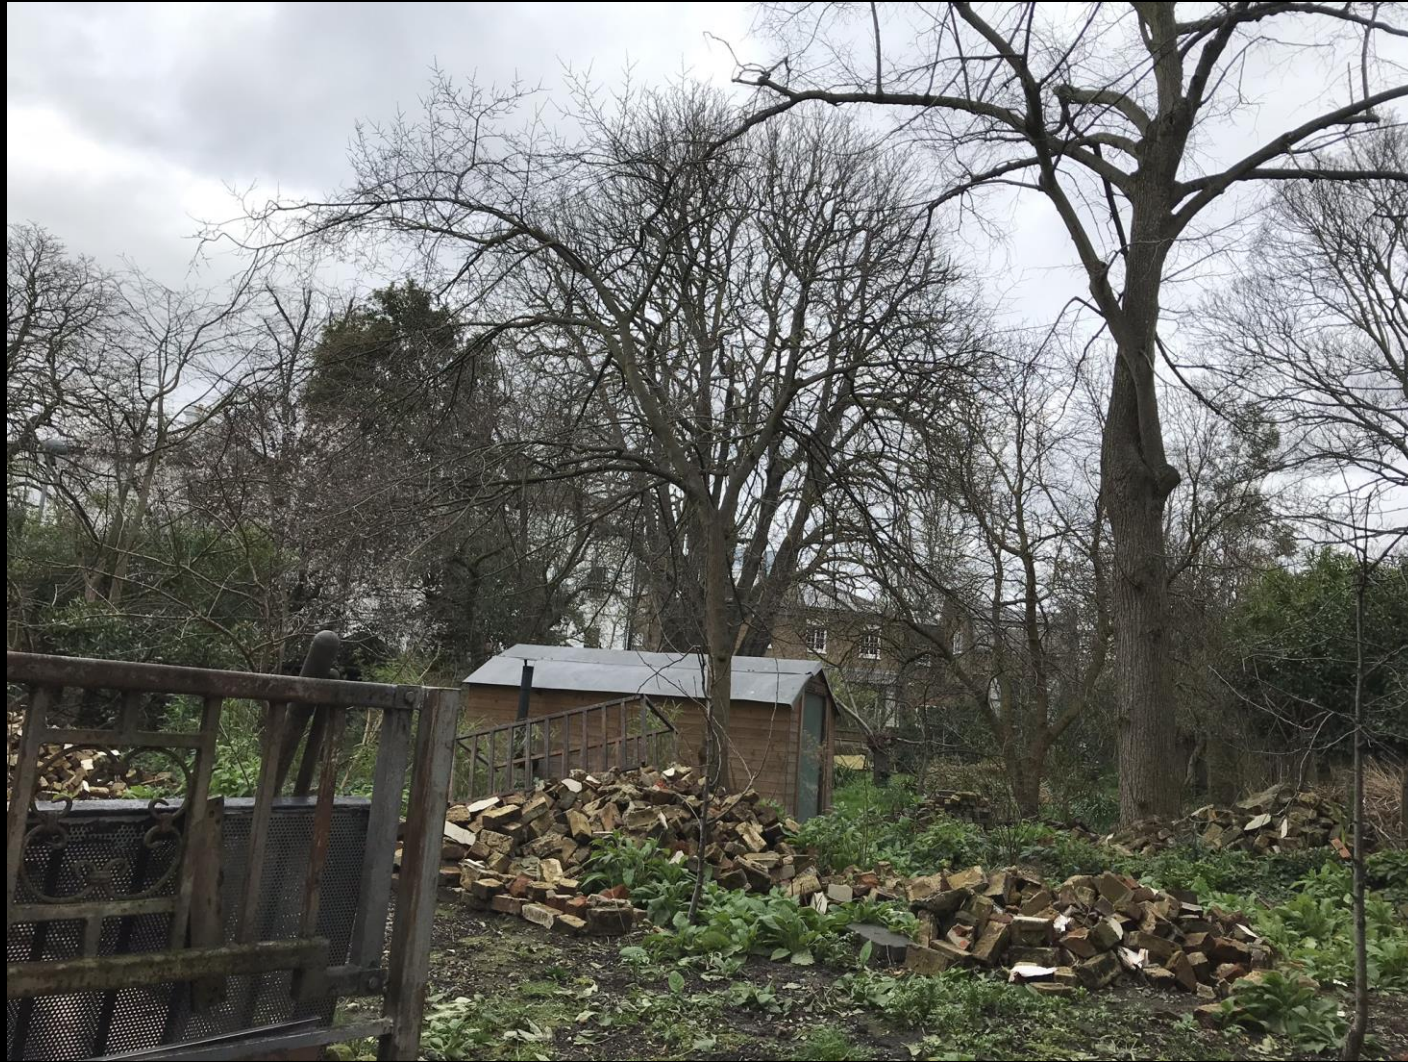
Trees T1 (right), T2 (left of centre) and rubble from old collapsed wall.

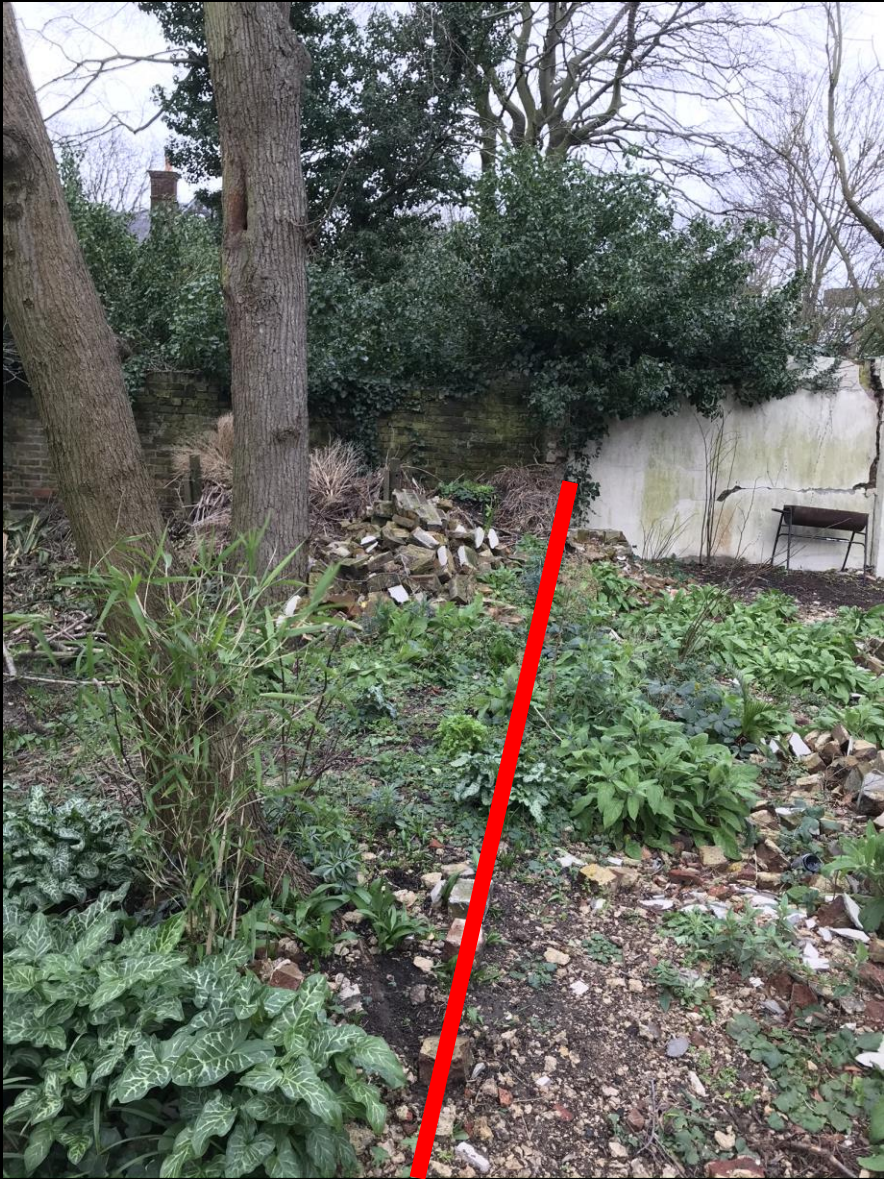
View from, approximately, north east. Approximate course of wall shown adjacent trees T1 and T2, by red line

- 5.12. I recommend that a bridged section be constructed over the area closest tree T1 and T2, to allow for expansion of the buttress and avoid damage by direct contact in maturity. This also has the added benefit of allowing wildlife, such as hedgehogs, to pass through the areas.

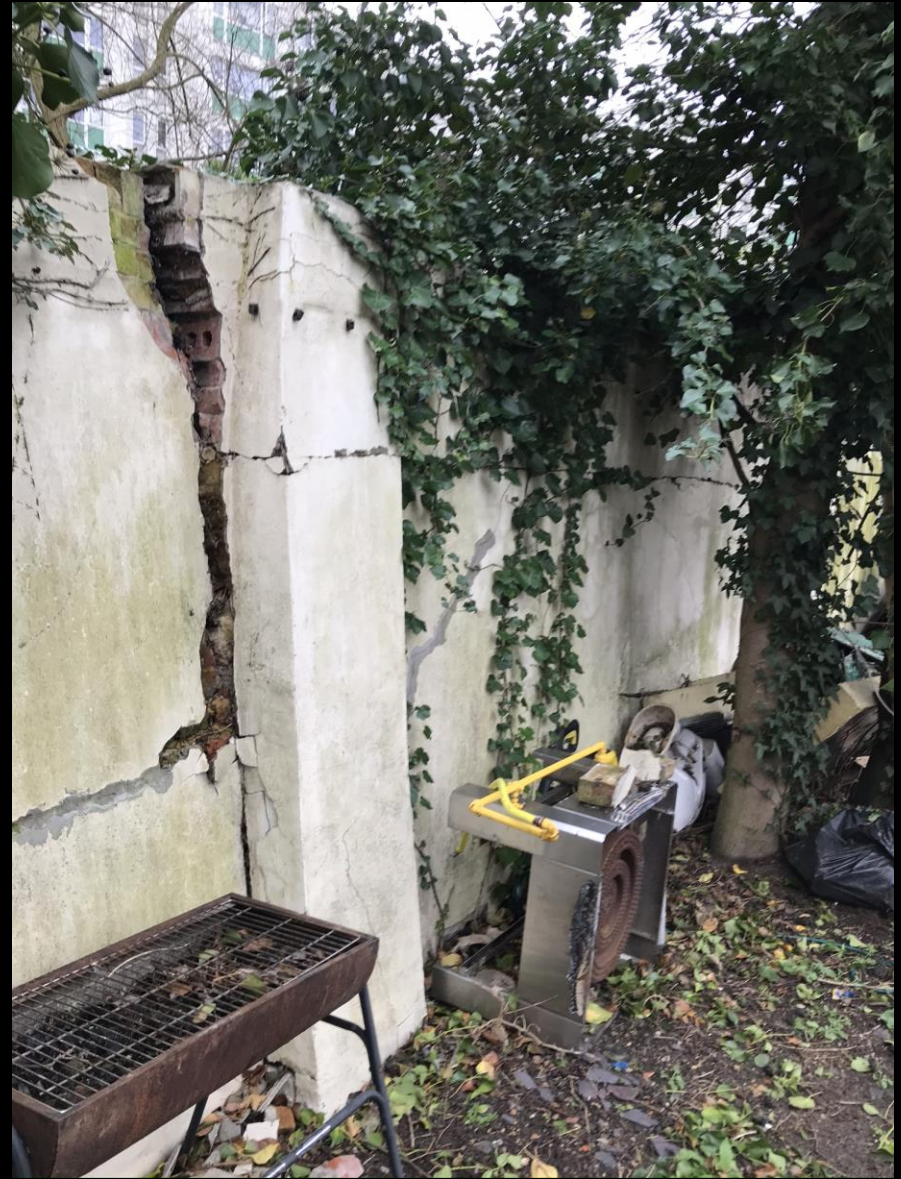
Poor condition of wall near trees T3 and T4.

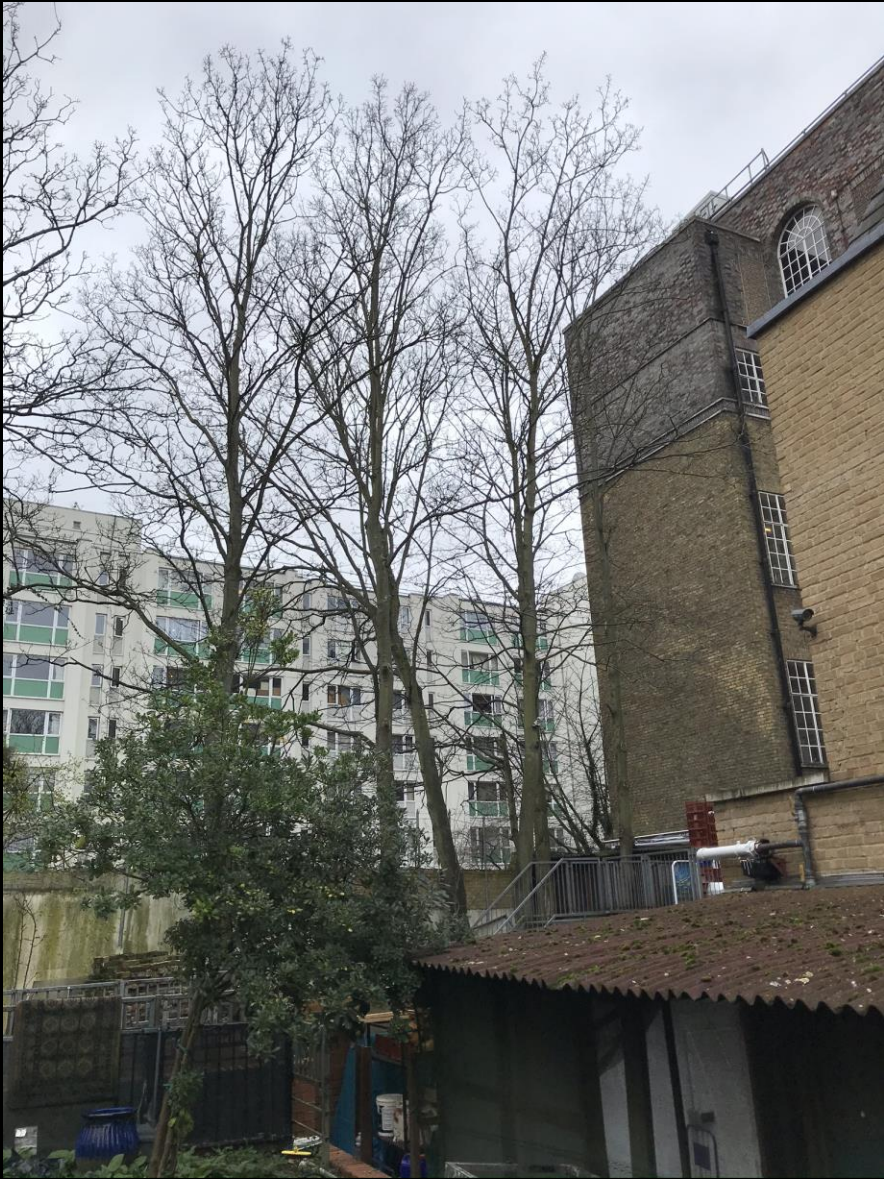
- 4.7. Trees T3-T10 all grow in close proximity to each other in a confined area to the south-east of the open space at the rear of a telephone exchange, adjacent to 140 Maida Vale. They are all Sycamore and although individually they are unremarkable in form they do offer a collective value and provide positive environmental benefits to the area.

Trees T5-T10 in south east corner of site
