1-38-4952

## REPORT

on trees in relation to  
13a Mornington Place, London, NW 1  
7RW  
for PBA Consulting

JOHN CROMAR'S  
ARBO RICULTURAL  
COMPANY LIMITED

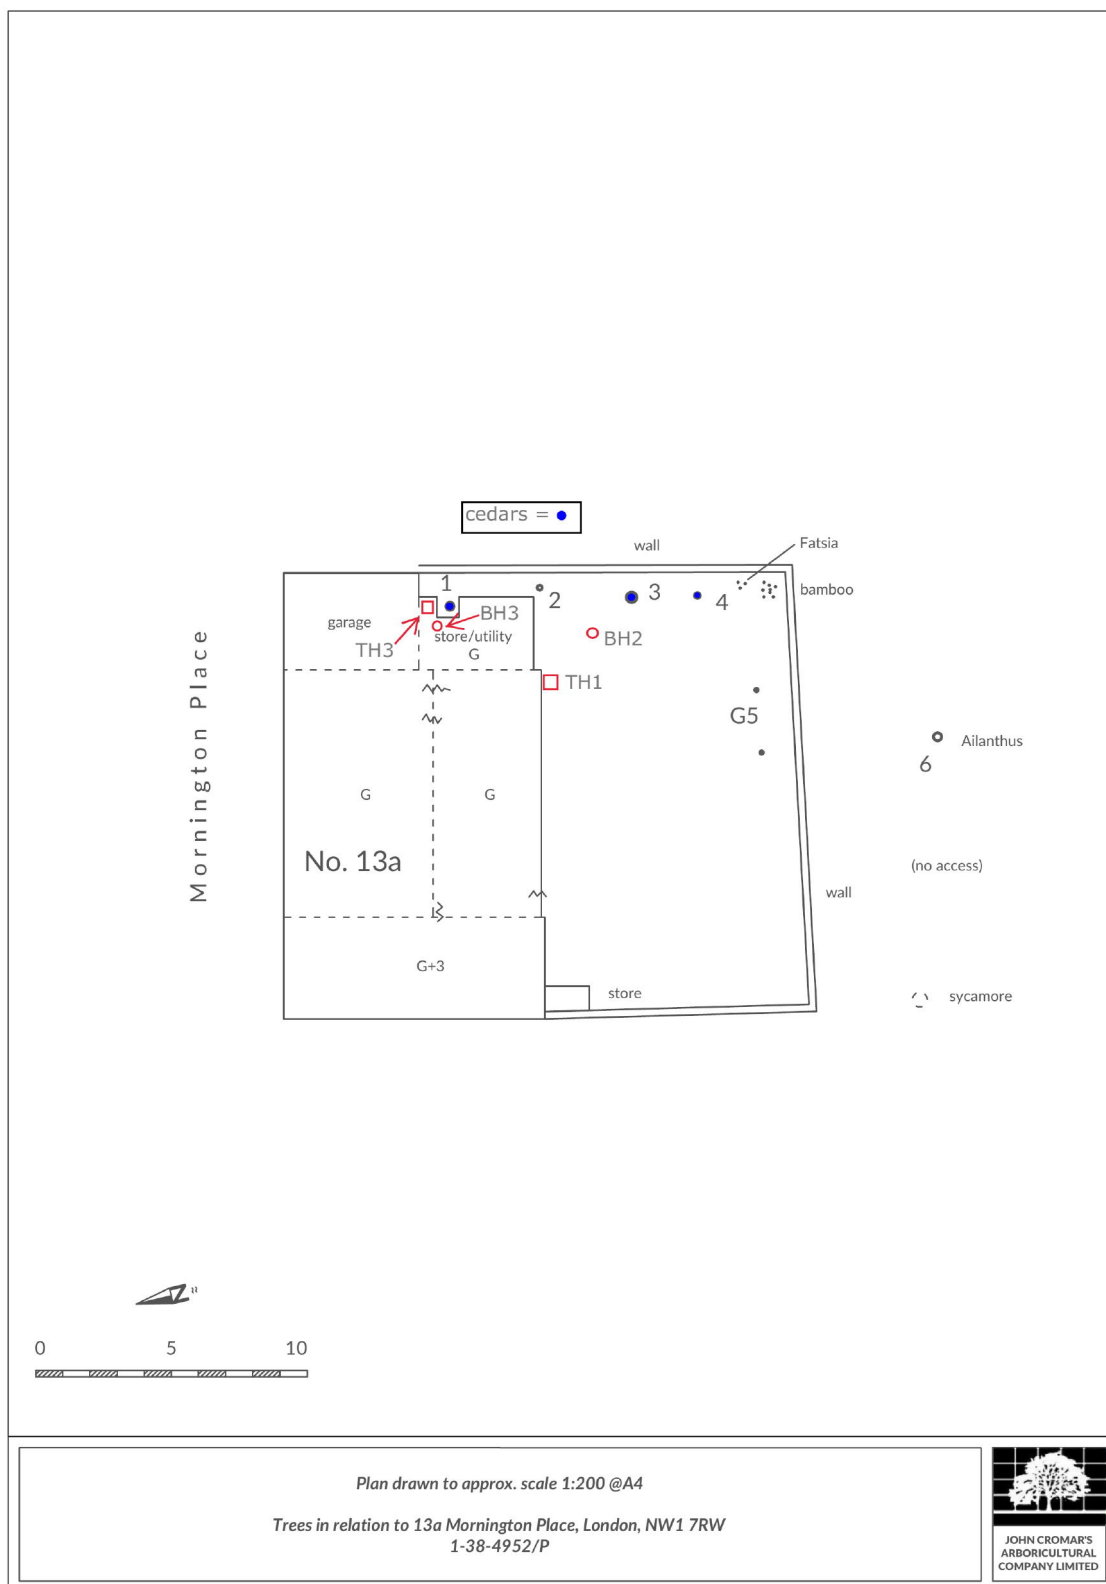
10 Plan

Tree number	Tree type	Height	Stem diameters	Proximity	Comments	Now	Repeat (Y/N +any repeat in years)	Reason	Cost - £
1	blue Atlantic cedar	14	300	0.8	No access. Remove to ground level.	Y	N	Suspect	950
2	Lawson cypress	12	200	0.4	Remove to ground level.	Y	N	Suspect	550
3	blue Atlantic cedar	14	382	3.64					
4	blue Atlantic cedar	11	213	6.19					
G5	evergreen magnolia	4	<120	8.3					
6	tree of heaven	13	300	14.5	No access.

Tree number	Tree type	Height	Stem diameters	Proximity	Comments
1	blue Atlantic cedar	14	300	0.8	Remove to ground level.
2	Lawson cypress	12	200	0.4	Remove to ground level.
