SUPPLEMENTARY INVESTIGATION REPORT

CRACK DAMAGE

Address of Insured: 13A Mornington Place

Situation of Damage: Rear Extension

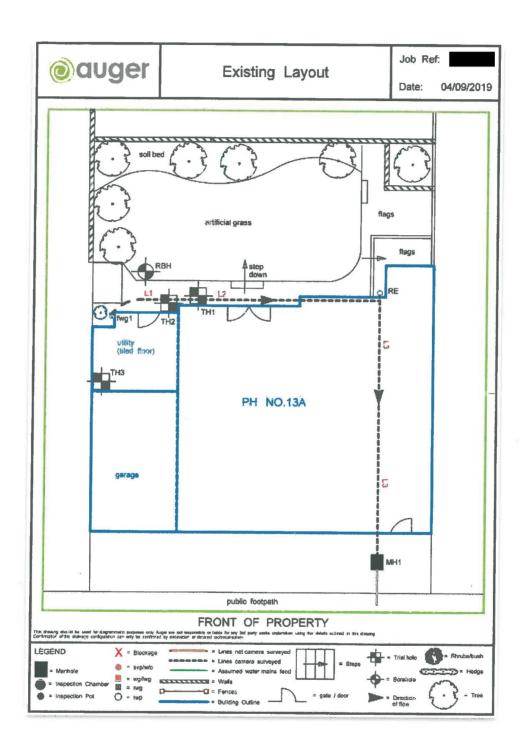
| © CI | ger | Trial Hole Log No Location: Internal in utility | | Job Ref | | |
| Depth (m) | Symbolic Log Strata Description | | | Insitu Tests SV(19) Of | | Root Sample |
| 0.0 | 150mm | Ground Level Tites Brickwork Single Step | 884;58 | | Soil | Root |
| .5 | | Dry very stiff brown CLAY with occasional stone inclusions | 98kpa | | © 1.3m Soil © 1.8m | @ 1.3m Root @ 1.8m |
| 5 | | | 130kpa 130kpa | 300 - 440 | Soil 2.3m Soil 2.8m | Root @ 2.3m Root @ 2.8m |
| 0 | | TRIAL HOLE TERMINATED | 130kpa | | | |

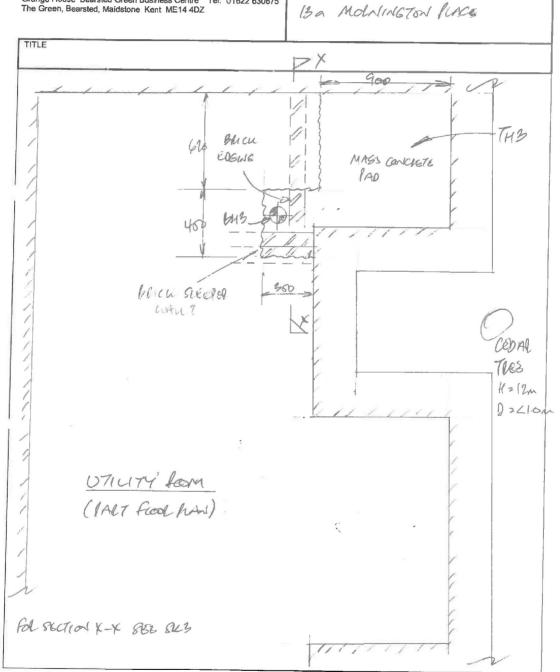
Details of the trial pit are included within Auger's report and our more detailed sketches 19088/SK2 and SK3. The trial pit revealed an unreinforced concrete slab varying between 150mm and 200mm thick, beneath which was a tarpaulin, assumed to act as a DPM (?). Adjacent to the rear wall a further 150mm concrete slab was found beneath the upper slab, although this was not present adjacent to the projection along the right-hand flank wall.

In the comer of the room the top and edges of a concrete pad foundation were uncovered. Probing indicated this extended to a depth of 1.3m below floor level.

13a Mobilial Ton PLACE TITLE 88CT(0) X-X = TH/6013 GALAGE WALL SITE TOP ON CONCRETE WAR ON SLAG. 18AD) FOUNDATION 150 conschits scory loo the conclute slab 80m. SANO TARPAULIN DAM? ALL PACK SLEEPER WAR ? 150 CONCRETE blica Suas BOGING MANY LARGE ROOTS AT MALLOW DEFTH (10-20 BIAMETON). MADE GLOWID BOTTOM OF FOUNDATION (AS PLOBED) VERY BRY FRAGIE SANDY CINY WITH SMAN FUNTS, BLICK & GLASS FOREMENTS + DOUTC (MADE GLOUND) AS 1.3-1.8 m (MADE GROWN) + lests -2.3m VOLY STIFF BRYCHY WITH FILLTS, below, concerté & GLASS (MADE GROUND PRESTS / PP = 300+, 444 Klar). AS 9.3-2-8m (MADE GROWD) +loo(s (18 = 1504). Bol To 3.2m -

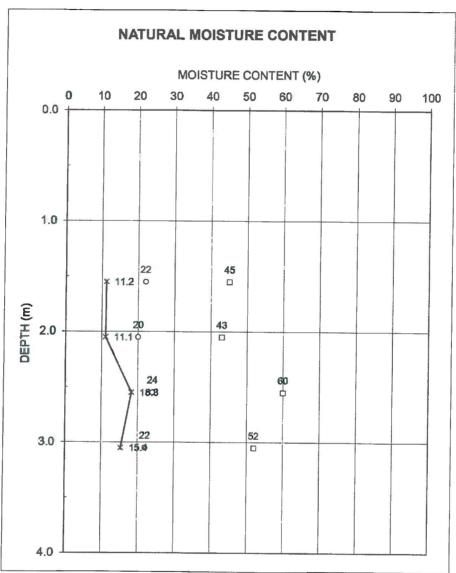
| SO | Itec | PLA | STICITY INDEX | | | |
|---|---|---|---|---|---|---|
| | Sample description | i | Dark brown sandy clay with brick and glass fragments | | • | |
| | Natural Water Content | : | 11.2 % DES | (CCATED | | |
| | Liquid Limit | : | 45 % | 0.4LC, | 18% | |
| | Plastic Limit | : | 22 % | B~C 2 | 13.02 | |
| | Plasticity Index | ; | 23 % | | | |

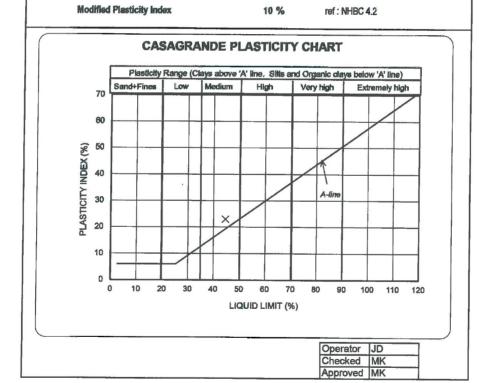
| 201 | | PLAS | TICITY INDEX | | | |
|---|---|---|--|---|---|---|
| | Sample description Test Method | ; | Dark brown sandy clay with brick, concrete and glass fr BS1377:Part2:1990:4.3 Mu | agments | | |
| | Natural Water Content | : | 11.1 % | ESICCATON |) | |
| | Liquid Limit | : | 43 % | | | |
| | Plastic Limit | * | 20 % | | | |
| | Plasticity Index | : | 23 % | | | |
| | Modified Plasticity Index | | 11 % | ref : NHBC 4,2 | | |

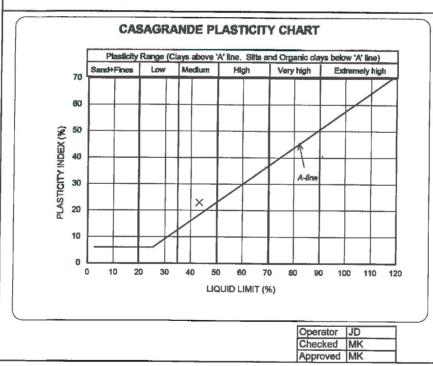
| Soi | | PLASTICITY | INDEX | | |
|---|---|---|---|---|---|
| | Sample descrip | tion : Dark brown | sandy clay with abun | lant small flints, | |

brick, concrete and glass fragments

18.3 %

DESICCATOD

60 %

24 %

36 %

29 %

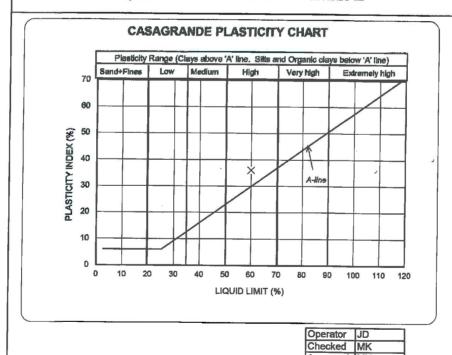
| So | | PLA | STICITY INDEX | | | |
|---|---|---|--|---|---|---|
| | Sample description | : | Dark brown mottled orange scattered brick, glass fragm | | | |

Natural Water Content : 15.4 % NES ICCATED

Liquid Limit : 52 %
Plastic Limit : 22 %

Plasticity Index : 30 %

Modified Plasticity Index 22 %
