Asbestos Survey Report 01/09/2019

Refurbishment Survey

Specified Areas Of 106 King Henry's Road

106 King Henry's Road

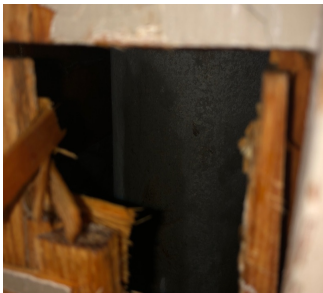
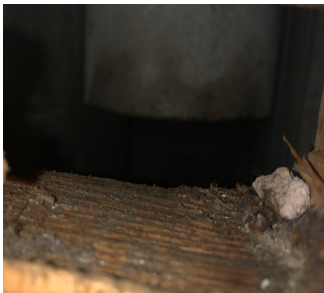
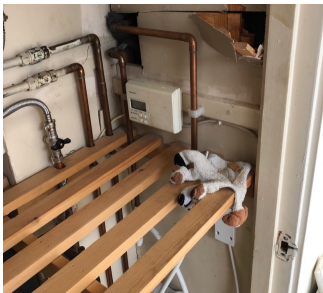
Item ID	001(OS)
Sample/link ID	AA10620-001
Property Name	Specified Areas Of 106 King Henry's Road
Area/floor	001
Room/location	004
Specific location	Wall
Product/debris type	Cement Product(s) Flue Pipe
Asbestos type	Identified Amosite
Extent	3 m
Accessibility/vulnerability	Low
Additional information	Not Sealed
Licensed/non-licensed	Non-licensed
R&D Element:	Yes
Air Test	-

Product Type (a)	1
Extent of Damage (b)	1
Surface Treatment (c)	0
Asbestos Fibre (d)	2
Total (a+b+c+d)	04
Material Risk Assessment	<div></div> Very Low

Action/recommendations	Remove ACM before Refurb. Work under FCC by FLC
------------------------	---

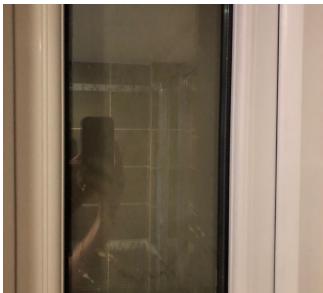
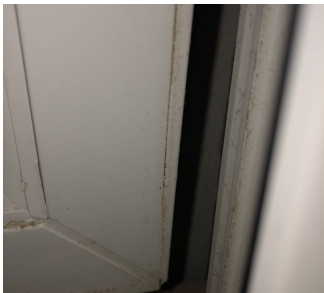
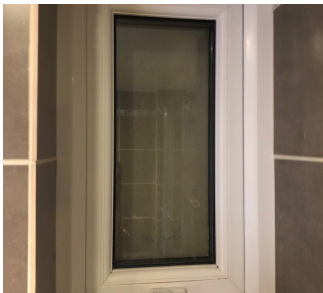
Item	Area/floor	Room/location	Reason
002	001	008	N/A due to panels behind behind small window.

Item ID	002
Property Name	Specified Areas Of 106 King Henry's Road
Area/floor	001
Room/location	008
Specific location	Wall
Product/debris type	Insulation Board Panel(s)
Extent	1 m²
Accessibility/vulnerability	Low
Additional information	Not Sealed

Product Type (a)	N/A
Extent of Damage (b)	N/A
Surface Treatment (c)	N/A
Asbestos Fibre (d)	N/A
Total (a+b+c+d)	12
Material Risk Assessment	<div></div> High

Action/recommendations	Remove ACM before Refurb. Work under FCC by FLC
------------------------	---

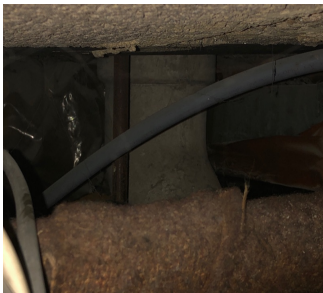
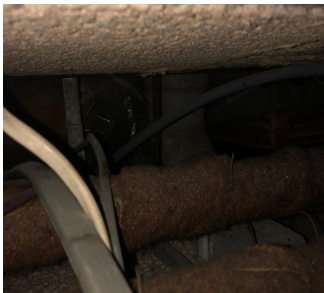
Item ID	003(VRS)
Sample/link ID	AA10620-001
Property Name	Specified Areas Of 106 King Henry's Road
Area/floor	001
Room/location	010
Specific location	Wall
Product/debris type	Cement Product(s) Flue Pipe
Asbestos type	Identified Amosite
Extent	3 m
Accessibility/vulnerability	Low
Additional information	Not Sealed
Licensed/non-licensed	Non-licensed
R&D Element:	Yes
Air Test	-

Product Type (a)	1
Extent of Damage (b)	1
Surface Treatment (c)	0
Asbestos Fibre (d)	2
Total (a+b+c+d)	04
Material Risk Assessment	<div></div> Very Low

Action/recommendations	Remove ACM before Refurb. Work under FCC by FLC
------------------------	---
