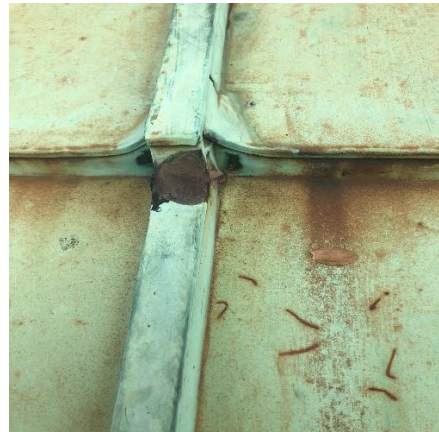
Repaired batten roll end with Mastic

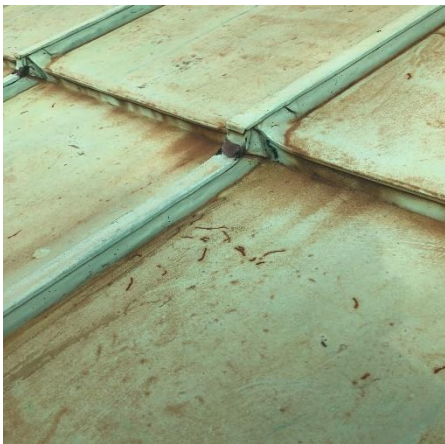
Evidence of rusting from underside corrosion

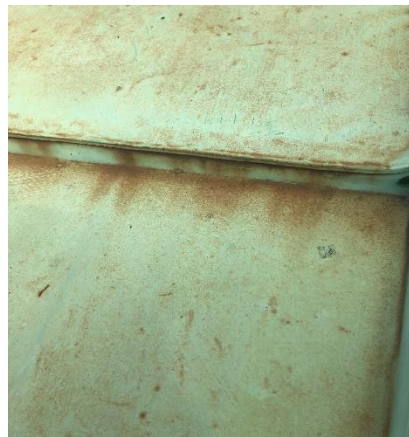
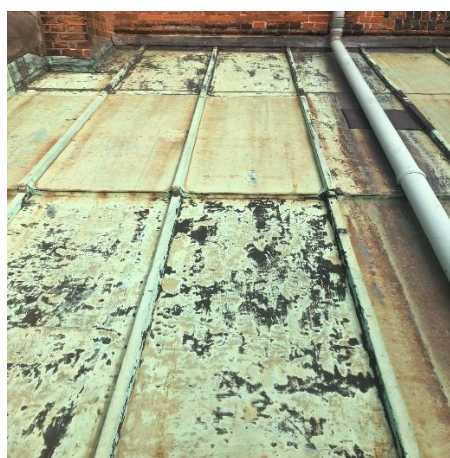
Evidence of historic bitumen paint

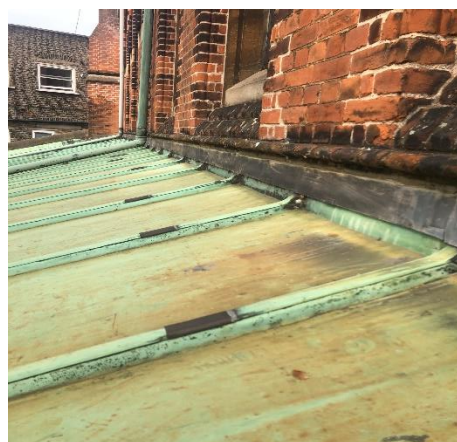
Patch repairs over batten rolls

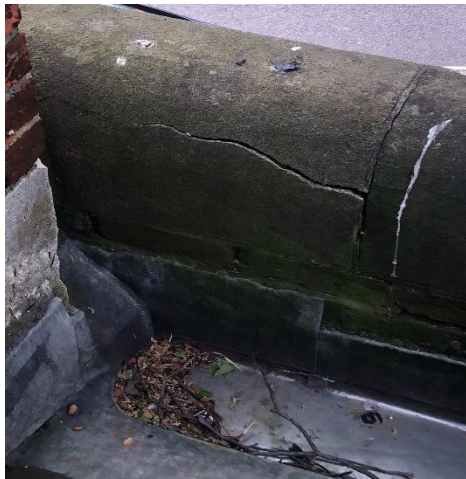
Large crack in coping

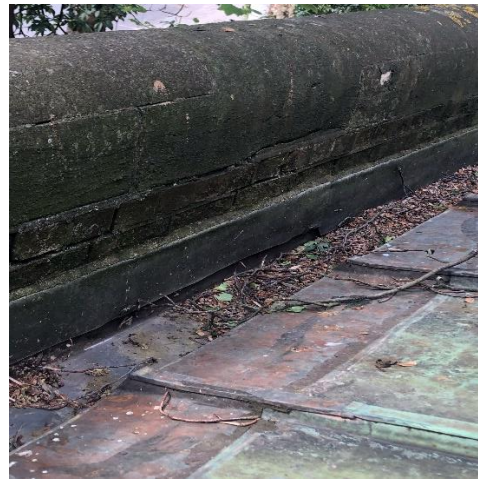
Missing pointing to parapet brickwork

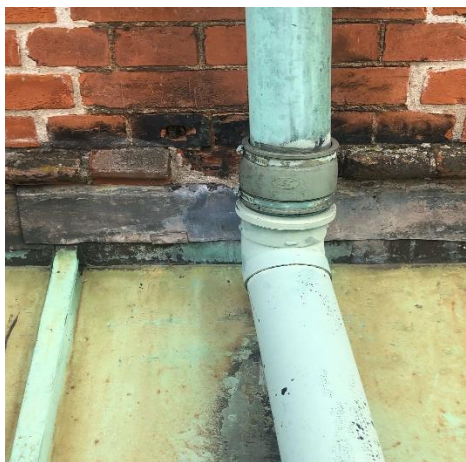
RW pipe unfixed at the bottom, poor brickwork.

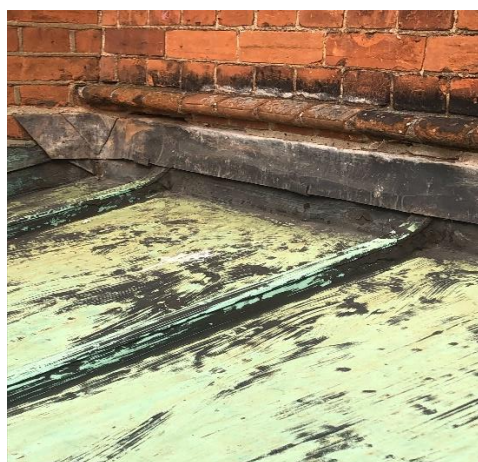
Missing pointing above lead flashing

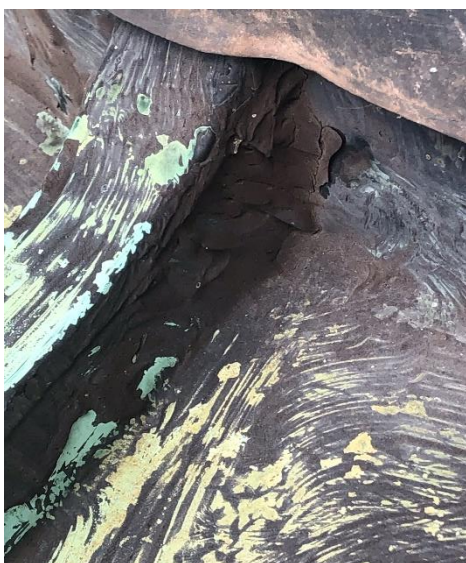
Mastic repair to batten roll

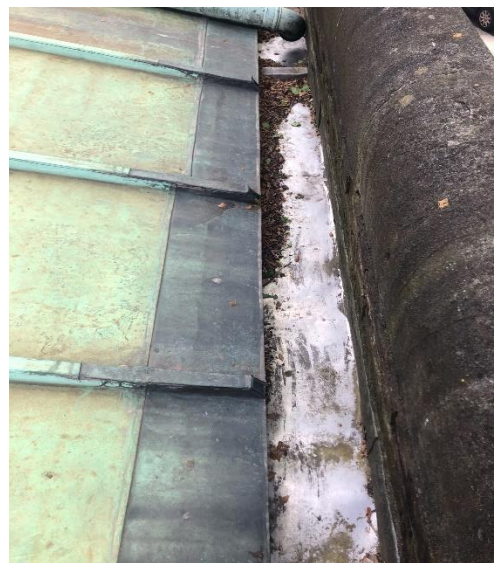
Stainless steel gutter lining
