12141gs-c111012cl-kam

12 October 2011

1A GLASTONBURY STREET, LONDON NW6: STRUCTURAL ENGINEERS REPORT

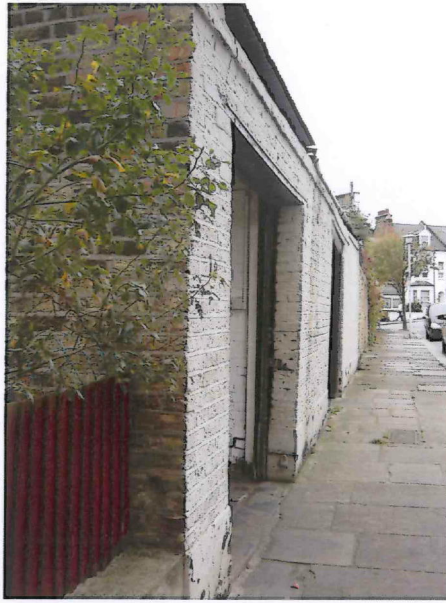
- 1.6 We note the front brick panel between the two garage doors is leaning outwards (see plate 2).
- 1.7 The brick above the main garage door lintel has cracked due to the undersized timber lintel (see plate 6). The brickwork is not tied to the roof joist and in fact there is a gap between the roof and the brick work (see plate 3). Over time this brick can become unstable and collapse.

Plate 2: Central brick pier leaning outwards at top

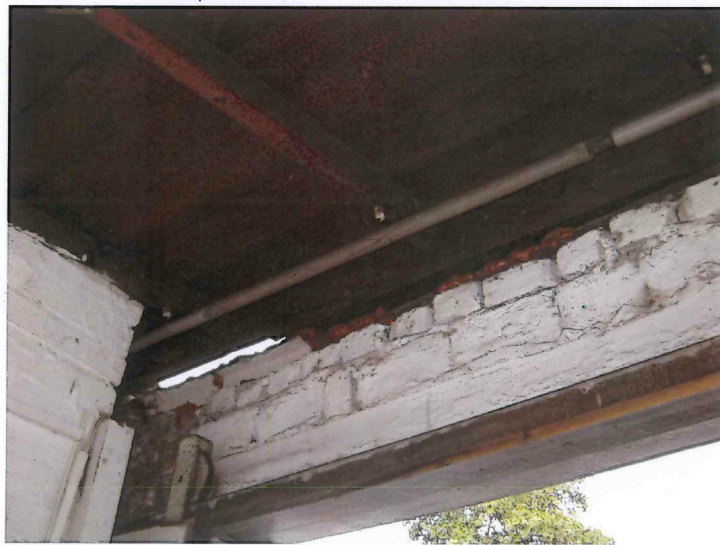
Plate 3: Brick above timber lintel to front not tied to timber roof

- 3.1 Install steel columns on pad foundations to provide additional restraint to the brick wall to the rear. We envisage 3 no. posts which will be tied to the timber roof.
- 3.2 All the timber lintels will need to be upgraded to concrete lintels.
- 3.3 Standard 35 x 5mm mild steel roof straps will need to be installed around the perimeter of the roof to provide restraint to the brickwork.
- 3.4 The central brick pier to the front that is bowing outwards will need to be tied back to the return wall.
- 3.5 General brick stitching will be required incorporating Helifix stainless steel bars.
- 3.6 A structural specification will be required to quantify the repairs in more detail.

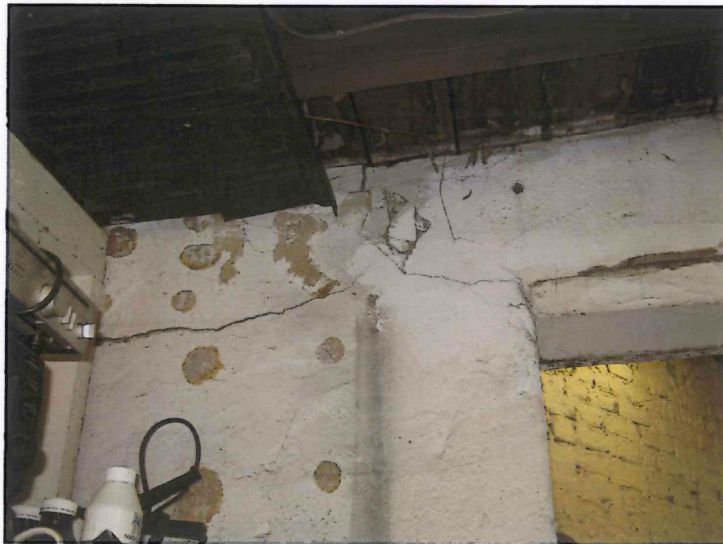
- 1.4 There is a vertical crack between the rear wall and the return wall to the right hand side of the timber panels (see plate 7). The return wall has horizontal fractures to the brickwork (please refer to plate 4)

Plate 4: Crack to rear brick pier

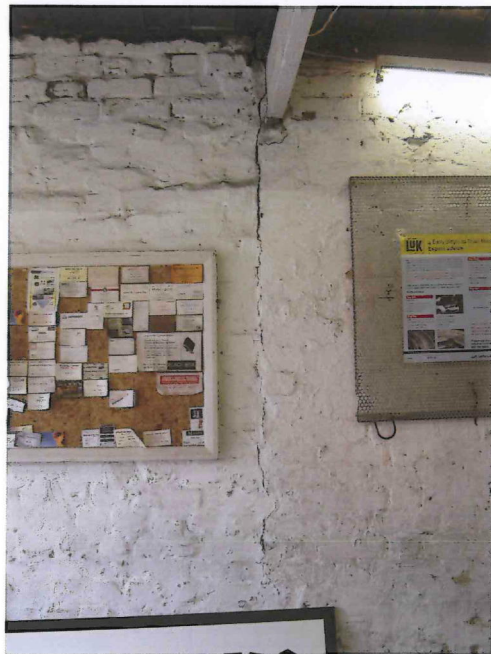
- 1.5 We note that the vertical crack to the left hand side brick wall is at the junction of the flank wall of the house and the new brick extension of the garage (see plate 5). The brickwork does not appear to be bonded and is a straight joint. This crack appears to be due to differential settlement between the two different foundations.

Plate 5: Vertical crack to left hand side flank wall

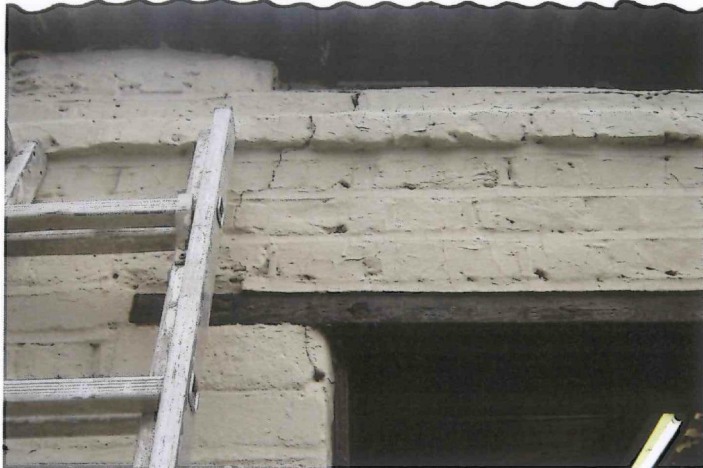
Plate 6: Crack to LHS above timber lintel bearing

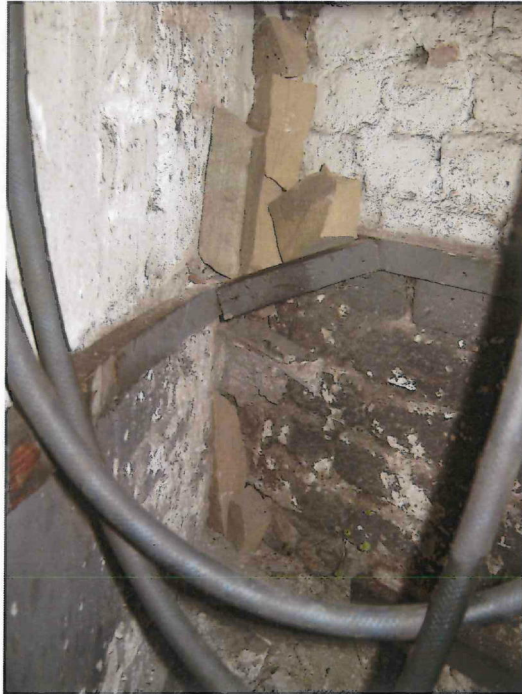
Plate 7: Vertical crack at junction of rear wall and return wall

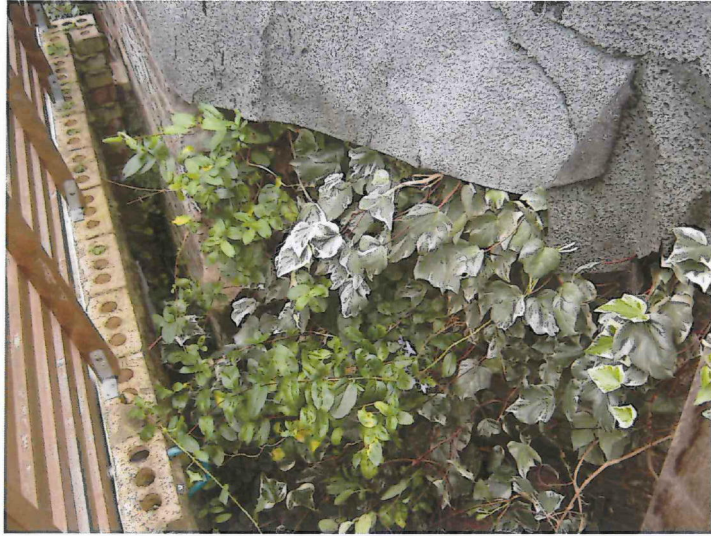
- 1.2 We had access the rear of the garage by the removal of a timber panel. This revealed a small strip of land overgrown with ivy. It was not possible to see the tree stump (see plate 8).

Plate 8: Rear external area
