4th March 2014
Ref: HCS/114/Ltr03

1A Glastonbury Street, London, NW6 1QJ
Change of Use Report

Further to our inspection on 4th February 2014 and review of the following documentation we write to provide our advice regarding the above.

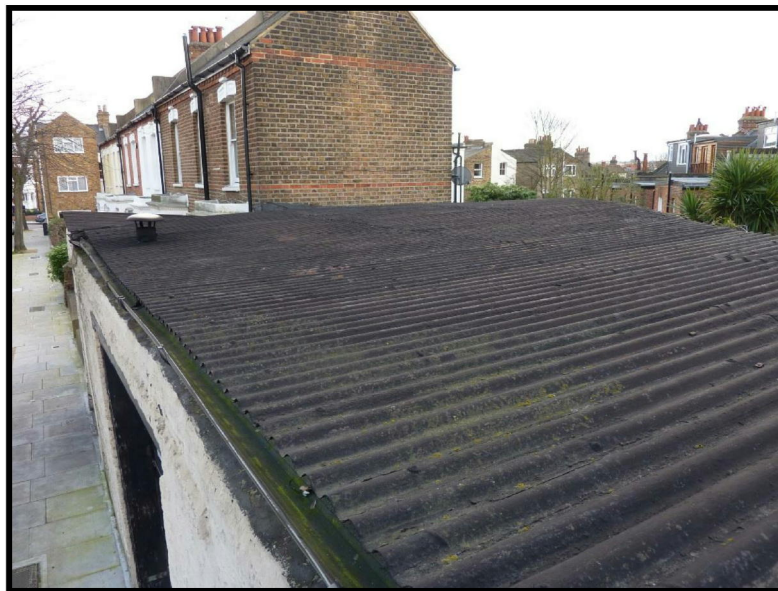
The roof coverings are aged and appear to have received a bituminous coating in a supposed attempt to prevent water penetration. Internally evidence of water ingress is wide spread with extensive staining to the underside of the timber deck.

PHOTOGRAPH 2 – Roof coverings.

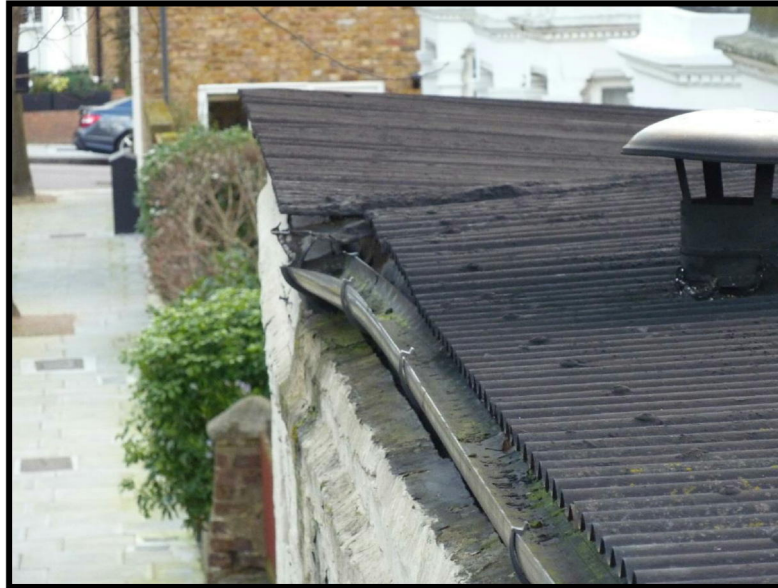
The roof coverings fall short of the face of the front elevation, consequently the gutter is situated over the wall therefore should the gutter overflow it is likely to enter the building. Furthermore the gutter has been installed to drain over the front elevation at the left end, this is a poor detail and a downpipe should be installed. Presently we envisage water is entering the building due to this defect.

PHOTOGRAPH 3 – Defective guttering.

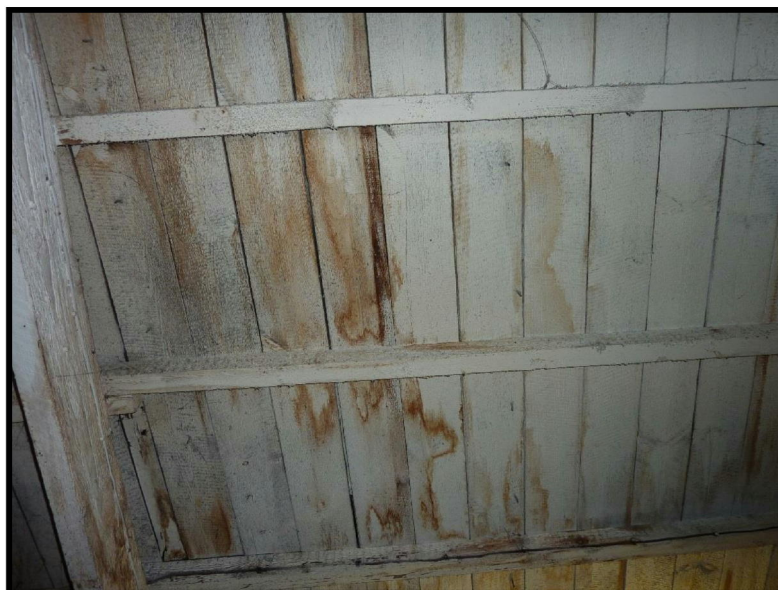
PHOTOGRAPH 4 – Water ingress through ceiling.

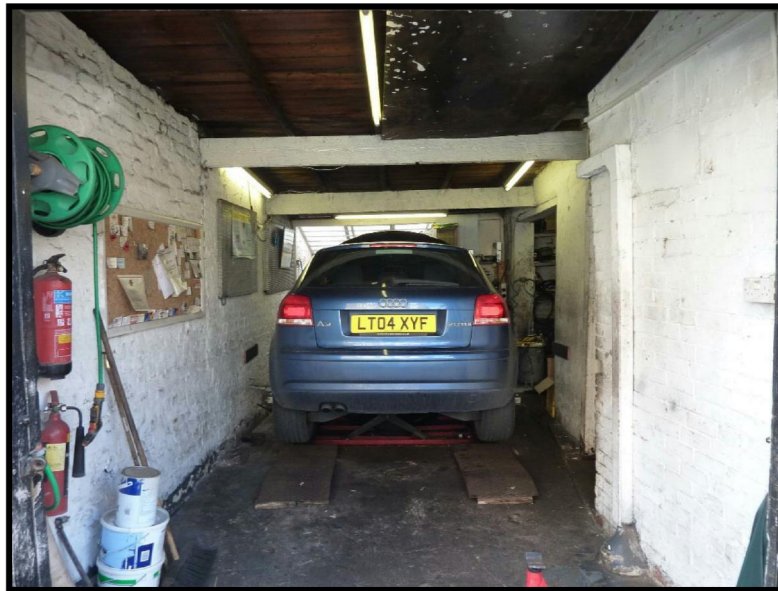
- The building has a relatively small floor area, barely adequate to fit one regular-sized car with no additional parking allocated to the property for other vehicles. Glastonbury Street has permit parking therefore no additional parking is known to be available to the business. During our inspection work was being undertaken to a van on the street as the workshop will not accommodate a vehicle of this size.

- The infrastructure serving the property is not adequate to allow the delivery of damaged motor vehicles to site.
- The ceiling height is approximately 2.6m high and there is no mechanics pit, therefore working underneath vehicles is challenging and potentially hazardous.

PHOTOGRAPH 5 – Limited workshop area.

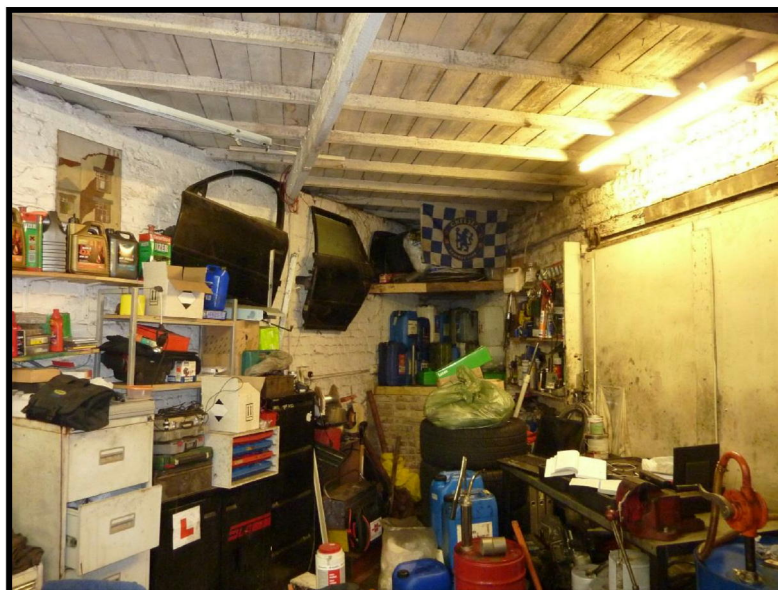
- The W.C. is unsanitary and unfit for purpose.
- The floor is uneven and the screed has broken-up in places causing trip hazards.
- The area is generally damp and there is evidence of water ingress raising concerns over the electrical installation.
- The area presents a high fire risk due to the number of flammable substances, lack of compartmentation and unclear escape routes.

PHOTOGRAPH 6 – Flammable substances.

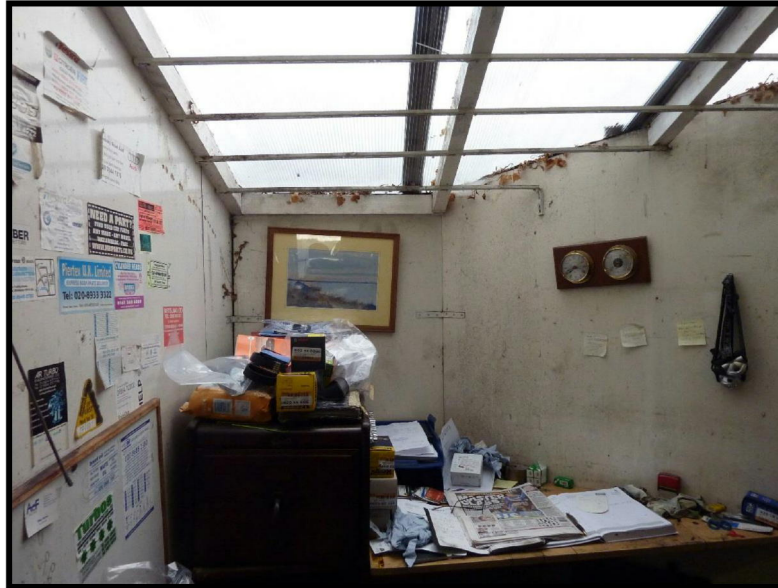
The construction concerning the rear lean-to is poor and there is evidence of damp in this area.

- The property is in a poor condition and likely to breach the requirements of the Workplace Regulations and Regulatory Reform (Fire Safety) Order.
- The premises are insecure as the sheet roof coverings over the office area to the rear are easy to penetrate and subsequently gain access through.

PHOTOGRAPH 7 – Office lean-to area.

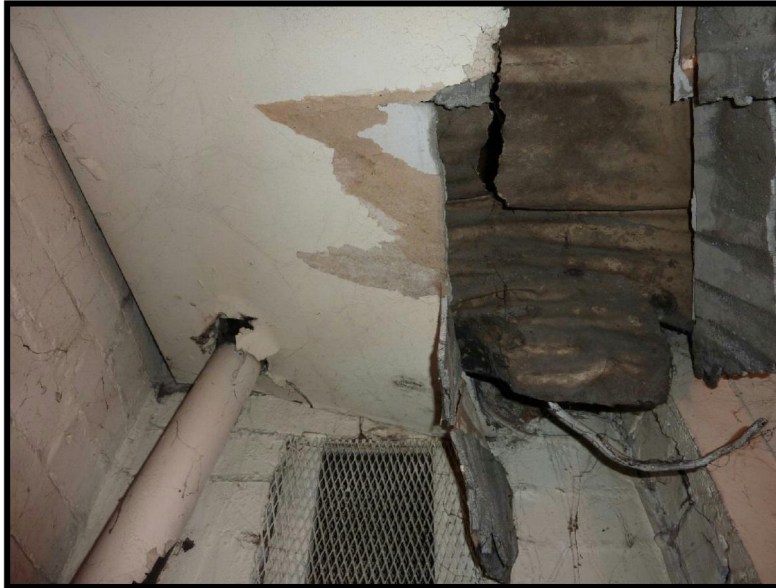
PHOTOGRAPH 9 – Damage to ceiling
