Project Name: Dr Williams Library

Conservation Engineering Report on
Works Proposed to the Library Building

Date: March 2020

Project Number: A6763

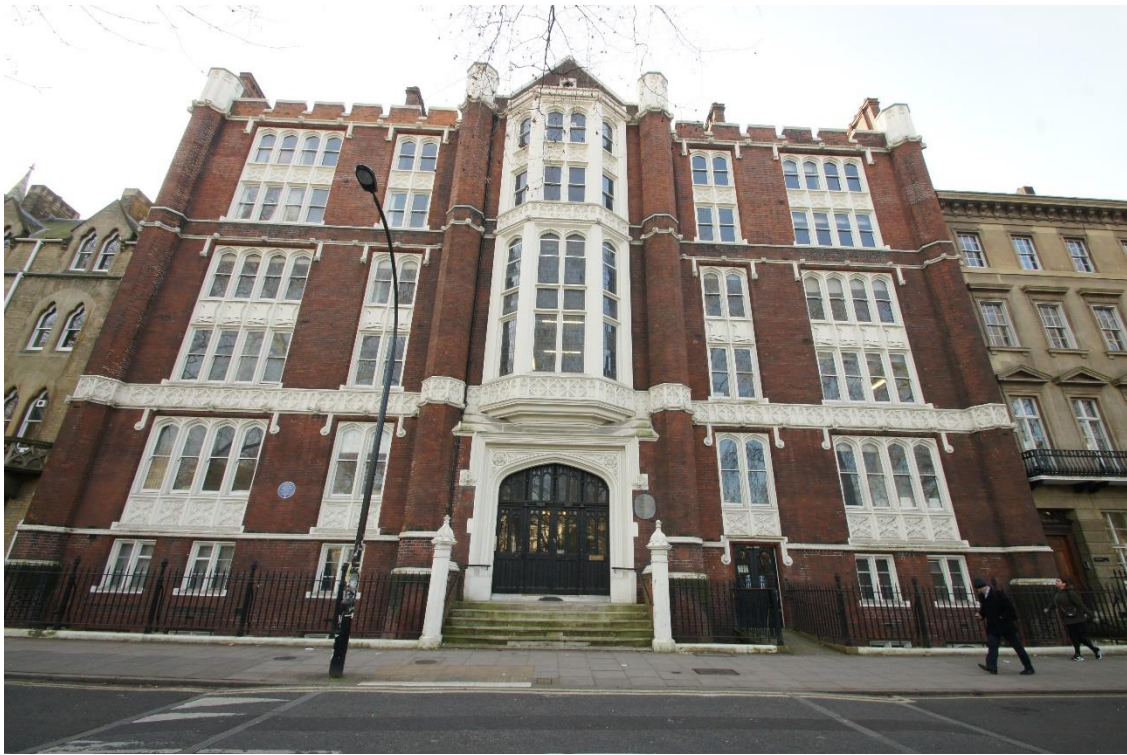
Photograph 1

- 1.4 Dr Williams' Library is a fine Grade II listed seven-storey loadbearing masonry building overlooking Gordon Square in London, WC1 (Photograph 1). It dates from 1848 and was built to designs by Thomas Donaldson. It has cellular offices and ancillary rooms arranged symmetrically north and south of a central core, in which the original two-storey lecture theatre, library and reading room are located. It is constructed in red and yellow stock bricks with stone features under a shallow-pitch roof.

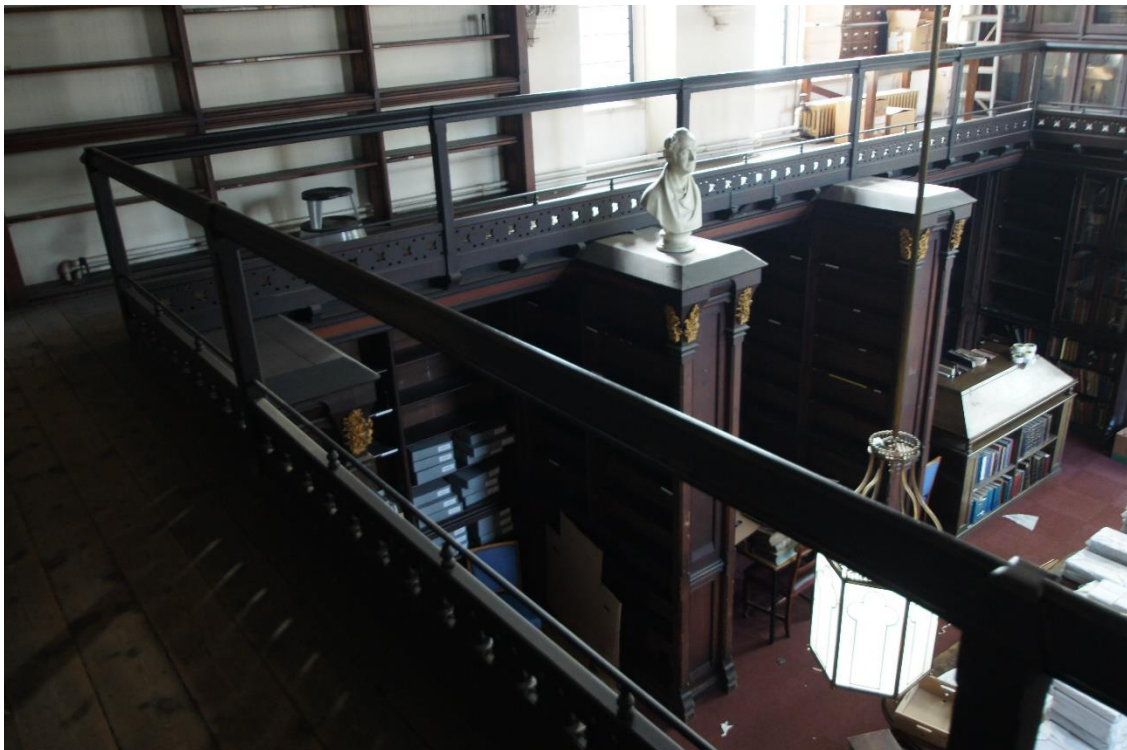
Photograph 2

2.1.3 Those earlier interventions involving addition include the balcony to the Reading Room at level 5 (Photograph 2), the two-stage walkways and the spiral stairs to the Library also around level 5 (Photograph 3), the new grid floor at level 7 (Photograph 4), the boarding-over of the book hoist and riser at the north and south ends of the corridor and the creation of a north accessible bridge-link to the front pavement at level 2.

- 3.4.1 The balconies around the reading room at level 5 will be extended out by about 550mm. The existing balustrades dismantled and reassembled with some new components, providing resistance to lateral loading and preventing falls in accordance with the modern standards in BS6399-Part 1 and the Building Regulations. These lightweight balconies are already supported on the structure bookcases and calculations will be undertaken to show how the slightly increased loads may safely be taken into this system. The twist from the balcony balusters will similarly be taken into existing balcony joists and capacity confirmed by calculation.
- 3.4.2 In this way the balcony balustrades will be dismantled for partial re-use but the balcony decks will not: they will be maintained and extended outwards.

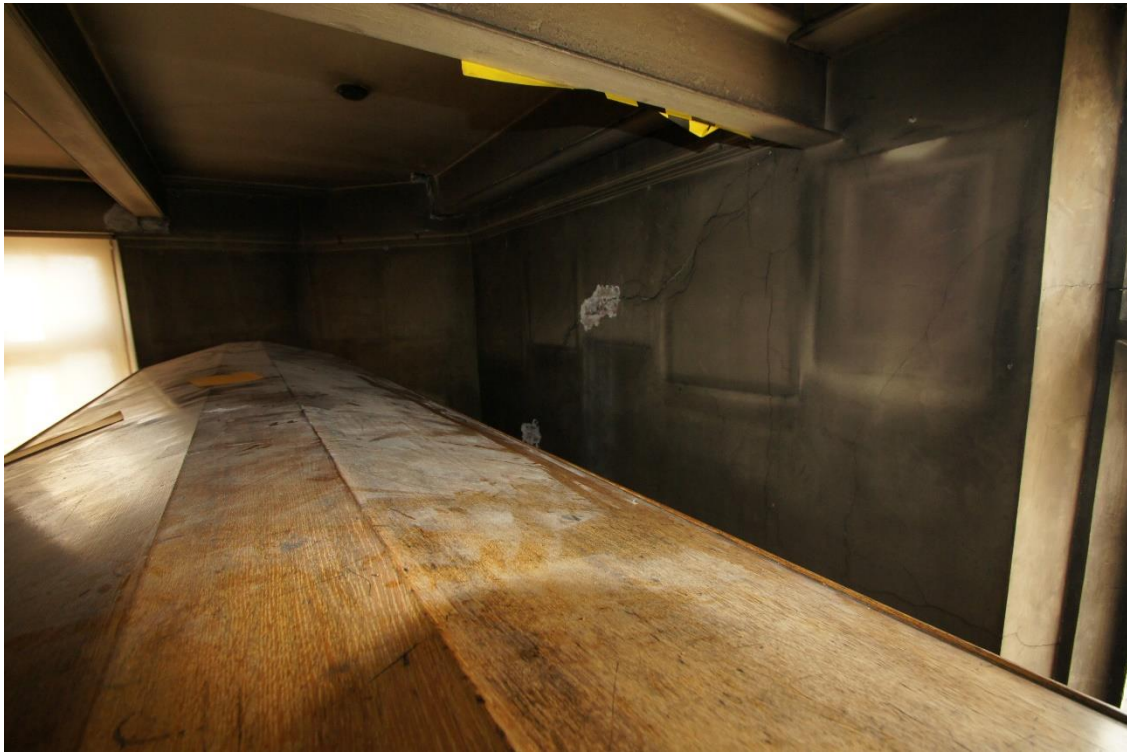
Photograph 5

- Slight diagonal cracks up to about 2mm wide to the rear wall, near the south-centre corner, between levels 6 and 7 (Photograph 5).
- Significant bowing (lean) in the chimneys
- A fractured tread to one stone pencheck (cantilever) stone stair on the south flights and damage to the landings from the introduction of building services (Photograph 6)
- Timber rots, potentially including dry rot, in the rear half-landing stores where water has wept from soil downpipes.

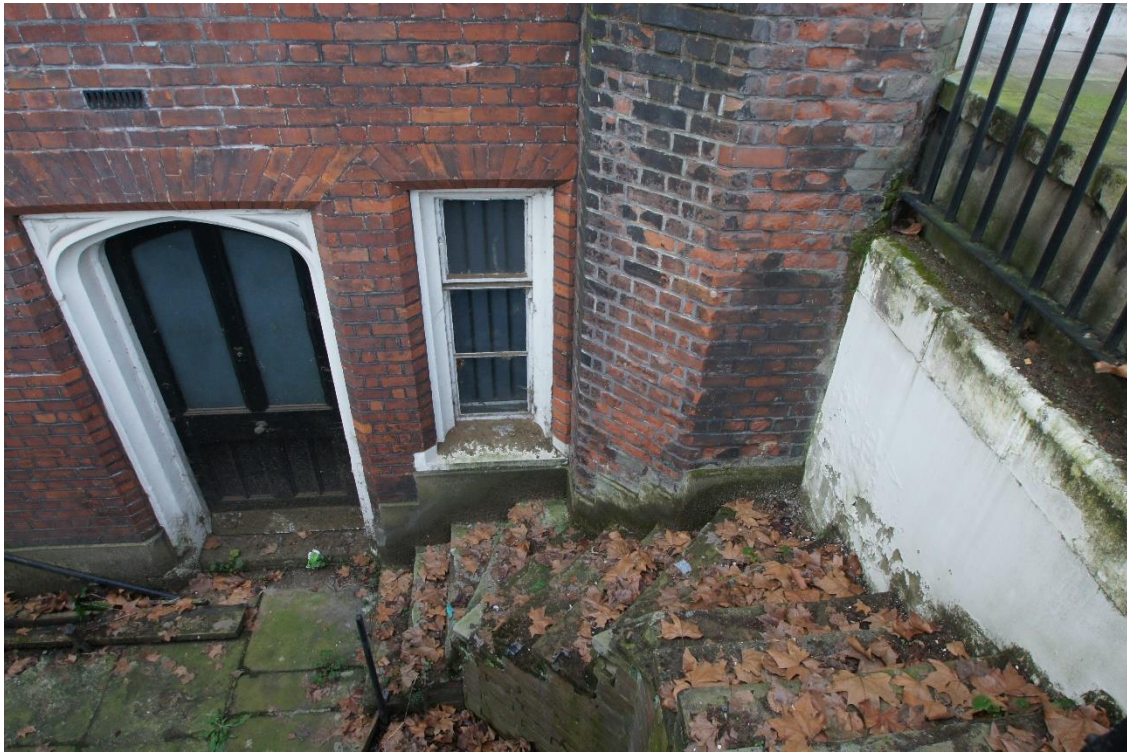
Photograph 7

2.2.4 The two external staircases in the front light well are a concern. The stone treads are built into the main façade and water collects at the edge, soaking into the brickwork, with damp penetrating the walls (Photograph 7). It is visible as staining and a greening with algae of the masonry. This is causing damp within the archives at level 1. It is a risk to fabric and it is proposed to remove the stairs and re-detail the flights.

3.7.1 As noted above, the detail of these stairs causes rainwater penetration and damp in the building. The existing stairs will be carefully dismantled and replaced by new steel stairs.

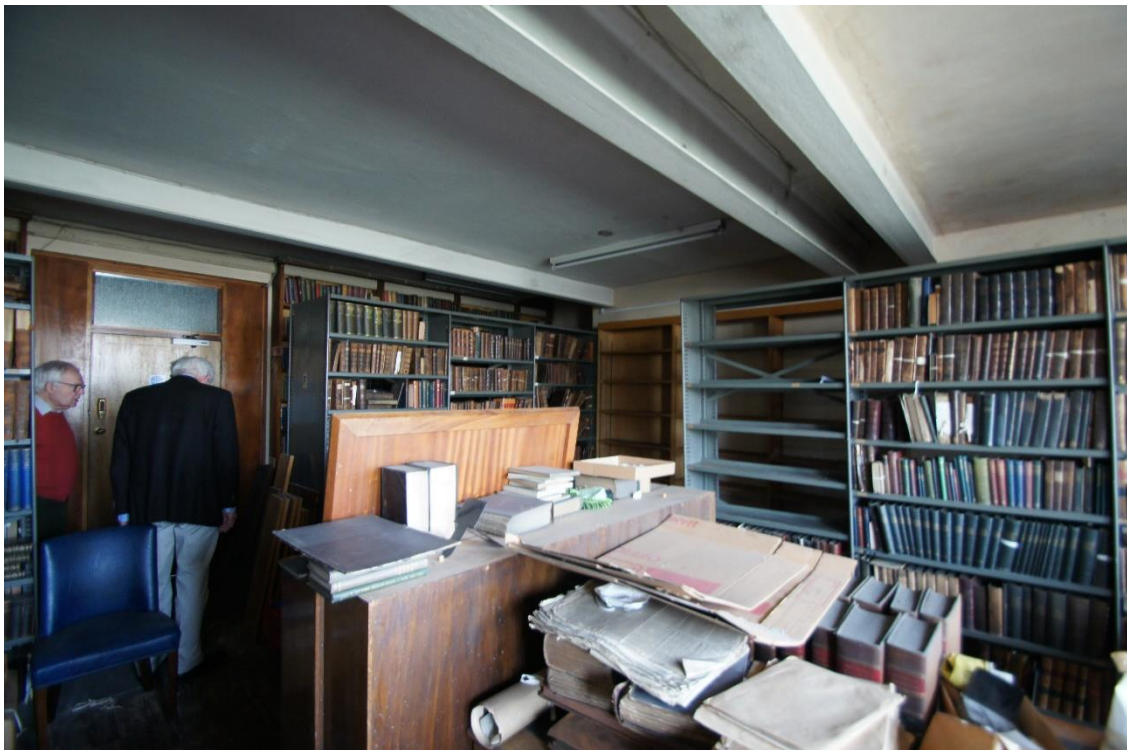
Photograph 8

2.5.1 It is understood that the building originally functioned as a residential study centre and that the north and south wings have been used for book storage and cataloguing since then (Photograph 8).
