CCTV Inspection Report

12-14 Maresfield Gardens
London
NW3 5SU

Reference: 40814

Date: February 2020

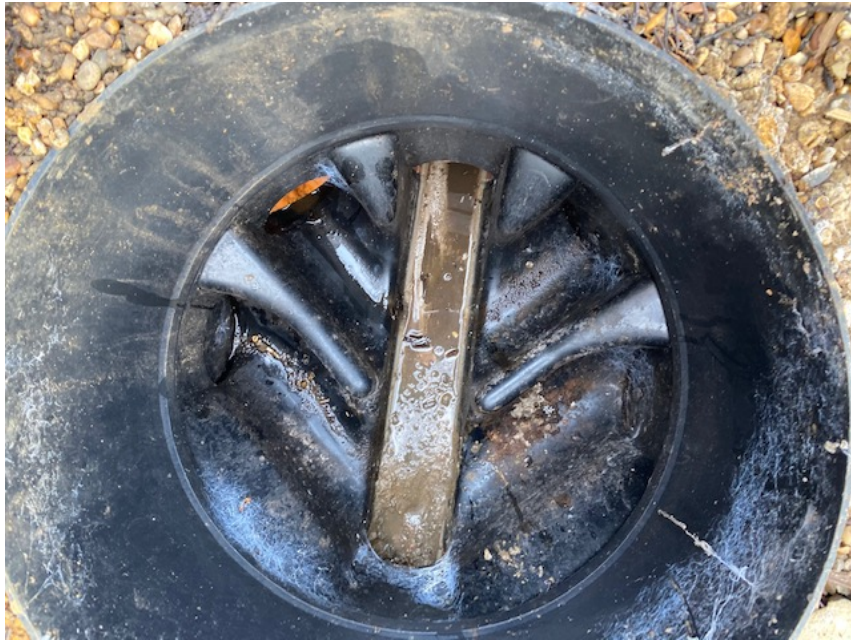
FW02: DEBRIS DEPOSITS

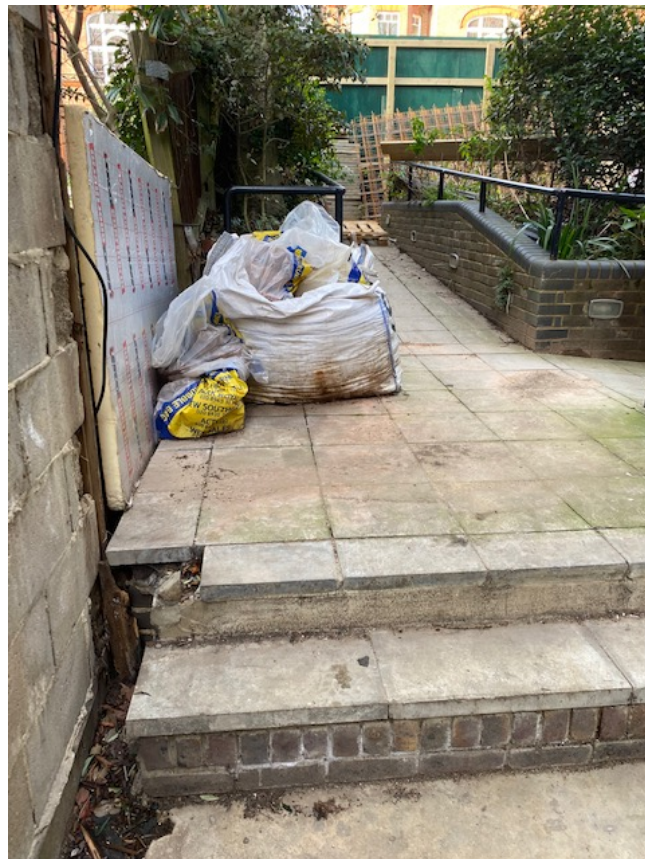
FW04: Unable to locate, beneath paving.

APPROX LOCATION OF FW04

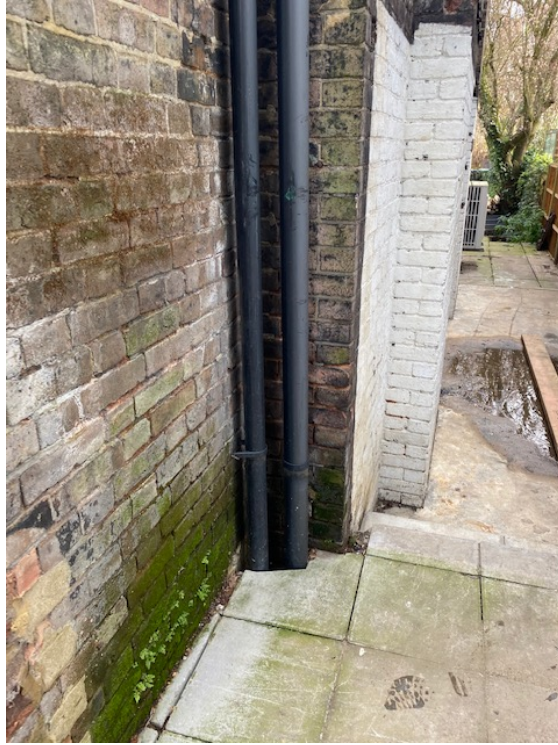
RWP 3 & 4: NO ACCESS

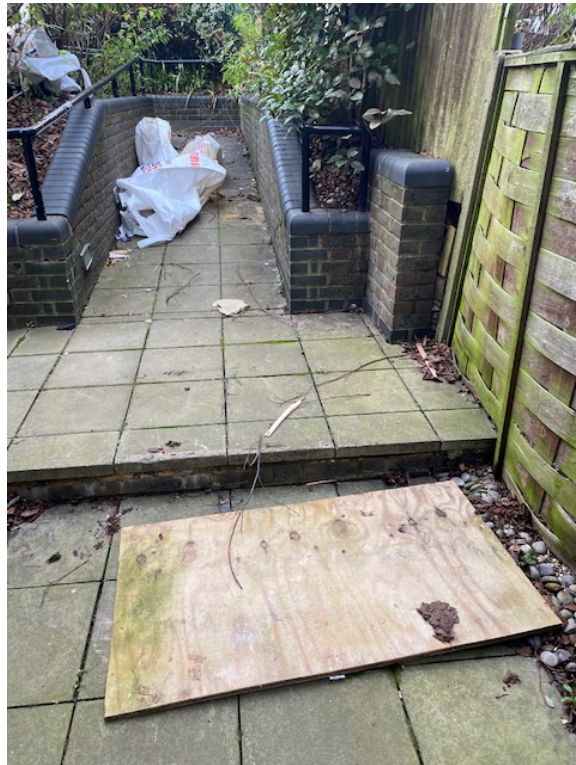
FW07: Unable to locate, beneath paving.

APPROX LOCATION OF FW07

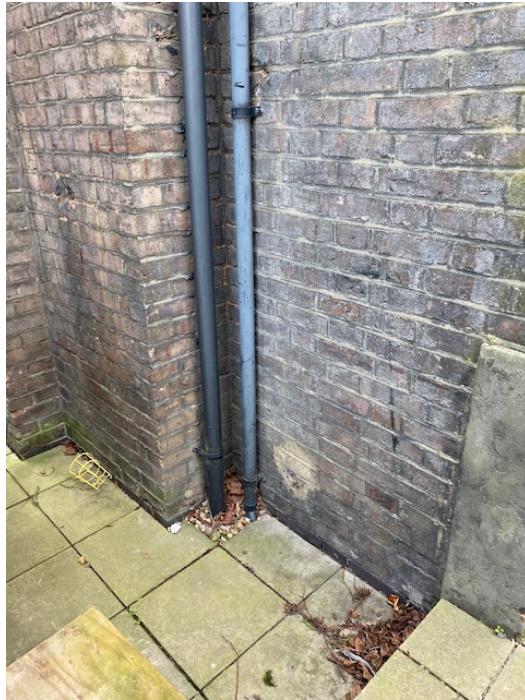
RWP'S 5 & 6: NO ACCESS

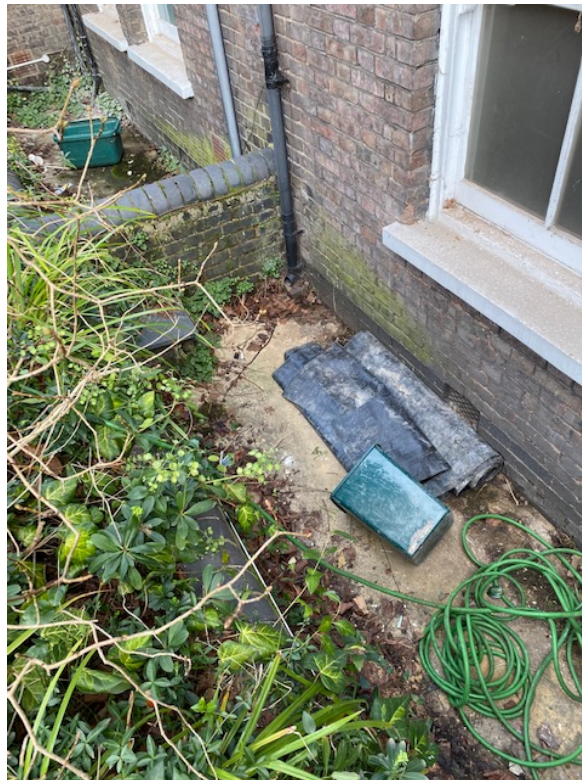
Rainwater downpipes 8 & 9 appear to discharge to ground.

RWP 9 DISCHARGES ONTO GROUND

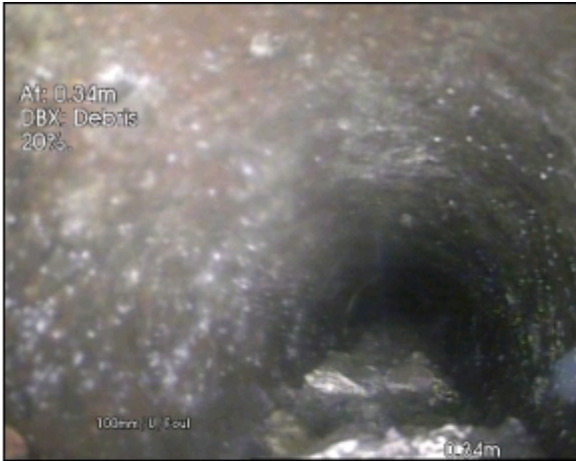
Meterage	CD	Code	Observation	Video	Pic.
0.02m		STX	Start of survey.	00:00:00	
0.34m		DBX	Debris 20%.	00:00:09	(1)
0.95m		RTX	Roots Fine 15%.	00:00:14	(2)
1.38m		DBX	Debris 25%.	00:00:18	(3)
1.40m		SAX	Survey abandoned.	00:00:20

No.	DESCRIPTION	LINE TOTAL
1	FW01-RWP1:	NO WORKS
2	FW01-SVP1:	NO WORKS
3	FW01-RWG1:	NO WORKS
4	FW01-FW02:	NO WORKS
5	FW02-RWG2:	NO WORKS
6	FW02-FW03: Install Patch repair at defect.	£425.00
7	FW03-B1: Carry out Specialist Root Cutting. Install Patch repair at defect. Continue CCTV survey.	£515.00
8	FW03-FW04: High pressure water Jet to leave free flowing. Install Patch repair at defect.	£495.00
9	FW05-RWG3:	NO WORKS
10	FW05-SVP2:	NO WORKS
11	FW05-RWP2:	NO WORKS
12	FW05-FW06:	NO WORKS
13	RWG4-MAIN LINE:	NO WORKS
14	FW06-FW07: Descale pipe work with specialist chain fail to leave free flowing.	£216.00
	Provisional Sum: We recommend allowing an additional budget cost to rectify any further defects found after the system clean and remedial works. As per our report some surveys were abandoned / incomplete due to access and debris deposits within the system. Therefore a full condition report was not possible. Allow budget £1,500.00	Budget on Request

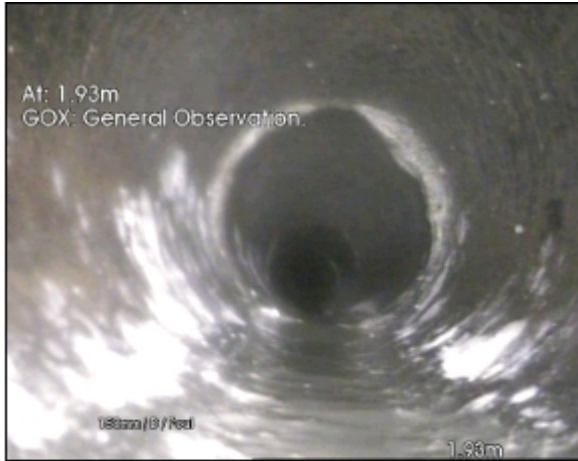
Meterage	CD	Code	Observation	Video	Pic.
0.00m		STX	Start of survey.	00:00:00	
1.93m		GOX	General Observation.	00:00:15	(1)
4.79m		FRX	Circumferential Fracture. at 10 O'Clock	00:00:32	(2)
5.51m		DBX	Debris 10%.	00:00:41	
8.67m		DBX	Debris 10%.	00:00:57	
11.58m		ENX	End of survey.	00:01:10
