Arboricultural Appraisal Report

Subsidence Damage Investigation at:

The Studio House
51 Upper Park Road
London
NW3 2UL

CLIENT:	Crawford & Company
CLIENT REF:	[REDACTED]
MWA REF:	[REDACTED]
MWA CONSULTANT:	George Peters BSc. (Hons)
REPORT DATE:	18/11/2019

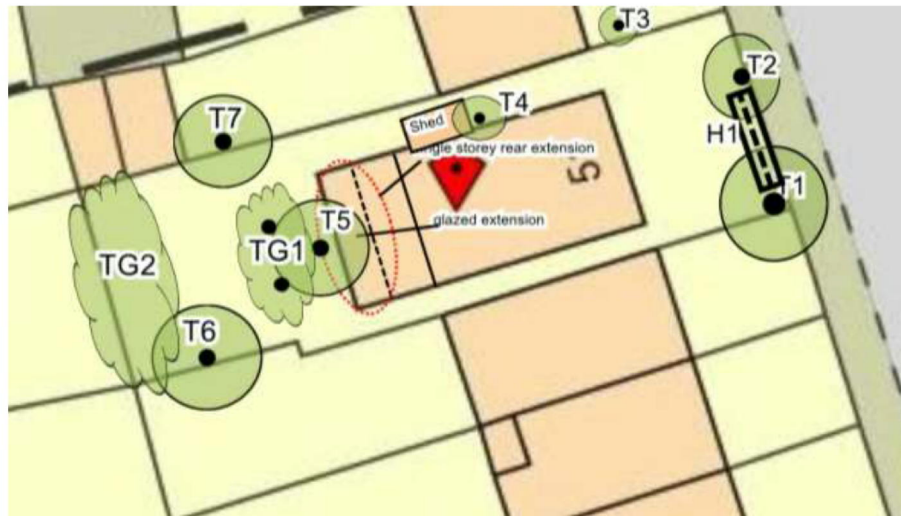
Site Plan

Approximate areas of damage

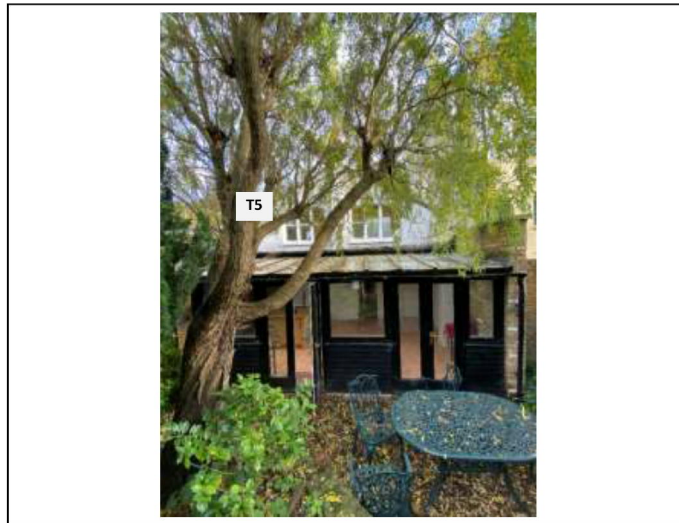
Our survey has identified vegetation within influencing distance of the building with a current potential to influence soil volumes below foundation level. The vegetation considered to be most significant in relation to the current damage is T5 (willow) and TG1 (yew).

Tree No.	Species	Ht (m)	Dia (mm)	Crown Spread (m)	Dist. to building (m)	Age Classification	Ownership
T5	Willow	6	400	5	1.7	Younger than Property	Policy Holder
Management history		No recent management noted.					
Recommendation		Remove (fell) to near ground level and treat stump to inhibit regrowth.					
TG1	Yew	3	100 Ms *	3.5	2	Younger than Property	Policy Holder
Management history		No recent management noted.					
Recommendation		Remove (fell) to near ground level and treat stump to inhibit regrowth.

View of T5, current claim.

If an arboricultural solution is to be implemented to mitigate the influence of the trees/shrubs considered to be responsible for the damage we recommend that T5 and TG1 are removed. Other vegetation recorded presents a potential future risk to building stability and management is therefore recommended.

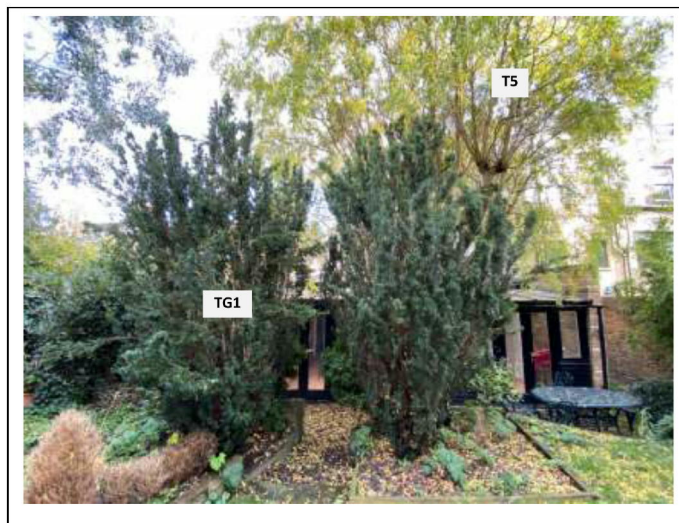
View of T5 and TG1, current claim.

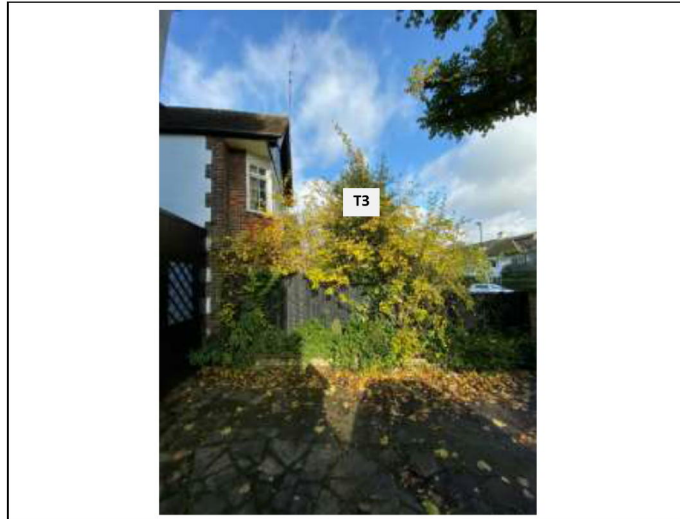
View of T3, future risk.

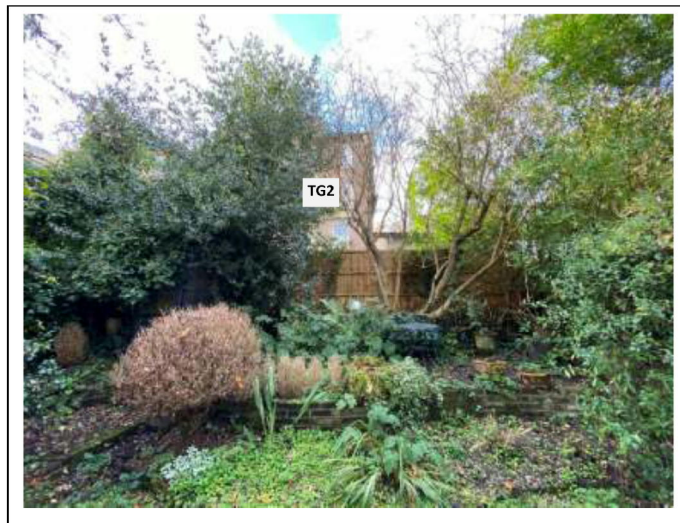
View of TG2, future risk.
