TECHNICAL REPORT ON A SUBSIDENCE CLAIM

Mrs J Margaret & Mr Andrew J King
9 Chalcot Gardens
London
NW3 4YB

SUBSIDENCE CLAIM

28th January 2020

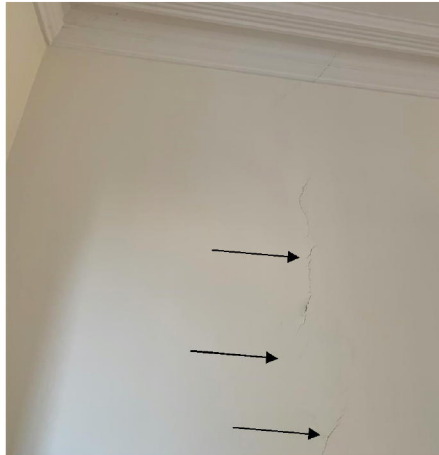
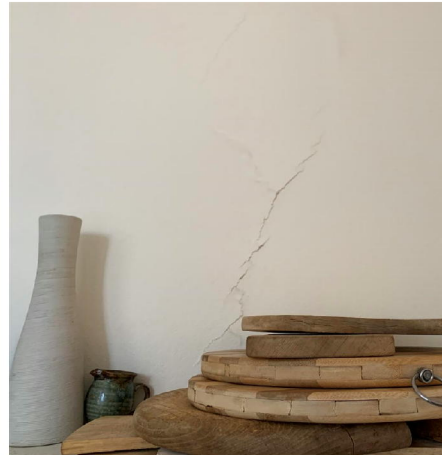
Dining Room

Vertical crack on spine wall with entrance hall.

In structural terms the damage falls into Category 2 of Table 1, Building Research Establishment⁸ Digest 251, which describes it as "slight".

The timing of the damage (late Summer 2019) indicates that the combined influence of the moisture demand from both trees is just starting to cause slight movement between the underpinned and non-underpinned sections of the property. The main crack is on the spine wall just to the rear of one of the main underpin bases. Summer 2018 was particularly hot and dry and resulted in a large increase in this type of subsidence. Summer 2019 also had dry spells which were sufficient to cause movement if any trees/vegetation had not been managed in the intervening period.

Provided the tree management works are completed expeditiously, consideration may then be given to carrying out the appropriate repairs to the property. This will include structural repairs to the bay and internal repairs/decorations to the Dining Room, Bedroom and bathroom in the Ground/1st Floor Flat.

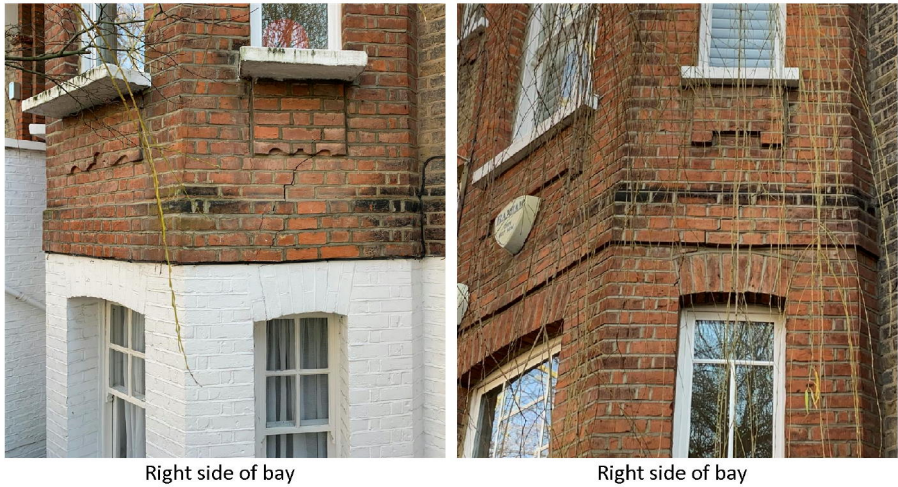
Front Elevation

Stepped crack on right splay of bay between lower ground & ground and between ground and 1st floor.

Fine stepped crack above central bay section at ground floor.

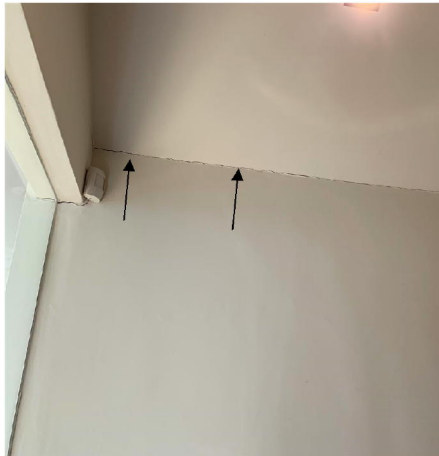
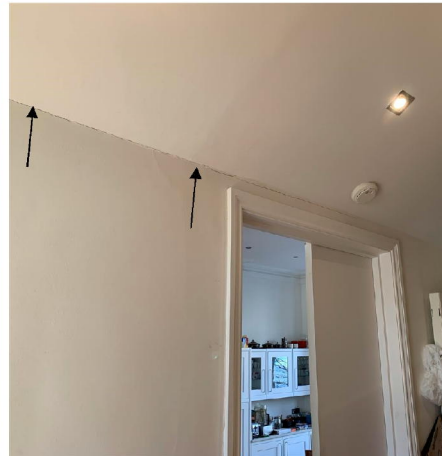
Shrinkage crack in rear hall area at junction of wall with ceiling.

Hall - shrinkage crack

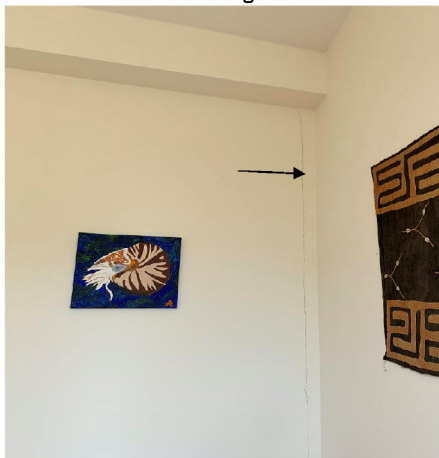
Shrinkage crack in rear bedroom at junction of stud wall with party wall.

Rear bedroom - shrinkage crack

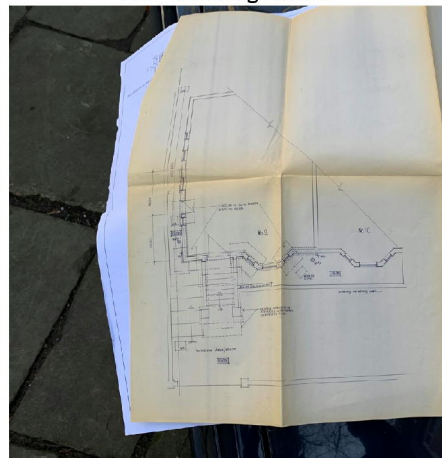
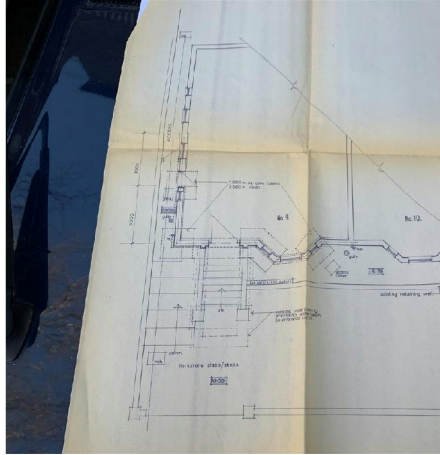
Underpinning Plan

Four storey large semi-detached house of traditional construction with brick walls surmounted by a ridged slated roof converted into 3 flats. The front elevation and 6m of the left flank elevation has been previously underpinned by the beam and base method to a depth shown on the drawings of 3.5m. The front Entrance steps have also been underpinned at an earlier time.

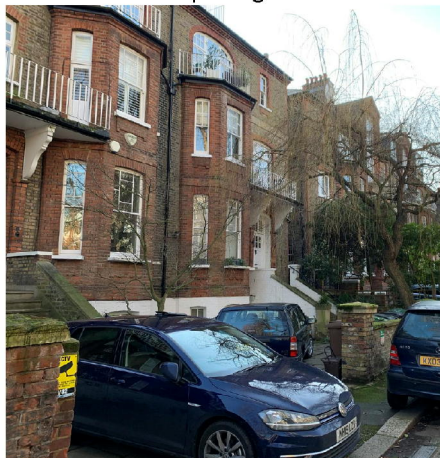
There is also a Willow tree in the front garden of No.10 which is also owned by Mrs King. This is about 20 years old and has been steadily growing. Willows are high moisture demand trees.

The Plane tree is already subject to pruning every 2 years and this has been effective. We consider the additional influence of the Willow tree is the main issue and therefore recommend it is removed. This will stop the two trees competing for moisture allowing the Plane tree management to be effective once again.

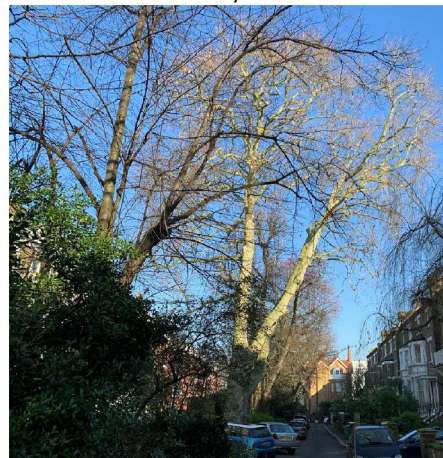
The mature Plane tree is owned/managed 2/3 to 1/3 contribution by No.8 and No.9 respectively. It requires pruning on a 2-yearly cycle to restrict its moisture demand and minimise the risk of future occurrences of subsidence. This tree management is an important part of the subsidence repair. We understand it was last pruned in 2018 before the main hot summer and is due further pruning this year.
