Site Note Assessment March 2020

Ref No:	WCEL/PEW/5ATA/TPISN01		
Re:	Site Supervision and Compliance Monitoring of Investigations for Foundation Trench Excavations.		
Site:	Dannatt House, 5A Templewood Avenue, Hampstead, London. NW3 7UY		
Instructing Client:	Julian Furman as Client & Bev Dockray as Architect	Date of Site Visit: 05 & 10/03/2020	Date of Site Note: 16/03/2020

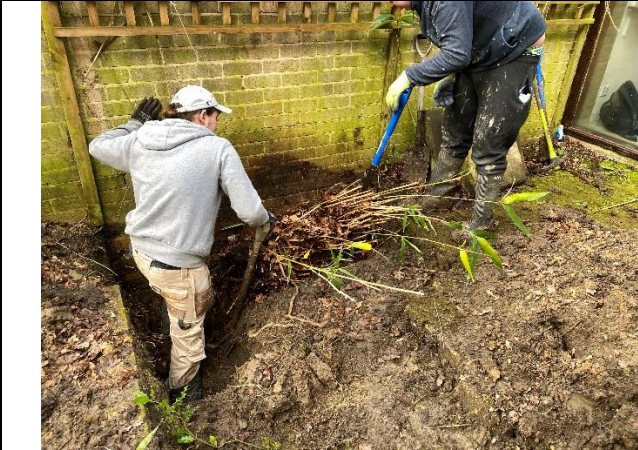
Trench 1 Previous Vegetation Removed

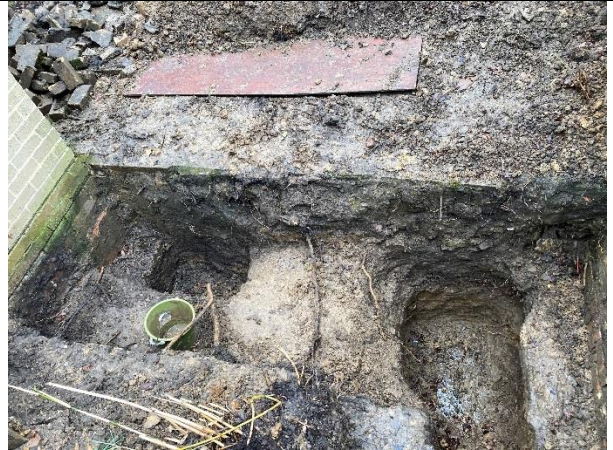
Trench 1 (Former Trial Pit Locations Adjacent to New Trench)

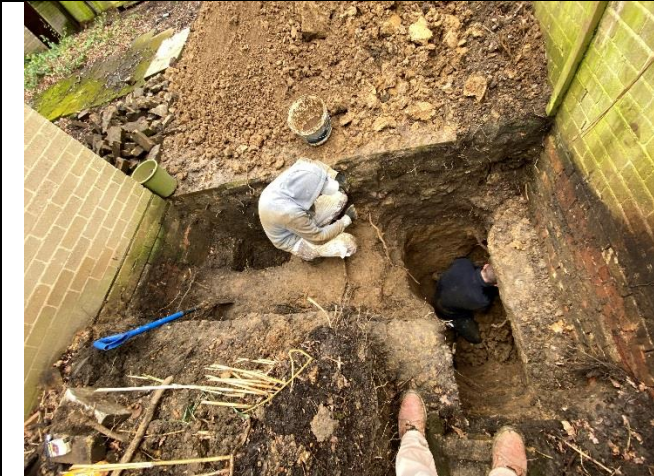
In the shallow section of the trench: 1x 22mm @ 300mmBGL, 2x22mm Not Oak at 250mm & 300mmBGL, 1x18mm @ 200mmBGL, 1x18mm subdividing to 12mm and 8mm across the trench @300mmBGL, 1x15mm@ 150mmBGL, 1x12mm @ 100mmBGL, 1x8mm @ 270mmBGL, 2x6mm @ 100mm & 350mmBGL. There were also very small numbers of small ephemeral sized feeding roots observed crossing the trench down to a depth of 300mm which are easy for the tree to regenerate within a growing season: 10x<2mm and 5x2-5mm diameter roots of live appearance through the trial trench profile, many of the roots appeared to have low starch content being dull and not very vibrant in appearance. This again indicates the limited interest of the specimen in being able to utilise the soil profile at present especially given the relatively modest distance from the Oak tree.

In the deep section of the trench: 2x6mm @ 1700mmBGL, 2x 5mm @ 120mmBGL, 3x 5mm @ 900mmBGL various locations. There were also very small numbers of small ephemeral sized feeding roots observed crossing the trench down to a depth of 1350mmBGL but none below this level. These ephemeral roots which are easy for the tree to regenerate within a growing season: 6x 2-5mm @ 50mm-400mmBGL and 6x2-4mm @ 1000mm-1350mmBGL these roots were of live appearance through the trial trench profile, many of the roots appeared to have low starch content being dull and not very vibrant in appearance. This again indicates the limited interest of the specimen in being able to utilise the soil profile at present especially given the relatively modest distance from the Oak tree.

Trench 1 (Shallow and Deep Sections)

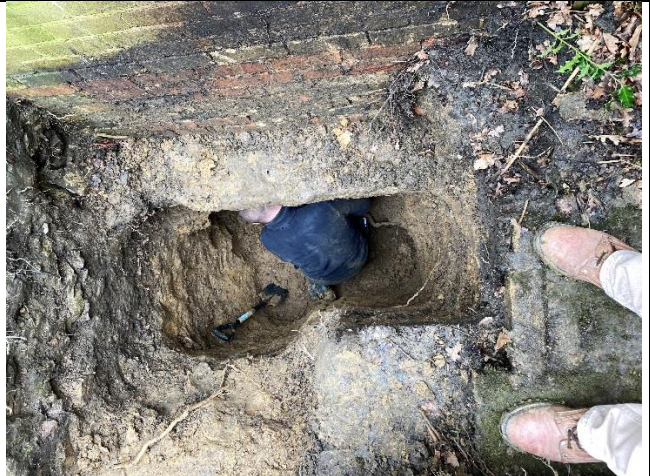
Trench 1 Deep Under Wall Foundation

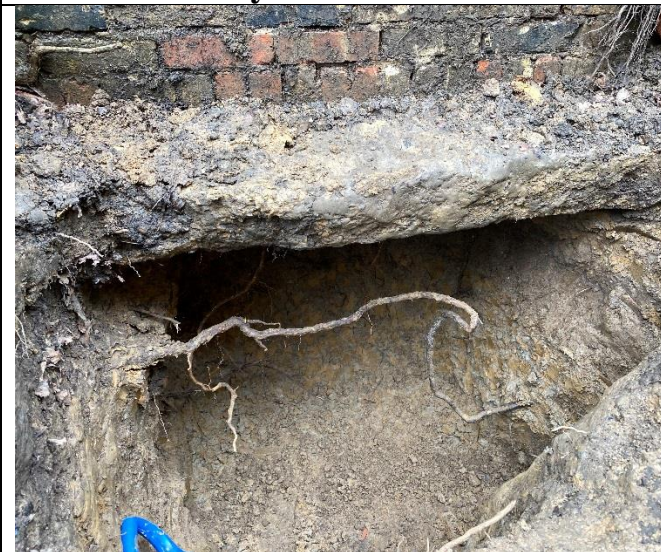
In the shallow trench only three notable arterial roots were observed and only one notable arterial root emanating from the Oak, the other two were from a small tree or large shrub now removed. In the deeper section of the trench near or under the boundary wall there were only two significant arterial roots observed (just greater than 25mm in diameter) one measuring 26mm at a depth of 1040mm at the edge of the excavation and would be retained and protected. The second is a slightly larger 27mm diameter root entering at 1020mm, (and would be removed to provide the foundation) the root reduces to 20mm very rapidly within the trench before doglegging and the dropping to the base of the tree pit at 2.1m BGL with a diameter of 12mm. It should be noted this adventitious root was generally at odds with the roots observed and is relatively inconsequential, the root can be observed in the photo. Overall, there were very few Oak roots observed, there were some other small arterial roots but they were all sub 23mm in diameter were observed crossing the trench perpendicular to the trench growing along and within the site. This is observed as being a very low volume of root activity and no structural or large arterial roots were observed. The soil at the top of the trench was friable compost/nutrient rich soil, though considering the friable nature there was a very low level of root activity

Trench 1 Only 1 Notable Root Present

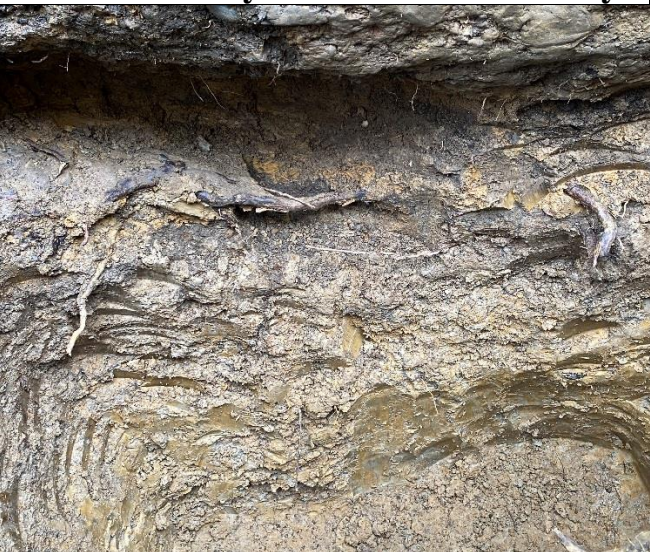
It is likely that the limited volume and distribution/nature of the roots is concurrent with the presence of historic soil alterations and level changes in the garden, a sub-surface obstruction (such as the boundary wall and its foundations) and poor dense clayey sub-soil conditions.

Trench 1 Very Limited Root Activity
