ADDENDUM TECHNICAL REPORT

[REDACTED]  
**94 Greencroft Gardens Freehold Ltd**  
**94 Greencroft Gardens**  
**London**  
**NW6 3PH**

**Allianz Commercial**  
**SUBSIDENCE CLAIM**

DATE 26 February 2020

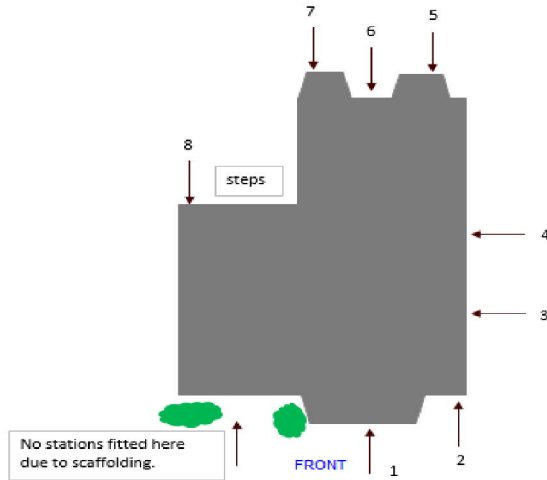
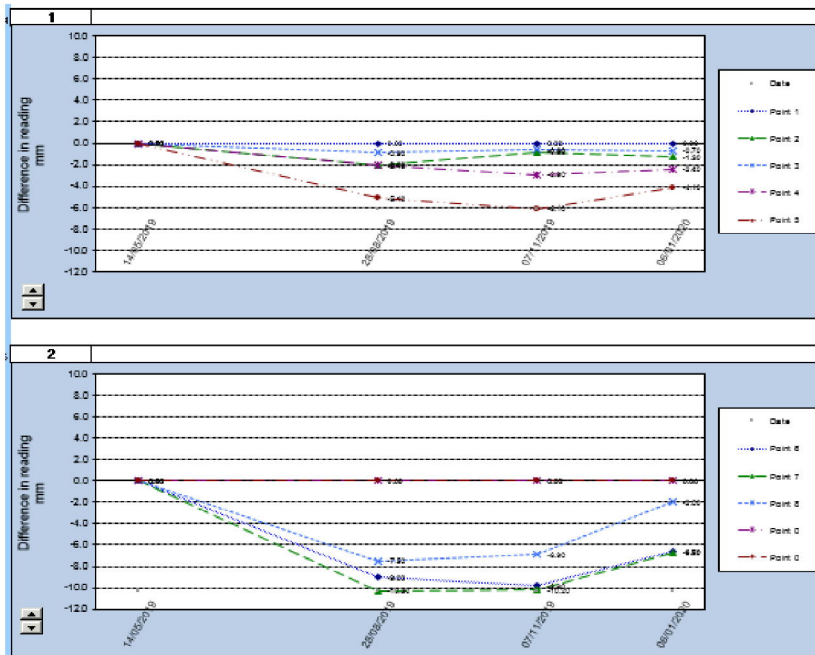
**LEVEL MONITORING**

Level monitoring has been completed over the period from May 2019 to January 2020. Over this period, downward movement has been recorded over the summer months of 2019 followed by upward movement over the winter months of 2019/20. This seasonal movement confirms a clay shrinkage mechanism. No other type of movement produces these results.

- Level monitoring indicates seasonal cyclical movement with downward movement in the summer months (as the clay shrinks) and upward movement in the winter months (as the clay swells).
