Arboricultural Appraisal Report

Subsidence Damage Investigation at:

94 Greencroft Gardens
London
NW6 3PH

REPORT DATE: 31/10/2019

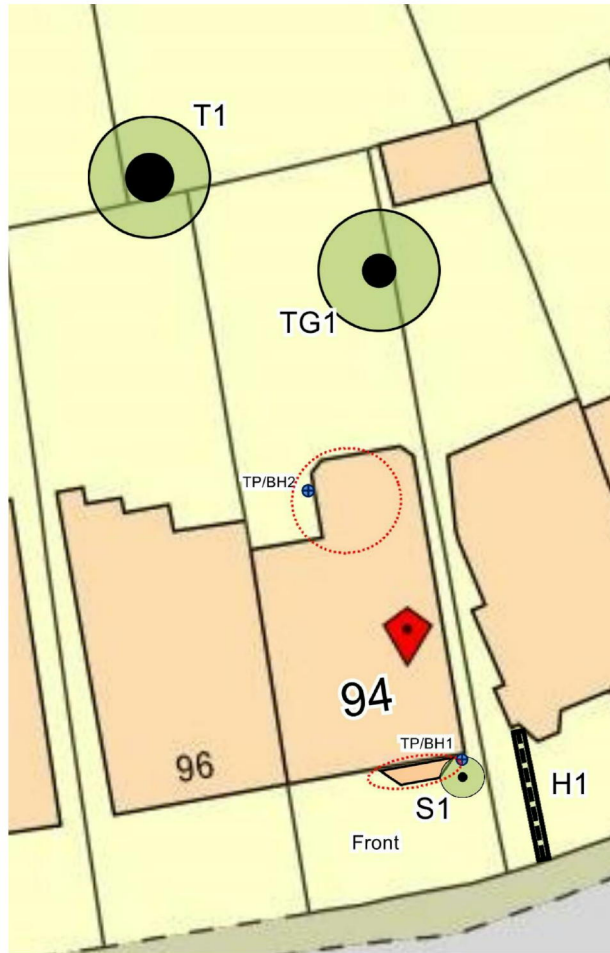
Site Plan

Approximate areas of damage

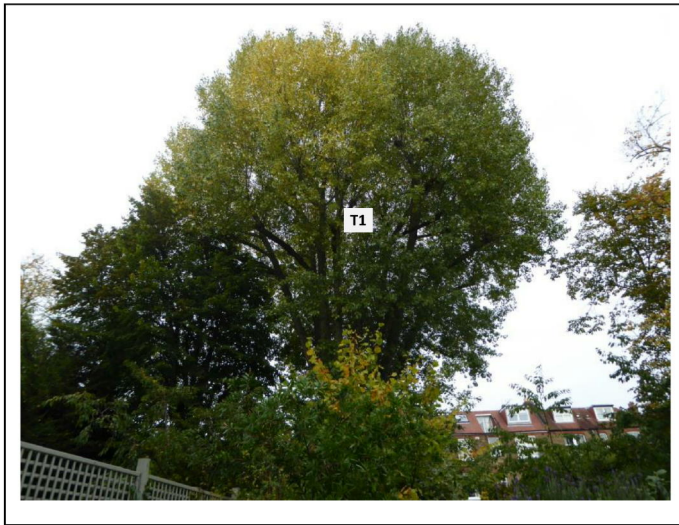
Roots were observed to the underside of foundations in TP/BH1 and to a depth of 2000mm bgl in TP/BH2 and recovered samples have been positively identified (using anatomical analysis) as Privet and Poplar, the origin of which will be H1 and T1 confirming influence on the soils below the foundations.

Based on the technical reports currently available, engineering opinion and our own site assessment we conclude the damage is consistent with shrinkage of the clay subsoil related to moisture abstraction by vegetation. Having considered the information currently available, it is our opinion that T1, S1 and H1 are materially contributing to the current subsidence damage.

View of T1

If an arboricultural solution is to be implemented to mitigate the influence of the implicated trees/vegetation we recommend that T1 and S1 are removed and that H1 is managed in accordance with Table 1. Other vegetation recorded presents a potential future risk to building stability and management is therefore recommended.

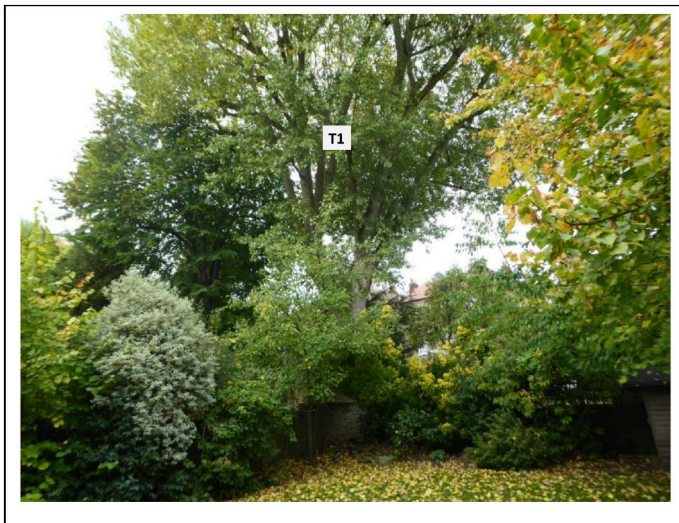
View of T1

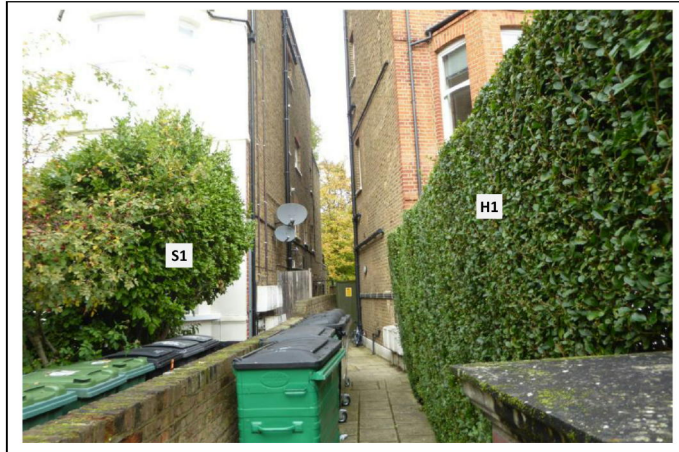
Irrespective of the identification of recovered root samples, the roots of S1 (Griselinia) are also likely to be present below foundation level in proximity to the area of movement/damage and influencing soil moisture and volumes.

View of S1 and H1

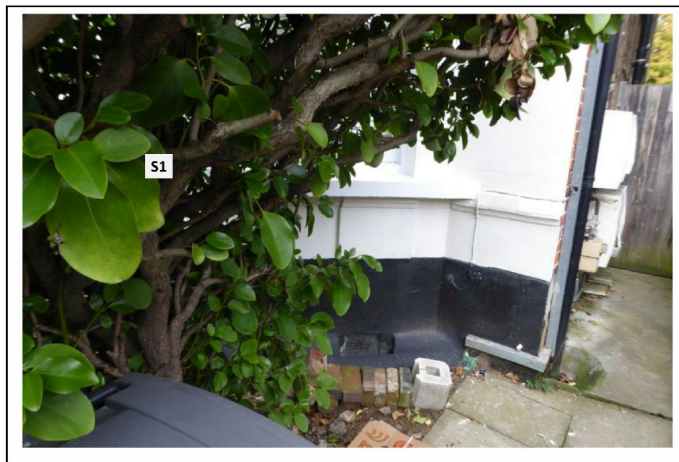
View of S1
