Claim Assessment Report

On behalf of Aviva

Report Date: 19 December 2018

Risk Address: 9 Regent 's Park Terrace, London, NW1 7EE

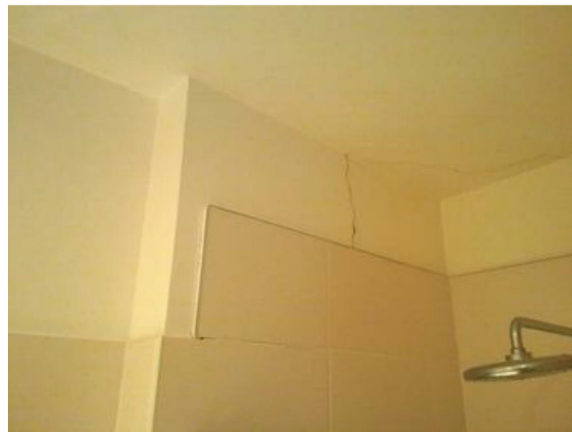
This room occupies the ground floor of the two storey rear extension. Damage noted mainly at the corner junction where the extension abuts the main building. There is cracking within the shower cubicle which extends from above the wall tiles to the right flank wall and continues along the ceiling and wall junction.

There is also minor cracking to the left-hand side wall above the side window. Within the lobby to the bathroom, cracking was noted to the front right corner above the door to the passageway and to the left-hand side above the side exit door.

FIGURE 03 Shows cracking inside the basement flat bathroom

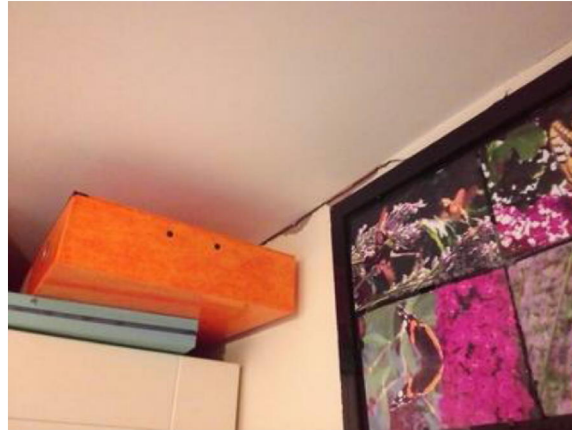
The office is positioned with the rear extension and inside this room there is evidence of cracking/separation along the ceiling and front wall (which is the rear elevation of the main-house) abutment. This extends from right to left. The damage is coupled with fine hairline cracking to the left flank wall and separation between the ceiling and wall junctions.

FIGURE 04 Shows cracking inside the office at first floor level of the extension

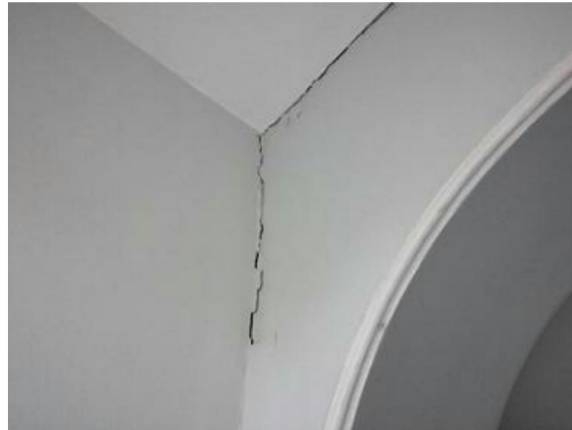
Upper floor landing recess. This section of the landing leads out onto the roof terrace of the two storey extension. Cracking measuring up to 5mm in width was noted to the front right corner where the extension and the main-house meets. The cracking continues along the ceiling and wall junction from right to left.

FIGURE 05 Shows cracking inside the upper landing recess which leads onto the roof terrace to rear extension

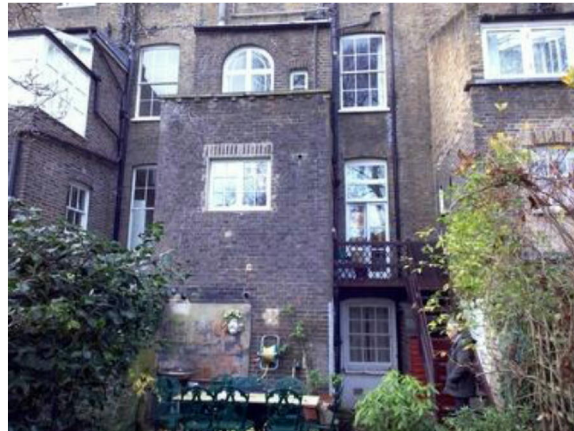
Cracking evidence at the left side junction where the extension abuts the main-building. We also

understand that there is further separation cracking at the right-hand side corner junction which is more severe. Unfortunately, this section of the extension can only be accessed through the neighbour's (No.08) property and therefore we were unable to view this damage at the time of our visit.

FIGURE 06 Shows the rear elevation of the affected two storey rear extension
