Asbestos Refurbishment Survey

**6th Floor Kingsway Building
1 Kemble Street
London
WC2B 4AN**

Survey Date: 19 December 2019

Project Reference: P-356976A

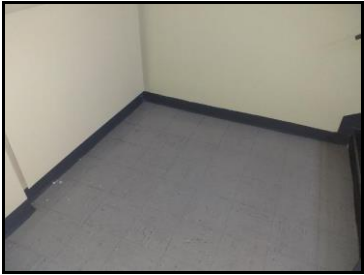
Building:	Space House	Floor:	Sixth Floor				
Location:	001 - Kemble Street Staircase (Kingsway)	Sample No / ID (Type):	P-356976/001 (Sampled)				
Surveyor:	Danny Webber	Survey date:	19/12/2019				
Sample Details

Item description:	Skirting board					
	Material description:	Vinyl product					
	Quantity / Extent:	20 m linear					
	Accessibility	Easy Access					
	Analysis:	No asbestos detected					
	Material identification:	Non-asbestos material					
Material Assessment Scoring:							
Product Type:	-	Condition:	-	Surface Treatment:	-	Asbestos Type:	-
Priority Assessment Scoring:							
Occupant Activity:	-	Disturbance:	-	Human Exposure:	-	Maintenance Activity:	-
Total Scores:							
Material Score:	-	Priority Score	-	Total Score:	0	Risk Rating:	N/A
Recommended action:	-						
Recommendation comments:	-						
Comments:	Material observed to continue from top to bottom of staircase.

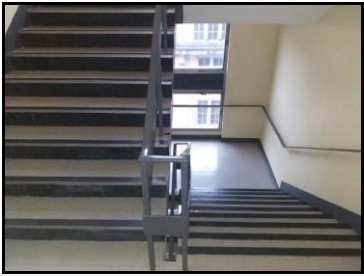
Building:	Space House	Floor:	Sixth Floor				
Location:	001 - Kemble Street Staircase (Kingsway)	Sample No / ID (Type):	P-356976/002 (Sampled)				
Surveyor:	Danny Webber	Survey date:	19/12/2019				
Sample Details

Item description:	Step nosings					
	Material description:	Thermoplastic product					
	Quantity / Extent:	18 Number					
	Accessibility	Easy Access					
	Analysis:	Chrysotile					
	Material identification:	Asbestos thermoplastic material					
Material Assessment Scoring:							
Product Type:	1	Condition:	1	Surface Treatment:	0	Asbestos Type:	1
Priority Assessment Scoring:							
Occupant Activity:	0	Disturbance:	2	Human Exposure:	0	Maintenance Activity:	0
Total Scores:							
Material Score:	3	Priority Score	2	Total Score:	5	Risk Rating:	Very Low
Recommended action:	Remove if likely to be disturbed by the refurbishment, otherwise monitor condition.						
Recommendation comments:	-

Comments:	Material observed to continue from top to bottom of staircase.

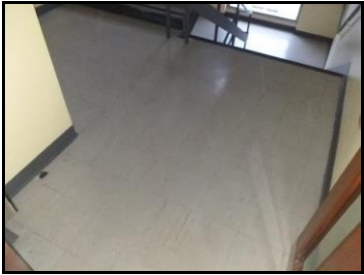
Building:	Space House	Floor:	Sixth Floor				
Location:	001 - Kemble Street Staircase (Kingsway)	Sample No / ID (Type):	P-356976/003 (Sampled)				
Surveyor:	Danny Webber	Survey date:	19/12/2019				
Sample Details

Item description:	Floor tiles (grey) & bitumen adhesive					
	Material description:	Thermoplastic product					
	Quantity / Extent:	16 m ²					
	Accessibility	Easy Access					
	Analysis:	Chrysotile					
	Material identification:	Asbestos thermoplastic/adhesive					
Material Assessment Scoring:							
Product Type:	1	Condition:	1	Surface Treatment:	0	Asbestos Type:	1
Priority Assessment Scoring:							
Occupant Activity:	0	Disturbance:	2	Human Exposure:	0	Maintenance Activity:	0
Total Scores:							
Material Score:	3	Priority Score	2	Total Score:	5	Risk Rating:	Very Low
Recommended action:	Remove if likely to be disturbed by the refurbishment, otherwise monitor condition.						
Recommendation comments:	-

Comments:	Material observed to continue from top to bottom of staircase.

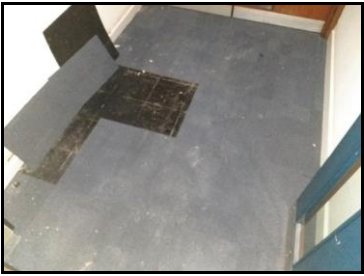
Building:	Space House	Floor:	Sixth Floor				
Location:	002 - Kemble Street Lobby (Kingsway)	Sample No / ID (Type):	P-356976/004 (Sampled)				
Surveyor:	Danny Webber	Survey date:	19/12/2019				
Sample Details

Item description:	Adhesive residue beneath carpet tiles					
	Material description:	Bituminous products					
	Quantity / Extent:	4 m ²					
	Accessibility	Easy Access					
	Analysis:	Chrysotile					
	Material identification:	Asbestos bitumen					
Material Assessment Scoring:							
Product Type:	1	Condition:	1	Surface Treatment:	0	Asbestos Type:	1
Priority Assessment Scoring:							
Occupant Activity:	0	Disturbance:	2	Human Exposure:	0	Maintenance Activity:	0
Total Scores:							
Material Score:	3	Priority Score	2	Total Score:	5	Risk Rating:	Very Low
Recommended action:	Remove if likely to be disturbed by the refurbishment, otherwise monitor condition.						
Recommendation comments:	-

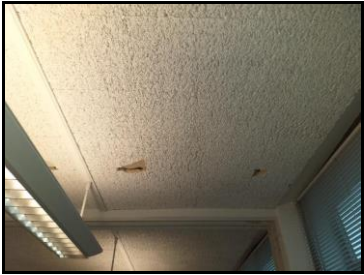
Building:	Space House	Floor:	Sixth Floor				
Location:	003 - Open Plan Area (Kingsway)	Sample No / ID (Type):	P-356976/005 (Sampled)				
Surveyor:	Danny Webber	Survey date:	19/12/2019				
Sample Details

Item description:	Ceiling above MMMF tiles					
	Material description:	Insulating board					
	Quantity / Extent:	100 m ²					
	Accessibility	Difficult Access					
	Analysis:	Chrysotile					
	Material identification:	Asbestos insulating board					
Material Assessment Scoring:							
Product Type:	2	Condition:	1	Surface Treatment:	1	Asbestos Type:	1
Priority Assessment Scoring:							
Occupant Activity:	0	Disturbance:	2	Human Exposure:	0	Maintenance Activity:	0
Total Scores:							
Material Score:	5	Priority Score	2	Total Score:	7	Risk Rating:	Low
Recommended action:	Remove if likely to be disturbed by the refurbishment, otherwise monitor condition.						
Recommendation comments:	It is strongly presumed after discussions on site that asbestos packing material will also be present above.

Comments:	Material located above windows between lighting trunking & windows.

P-356976/005 (S)	Space House - Sixth Floor - Open Plan Area (Kingsway)	Ceiling above MMMF tiles	Asbestos insulating board	Chrysotile	100 m2	5	2	7	Remove if likely to be disturbed by the refurbishment, otherwise monitor condition.
P-356976/006 (S)	Space House - Sixth Floor - Open Plan Area (Kingsway)	MMMF ceiling tile adhesive	Non-asbestos material	No asbestos detected	600 m2	0	-	0	-
P-356976/007 (S)	Space House - Sixth Floor - Open Plan Area (Kingsway)	Window sills	Asbestos cement	Chrysotile	82 m linear	4	3	7	Remove if likely to be disturbed by the refurbishment, otherwise monitor condition.
P-356976/008 (S)	Space House - Sixth Floor - Open Plan Area (Kingsway)	Window sills	Asbestos thermoplastic/adhesive	Chrysotile	Through out m2	5	3	8	Remove if likely to be disturbed by the refurbishment, otherwise monitor condition.
P-356976/009 (S)	Space House - Sixth Floor - Open Plan Area (Kingsway)	Debris	Non-asbestos material	No asbestos detected	10 m2	0	-	0	-

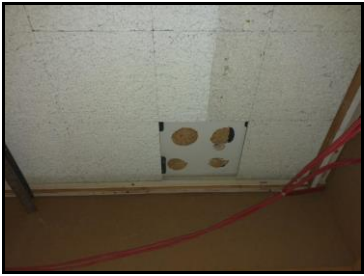
Building:	Space House	Floor:	Sixth Floor				
Location:	003 - Open Plan Area (Kingsway)	Sample No / ID (Type):	P-356976/006 (Sampled)				
Surveyor:	Danny Webber	Survey date:	19/12/2019				
Sample Details

Item description:	MMMF ceiling tile adhesive					
	Material description:	Bituminous products					
	Quantity / Extent:	600 m ²					
	Accessibility	Difficult Access					
	Analysis:	No asbestos detected					
	Material identification:	Non-asbestos material					
Material Assessment Scoring:							
Product Type:	-	Condition:	-	Surface Treatment:	-	Asbestos Type:	-
Priority Assessment Scoring:							
Occupant Activity:	-	Disturbance:	-	Human Exposure:	-	Maintenance Activity:	-
Total Scores:							
Material Score:	-	Priority Score	-	Total Score:	0	Risk Rating:	N/A
Recommended action:	-						
Recommendation comments:	-						
Comments:	-

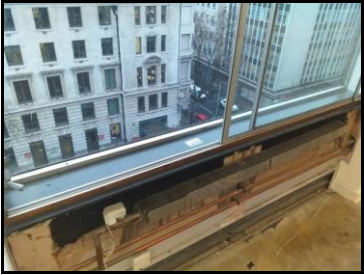
Building:	Space House	Floor:	Sixth Floor				
Location:	003 - Open Plan Area (Kingsway)	Sample No / ID (Type):	P-356976/007 (Sampled)				
Surveyor:	Danny Webber	Survey date:	19/12/2019				
Sample Details

Item description:	Window sills					
	Material description:	Cement product					
	Quantity / Extent:	82 m linear					
	Accessibility	Easy Access					
	Analysis:	Chrysotile					
	Material identification:	Asbestos cement					
Material Assessment Scoring:							
Product Type:	1	Condition:	1	Surface Treatment:	1	Asbestos Type:	1
Priority Assessment Scoring:							
Occupant Activity:	0	Disturbance:	3	Human Exposure:	0	Maintenance Activity:	0
Total Scores:							
Material Score:	4	Priority Score	3	Total Score:	7	Risk Rating:	Very Low
Recommended action:	Remove if likely to be disturbed by the refurbishment, otherwise monitor condition.						
Recommendation comments:	It is strongly presumed after discussions on site that asbestos packing material will also be present beneath.

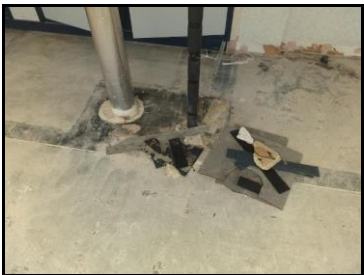
Building:	Space House	Floor:	Sixth Floor				
Location:	003 - Open Plan Area (Kingsway)	Sample No / ID (Type):	P-356976/008 (Sampled)				
Surveyor:	Danny Webber	Survey date:	19/12/2019				
Sample Details

Item description:	Window sills					
	Material description:	Thermoplastic floor tiles					
	Quantity / Extent:	Throughout m ²					
	Accessibility	Easy Access					
	Analysis:	Chrysotile					
	Material identification:	Asbestos thermoplastic/adhesive					
Material Assessment Scoring:							
Product Type:	1	Condition:	3	Surface Treatment:	0	Asbestos Type:	1
Priority Assessment Scoring:							
Occupant Activity:	0	Disturbance:	3	Human Exposure:	0	Maintenance Activity:	0
Total Scores:							
Material Score:	5	Priority Score	3	Total Score:	8	Risk Rating:	Low
Recommended action:	Remove if likely to be disturbed by the refurbishment, otherwise monitor condition.						
Recommendation comments:	Material is located throughout open plan area, predominantly beneath timber skirting boards around perimeter of building.

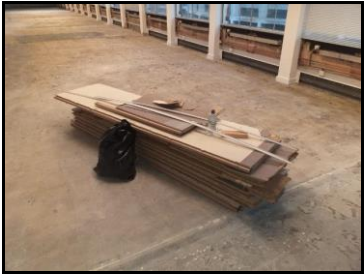
Building:	Space House	Floor:	Sixth Floor				
Location:	003 - Open Plan Area (Kingsway)	Sample No / ID (Type):	P-356976/009 (Sampled)				
Surveyor:	Danny Webber	Survey date:	19/12/2019				
Sample Details

Item description:	Debris					
	Material description:	Insulating board					
	Quantity / Extent:	10 m ²					
	Accessibility	Easy Access					
	Analysis:	No asbestos detected					
	Material identification:	Non-asbestos material					
Material Assessment Scoring:							
Product Type:	-	Condition:	-	Surface Treatment:	-	Asbestos Type:	-
Priority Assessment Scoring:							
Occupant Activity:	-	Disturbance:	-	Human Exposure:	-	Maintenance Activity:	-
Total Scores:							
Material Score:	-	Priority Score	-	Total Score:	0	Risk Rating:	N/A
Recommended action:	-						
Recommendation comments:	-						
Comments:	-

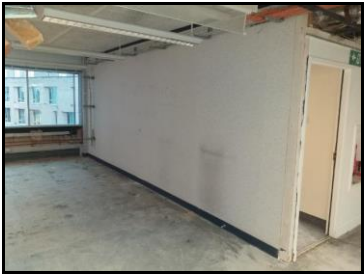
Building:	Space House	Floor:	Sixth Floor				
Location:	003 - Open Plan Area (Kingsway)	Sample No / ID (Type):	P-356976/010 (Sampled)				
Surveyor:	Danny Webber	Survey date:	19/12/2019				
Sample Details

Item description:	Wall lining beneath plasterboard lining					
	Material description:	Insulating board					
	Quantity / Extent:	18 m ²					
	Accessibility	Difficult Access					
	Analysis:	Chrysotile					
	Material identification:	Asbestos insulating board					
Material Assessment Scoring:							
Product Type:	2	Condition:	1	Surface Treatment:	1	Asbestos Type:	1
Priority Assessment Scoring:							
Occupant Activity:	0	Disturbance:	2	Human Exposure:	0	Maintenance Activity:	0
Total Scores:							
Material Score:	5	Priority Score	2	Total Score:	7	Risk Rating:	Low
Recommended action:	Remove if likely to be disturbed by the refurbishment, otherwise monitor condition.						
Recommendation comments:	-

P-356976/010 (S)	Space House - Sixth Floor - Open Plan Area (Kingsway)	Wall lining beneath plasterboard lining	Asbestos insulating board	Chrysotile	18 m2	5	2	7	Remove if likely to be disturbed by the refurbishment, otherwise monitor condition.
P-356976/011 (S)	Space House - Sixth Floor - Kimble Street Risers (Kingsway)	Pipework insulation	Non-asbestos material	No asbestos detected	6 m linear	0	-	0	-
P-356976/012 (S)	Space House - Sixth Floor - Kitchen (Kingsway)	Ceiling & floor packing at pipe penetrations	Non-asbestos material	No asbestos detected	<1 m2	0	-	0	-
P-356976/013 (S)	Space House - Sixth Floor - Kitchen (Kingsway)	Riser panels	Non-asbestos material	No asbestos detected	1 m2	0	-	0	-
P-356976/As 004 (X)	Space House - Sixth Floor - Open Plan Area (Kingsway)	Adhesive residue partially beneath floor screed	Asbestos bitumen	Chrysotile	600 m2	3	3	6	Remove if likely to be disturbed by the refurbishment, otherwise monitor condition.

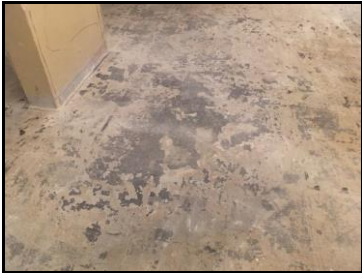
Building:	Space House	Floor:	Sixth Floor				
Location:	003 - Open Plan Area (Kingsway)	Sample No / ID (Type):	P-356976/As 004 (Cross Referenced)				
Surveyor:	Danny Webber	Survey date:	19/12/2019				
Sample Details

Item description:	Adhesive residue partially beneath floor screed					
	Material description:	Bituminous products					
	Quantity / Extent:	600 m ²					
	Accessibility	Easy Access					
	Analysis:	Chrysotile					
	Material identification:	Asbestos bitumen					
Material Assessment Scoring:							
Product Type:	1	Condition:	1	Surface Treatment:	0	Asbestos Type:	1
Priority Assessment Scoring:							
Occupant Activity:	0	Disturbance:	3	Human Exposure:	0	Maintenance Activity:	0
Total Scores:							
Material Score:	3	Priority Score	3	Total Score:	6	Risk Rating:	Very Low
Recommended action:	Remove if likely to be disturbed by the refurbishment, otherwise monitor condition.						
Recommendation comments:	-

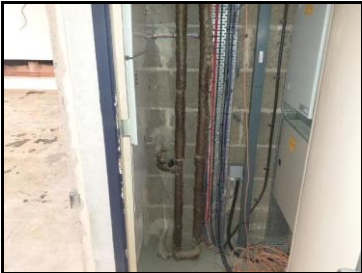
Building:	Space House	Floor:	Sixth Floor				
Location:	004 - Kimble Street Risers (Kingsway)	Sample No / ID (Type):	P-356976/011 (Sampled)				
Surveyor:	Danny Webber	Survey date:	19/12/2019				
Sample Details

Item description:	Pipework insulation					
	Material description:	Paper					
	Quantity / Extent:	6 m linear					
	Accessibility	Easy Access					
	Analysis:	No asbestos detected					
	Material identification:	Non-asbestos material					
Material Assessment Scoring:							
Product Type:	-	Condition:	-	Surface Treatment:	-	Asbestos Type:	-
Priority Assessment Scoring:							
Occupant Activity:	-	Disturbance:	-	Human Exposure:	-	Maintenance Activity:	-
Total Scores:							
Material Score:	-	Priority Score	-	Total Score:	0	Risk Rating:	N/A
Recommended action:	-						
Recommendation comments:	-						
Comments:	-

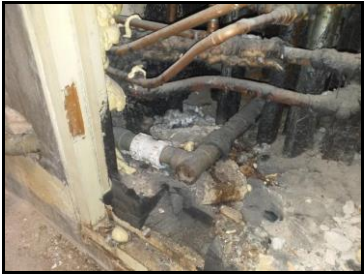
Building:	Space House	Floor:	Sixth Floor				
Location:	005 - Kitchen (Kingsway)	Sample No / ID (Type):	P-356976/012 (Sampled)				
Surveyor:	Danny Webber	Survey date:	19/12/2019				
Sample Details

Item description:	Ceiling & floor packing at pipe penetrations					
	Material description:	Insulation					
	Quantity / Extent:	<1 m ²					
	Accessibility	Easy Access					
	Analysis:	No asbestos detected					
	Material identification:	Non-asbestos material					
Material Assessment Scoring:							
Product Type:	-	Condition:	-	Surface Treatment:	-	Asbestos Type:	-
Priority Assessment Scoring:							
Occupant Activity:	-	Disturbance:	-	Human Exposure:	-	Maintenance Activity:	-
Total Scores:							
Material Score:	-	Priority Score	-	Total Score:	0	Risk Rating:	N/A
Recommended action:	-						
Recommendation comments:	-						
Comments:	Material observed within riser.

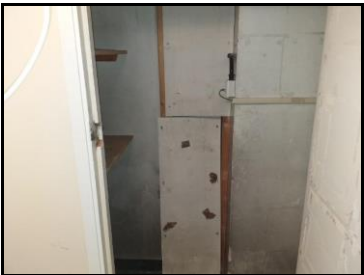
Building:	Space House	Floor:	Sixth Floor				
Location:	005 - Kitchen (Kingsway)	Sample No / ID (Type):	P-356976/013 (Sampled)				
Surveyor:	Danny Webber	Survey date:	19/12/2019				
Sample Details

Item description:	Riser panels					
	Material description:	Insulating board					
	Quantity / Extent:	1 m ²					
	Accessibility	Easy Access					
	Analysis:	No asbestos detected					
	Material identification:	Non-asbestos material					
Material Assessment Scoring:							
Product Type:	-	Condition:	-	Surface Treatment:	-	Asbestos Type:	-
Priority Assessment Scoring:							
Occupant Activity:	-	Disturbance:	-	Human Exposure:	-	Maintenance Activity:	-
Total Scores:							
Material Score:	-	Priority Score	-	Total Score:	0	Risk Rating:	N/A
Recommended action:	-						
Recommendation comments:	-						
Comments:	Material observed within cupboard.

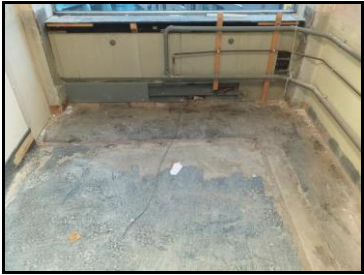
Building:	Space House	Floor:	Sixth Floor				
Location:	005 - Kitchen (Kingsway)	Sample No / ID (Type):	P-356976/As 004 (Cross Referenced)				
Surveyor:	Danny Webber	Survey date:	19/12/2019				
Sample Details

Item description:	Adhesive residue partially beneath modern linoleum					
	Material description:	Bituminous products					
	Quantity / Extent:	12 m ²					
	Accessibility	Easy Access					
	Analysis:	Chrysotile					
	Material identification:	Asbestos bitumen					
Material Assessment Scoring:							
Product Type:	1	Condition:	1	Surface Treatment:	0	Asbestos Type:	1
Priority Assessment Scoring:							
Occupant Activity:	0	Disturbance:	3	Human Exposure:	0	Maintenance Activity:	0
Total Scores:							
Material Score:	3	Priority Score	3	Total Score:	6	Risk Rating:	Very Low
Recommended action:	Remove if likely to be disturbed by the refurbishment, otherwise monitor condition.						
Recommendation comments:	-

P-356976/As 004 (X)	Space House - Sixth Floor - Kitchen (Kingsway)	Adhesive residue partially beneath modern linoleum	Asbestos bitumen	Chrysotile	12 m2	3	3	6	Remove if likely to be disturbed by the refurbishment, otherwise monitor condition.
P-356976/As 006 (X)	Space House - Sixth Floor - Kitchen (Kingsway)	MMMF ceiling tile adhesive	Non-asbestos material	No asbestos detected	12 m2	0	-	0	-

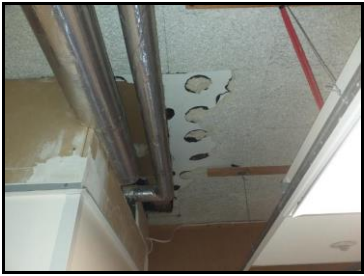
Building:	Space House	Floor:	Sixth Floor				
Location:	005 - Kitchen (Kingsway)	Sample No / ID (Type):	P-356976/As 006 (Cross Referenced)				
Surveyor:	Danny Webber	Survey date:	19/12/2019				
Sample Details

Item description:	MMMF ceiling tile adhesive					
	Material description:	Bituminous products					
	Quantity / Extent:	12 m ²					
	Accessibility	Difficult Access					
	Analysis:	No asbestos detected					
	Material identification:	Non-asbestos material					
Material Assessment Scoring:							
Product Type:	-	Condition:	-	Surface Treatment:	-	Asbestos Type:	-
Priority Assessment Scoring:							
Occupant Activity:	-	Disturbance:	-	Human Exposure:	-	Maintenance Activity:	-
Total Scores:							
Material Score:	-	Priority Score	-	Total Score:	0	Risk Rating:	N/A
Recommended action:	-						
Recommendation comments:	-						
Comments:	-

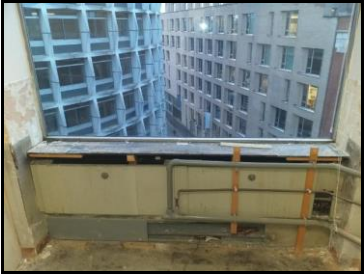
Building:	Space House	Floor:	Sixth Floor				
Location:	005 - Kitchen (Kingsway)	Sample No / ID (Type):	P-356976/As 007 (Cross Referenced)				
Surveyor:	Danny Webber	Survey date:	19/12/2019				
Sample Details

Item description:	Window sills					
	Material description:	Cement product					
	Quantity / Extent:	3 m linear					
	Accessibility	Easy Access					
	Analysis:	Chrysotile					
	Material identification:	Asbestos cement					
Material Assessment Scoring:							
Product Type:	1	Condition:	1	Surface Treatment:	1	Asbestos Type:	1
Priority Assessment Scoring:							
Occupant Activity:	0	Disturbance:	3	Human Exposure:	0	Maintenance Activity:	0
Total Scores:							
Material Score:	4	Priority Score	3	Total Score:	7	Risk Rating:	Very Low
Recommended action:	Remove if likely to be disturbed by the refurbishment, otherwise monitor condition.						
Recommendation comments:	It is strongly presumed after discussions on site that asbestos packing material will also be present beneath.

Sample No. / ID (Approach*)	Location details	Item Description	Material description	Asbestos type	Extent	Material score	Priority score	Total score	Recommendation
P-356976/As 007 (X)	Space House - Sixth Floor - Kitchen (Kingsway)	Window sills	Asbestos cement	Chrysotile	3 m linear	4	3	7	Remove if likely to be disturbed by the refurbishment, otherwise monitor condition.
P-356976/As 010 (X)	Space House - Sixth Floor - Kitchen (Kingsway)	Wall lining	Asbestos insulating board	Chrysotile	18 m2	5	2	7	Remove if likely to be disturbed by the refurbishment, otherwise monitor condition.

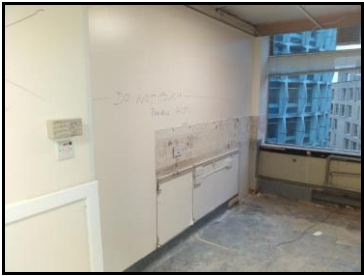
Building:	Space House	Floor:	Sixth Floor				
Location:	005 - Kitchen (Kingsway)	Sample No / ID (Type):	P-356976/As 010 (Cross Referenced)				
Surveyor:	Danny Webber	Survey date:	19/12/2019				
Sample Details

Item description:	Wall lining					
	Material description:	Insulating board					
	Quantity / Extent:	18 m ²					
	Accessibility	Easy Access					
	Analysis:	Chrysotile					
	Material identification:	Asbestos insulating board					
Material Assessment Scoring:							
Product Type:	2	Condition:	1	Surface Treatment:	1	Asbestos Type:	1
Priority Assessment Scoring:							
Occupant Activity:	0	Disturbance:	2	Human Exposure:	0	Maintenance Activity:	0
Total Scores:							
Material Score:	5	Priority Score	2	Total Score:	7	Risk Rating:	Low
Recommended action:	Remove if likely to be disturbed by the refurbishment, otherwise monitor condition.						
Recommendation comments:	-						
Comments:	-

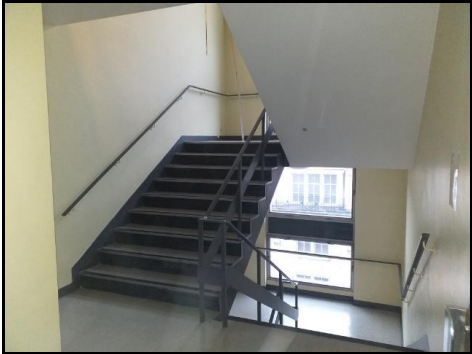
Building Name:	Space House	Floor Level:	Sixth Floor
Location Number:	001	Location Description:	Kemble Street Staircase (Kingsway)
Surveyor:	Danny Webber	Survey Date:	19/12/2019
Room Data / Observations:

General Comments:	
		<p>Plaster skimmed concrete ceiling. Plaster skimmed masonry walls. Timber doors & frame. Metal windows. Metal radiator. Composite skirting board (sampled). Composite step nosings (sampled). Concrete floor beneath floor tiles (sampled).</p> <p>No access could be gained within window cavity void, assistance from window removal specialists required.</p>

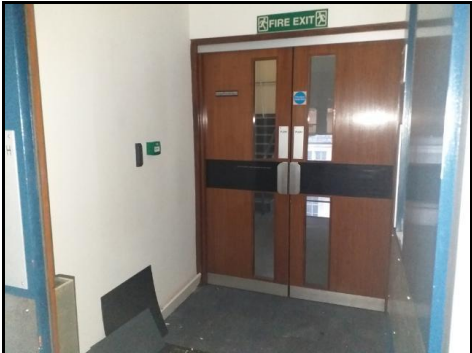
Building Name:	Space House	Floor Level:	Sixth Floor
Location Number:	002	Location Description:	Kemble Street Lobby (Kingsway)
Surveyor:	Danny Webber	Survey Date:	19/12/2019
Room Data / Observations:

General Comments:	
		<p>Plaster skimmed concrete ceiling. Plaster skimmed masonry walls. Timber doors & frames. Timber skirting board. Concrete floor beneath carpet tiles.</p>

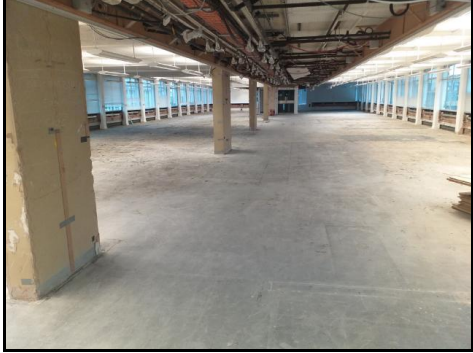
Building Name:	Space House	Floor Level:	Sixth Floor
Location Number:	003	Location Description:	Open Plan Area (Kingsway)
Surveyor:	Danny Webber	Survey Date:	19/12/2019

<p>General Comments:</p> <p>Concrete ceiling above meshed plaster above MMMF ceiling tiles. Foam & MMMF insulated pipework. Plaster skimmed masonry, plasterboard & cement (sampled) walls. Meshed plaster skim beam cladding with concrete beams & cast iron rainwater pipe within. Metal windows with composite sills (sampled). Timber doors & frames. Timber lining to fire extinguisher housing. Timber skirting board. Concrete floor.</p> <p>No access could be gained within window cavity void, assistance from window removal specialists required.</p>
---	---

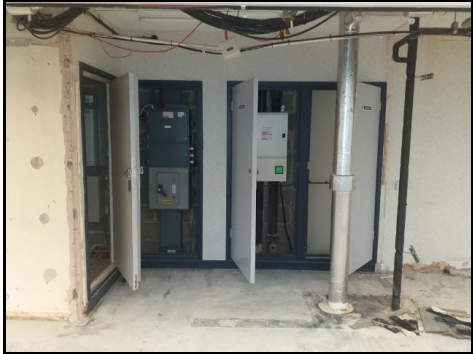
Building Name:	Space House	Floor Level:	Sixth Floor
Location Number:	004	Location Description:	Kimble Street Risers (Kingsway)
Surveyor:	Danny Webber	Survey Date:	19/12/2019

<p>General Comments:</p> <p>Concrete ceiling. Masonry walls. Timber doors & frames. MMMF insulated pipework (sampled). Concrete floor.</p>
---	--

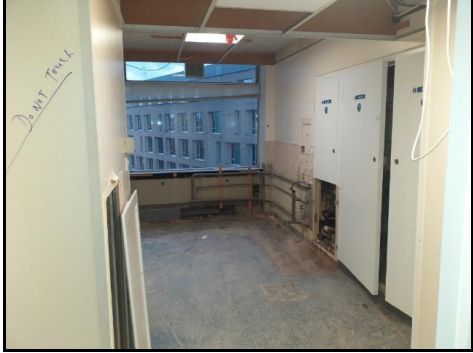
Building Name:	Space House	Floor Level:	Sixth Floor
Location Number:	005	Location Description:	Kitchen (Kingsway)
Surveyor:	Danny Webber	Survey Date:	19/12/2019

<p>General Comments:</p> <p>Concrete (plaster skimmed above window) ceiling above meshed plaster above MMMF ceiling tiles. Foam & MMMF insulated pipework. Plaster skimmed masonry & cement (sampled) walls. Plasterboard boxing. Glass fibreboard riser panel (sampled). Metal windows with composite sills (sampled). Timber doors & frames. Plastic skirting board. Concrete floor partially beneath modern linoleum.</p> <p>No access could be gained within window cavity void, assistance from window removal specialists required.</p>
---	--
