Asbestos Refurbishment Survey Roof to 12th Floor(Tower)

**Space House
1 Kemble Street
London
WC2B 4AN**

Project Reference: P-358038A

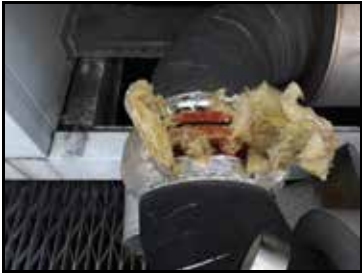
Building:	Space House (Tower)	Floor:	Sixteenth Floor				
Location:	001 - Roof	Sample No / ID (Type):	P-358038/001 (Sampled)				
Surveyor:	Martin Quigley	Survey date:	06/01/2020				
Sample Details

Item description:	Gasket to pipework flange					
	Material description:	Gasket					
	Quantity / Extent:	20 Number					
	Accessibility	Easy Access					
	Analysis:	No asbestos detected					
	Material identification:	Non-asbestos material					
Material Assessment Scoring:							
Product Type:	-	Condition:	-	Surface Treatment:	-	Asbestos Type:	-
Priority Assessment Scoring:							
Occupant Activity:	-	Disturbance:	-	Human Exposure:	-	Maintenance Activity:	-
Total Scores:							
Material Score:	-	Priority Score	-	Total Score:	0	Risk Rating:	N/A
Recommended action:	-						
Recommendation comments:	-						
Comments:	-

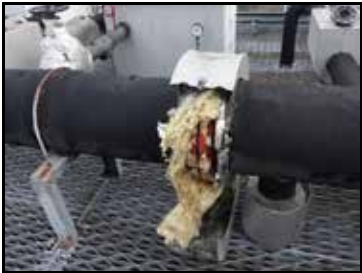
Building:	Space House (Tower)	Floor:	Sixteenth Floor				
Location:	001 - Roof	Sample No / ID (Type):	P-358038/002 (Sampled)				
Surveyor:	Martin Quigley	Survey date:	06/01/2020				
Sample Details

Item description:	Gasket to pipework flange					
	Material description:	Gasket					
	Quantity / Extent:	20 Number					
	Accessibility	Easy Access					
	Analysis:	No asbestos detected					
	Material identification:	Non-asbestos material					
Material Assessment Scoring:							
Product Type:	-	Condition:	-	Surface Treatment:	-	Asbestos Type:	-
Priority Assessment Scoring:							
Occupant Activity:	-	Disturbance:	-	Human Exposure:	-	Maintenance Activity:	-
Total Scores:							
Material Score:	-	Priority Score	-	Total Score:	0	Risk Rating:	N/A
Recommended action:	-						
Recommendation comments:	-						
Comments:	-

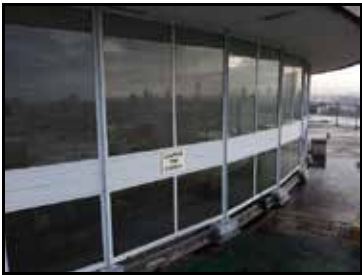
Building:	Space House (Tower)	Floor:	Sixteenth Floor				
Location:	001 - Roof	Sample No / ID (Type):	P-358038/003 (Sampled)				
Surveyor:	Martin Quigley	Survey date:	06/01/2020				
Sample Details

Item description:	Putty to window frames					
	Material description:	Mastics					
	Quantity / Extent:	100 m linear					
	Accessibility	Easy Access					
	Analysis:	No asbestos detected					
	Material identification:	Non-asbestos material					
Material Assessment Scoring:							
Product Type:	-	Condition:	-	Surface Treatment:	-	Asbestos Type:	-
Priority Assessment Scoring:							
Occupant Activity:	-	Disturbance:	-	Human Exposure:	-	Maintenance Activity:	-
Total Scores:							
Material Score:	-	Priority Score	-	Total Score:	0	Risk Rating:	N/A
Recommended action:	-						
Recommendation comments:	-						
Comments:	Representative sample to putty on all metal windows throughout building.

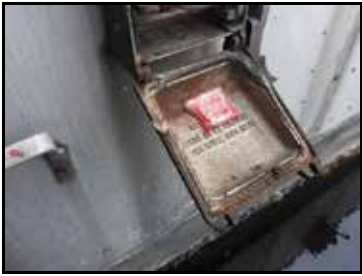
Building:	Space House (Tower)	Floor:	Sixteenth Floor				
Location:	001 - Roof	Sample No / ID (Type):	P-358038/009 (Sampled)				
Surveyor:	Martin Quigley	Survey date:	06/01/2020				
Sample Details

Item description:	Rope seal to electrical unit					
	Material description:	Woven product					
	Quantity / Extent:	2 Number					
	Accessibility	Easy Access					
	Analysis:	No asbestos detected					
	Material identification:	Non-asbestos material					
Material Assessment Scoring:							
Product Type:	-	Condition:	-	Surface Treatment:	-	Asbestos Type:	-
Priority Assessment Scoring:							
Occupant Activity:	-	Disturbance:	-	Human Exposure:	-	Maintenance Activity:	-
Total Scores:							
Material Score:	-	Priority Score	-	Total Score:	0	Risk Rating:	N/A
Recommended action:	-						
Recommendation comments:	-						
Comments:	-

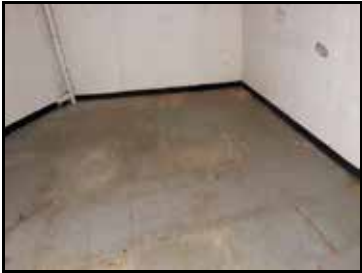
Building:	Space House (Tower)	Floor:	Sixteenth Floor				
Location:	002 - Store	Sample No / ID (Type):	P-358038/004 (Sampled)				
Surveyor:	Martin Quigley	Survey date:	06/01/2020				
Sample Details

Item description:	Floor tiles					
	Material description:	Thermoplastic product					
	Quantity / Extent:	16 m ²					
	Accessibility	Easy Access					
	Analysis:	No asbestos detected					
	Material identification:	Non-asbestos material					
Material Assessment Scoring:							
Product Type:	-	Condition:	-	Surface Treatment:	-	Asbestos Type:	-
Priority Assessment Scoring:							
Occupant Activity:	-	Disturbance:	-	Human Exposure:	-	Maintenance Activity:	-
Total Scores:							
Material Score:	-	Priority Score	-	Total Score:	0	Risk Rating:	N/A
Recommended action:	-						
Recommendation comments:	-						
Comments:	-

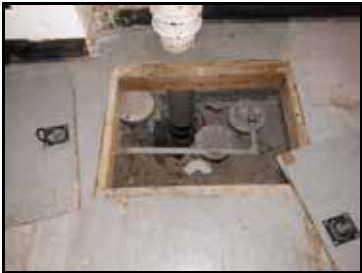
Building:	Space House (Tower)	Floor:	Sixteenth Floor				
Location:	002 - Store	Sample No / ID (Type):	P-358038/As 001 (Cross Referenced)				
Surveyor:	Martin Quigley	Survey date:	06/01/2020				
Sample Details

Item description:	Gasket to pipework flange within floor void					
	Material description:	Gasket					
	Quantity / Extent:	3 Number					
	Accessibility	Easy Access					
	Analysis:	No asbestos detected					
	Material identification:	Non-asbestos material					
Material Assessment Scoring:							
Product Type:	-	Condition:	-	Surface Treatment:	-	Asbestos Type:	-
Priority Assessment Scoring:							
Occupant Activity:	-	Disturbance:	-	Human Exposure:	-	Maintenance Activity:	-
Total Scores:							
Material Score:	-	Priority Score	-	Total Score:	0	Risk Rating:	N/A
Recommended action:	-						
Recommendation comments:	-						
Comments:	-

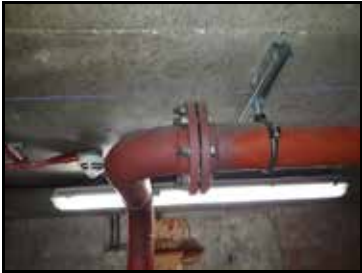
Building:	Space House (Tower)	Floor:	Sixteenth Floor				
Location:	003 - Water tank room	Sample No / ID (Type):	P-358038/005 (Sampled)				
Surveyor:	Martin Quigley	Survey date:	06/01/2020				
Sample Details

Item description:	Gasket to pipework flange					
	Material description:	Gasket					
	Quantity / Extent:	3 Number					
	Accessibility	Easy Access					
	Analysis:	No asbestos detected					
	Material identification:	Non-asbestos material					
Material Assessment Scoring:							
Product Type:	-	Condition:	-	Surface Treatment:	-	Asbestos Type:	-
Priority Assessment Scoring:							
Occupant Activity:	-	Disturbance:	-	Human Exposure:	-	Maintenance Activity:	-
Total Scores:							
Material Score:	-	Priority Score	-	Total Score:	0	Risk Rating:	N/A
Recommended action:	-						
Recommendation comments:	-						
Comments:	-

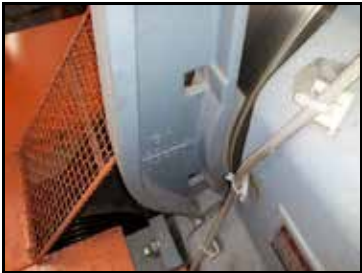
Building:	Space House (Tower)	Floor:	Sixteenth Floor				
Location:	004 - Lift motor room	Sample No / ID (Type):	P-358038/006 (Sampled)				
Surveyor:	Martin Quigley	Survey date:	06/01/2020				
Sample Details

Item description:	Brake pad to lift motor					
	Material description:	Resin					
	Quantity / Extent:	8 Number					
	Accessibility	Medium Access					
	Analysis:	No asbestos detected					
	Material identification:	Non-asbestos material					
Material Assessment Scoring:							
Product Type:	-	Condition:	-	Surface Treatment:	-	Asbestos Type:	-
Priority Assessment Scoring:							
Occupant Activity:	-	Disturbance:	-	Human Exposure:	-	Maintenance Activity:	-
Total Scores:							
Material Score:	-	Priority Score	-	Total Score:	0	Risk Rating:	N/A
Recommended action:	-						
Recommendation comments:	-						
Comments:	-

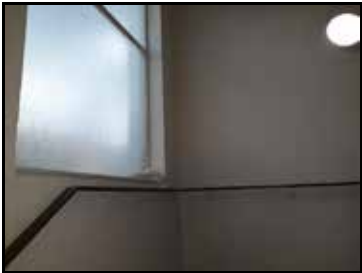
Item description:	Textured coating to walls					
	Material description:	Textured coatings					
	Quantity / Extent:	40 m ²					
	Accessibility	Easy Access					
	Analysis:	No asbestos detected					
	Material identification:	Non-asbestos material					
Material Assessment Scoring:							
Product Type:	-	Condition:	-	Surface Treatment:	-	Asbestos Type:	-
Priority Assessment Scoring:							
Occupant Activity:	-	Disturbance:	-	Human Exposure:	-	Maintenance Activity:	-
Total Scores:							
Material Score:	-	Priority Score	-	Total Score:	0	Risk Rating:	N/A
Recommended action:	-						
Recommendation comments:	-						
Comments:	-

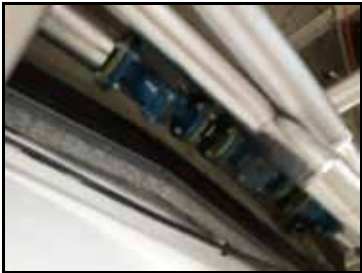
Item description:	Gasket to pipework flange					
	Material description:	Gasket					
	Quantity / Extent:	16 Number					
	Accessibility	Easy Access					
	Analysis:	No asbestos detected					
	Material identification:	Non-asbestos material					
Material Assessment Scoring:							
Product Type:	-	Condition:	-	Surface Treatment:	-	Asbestos Type:	-
Priority Assessment Scoring:							
Occupant Activity:	-	Disturbance:	-	Human Exposure:	-	Maintenance Activity:	-
Total Scores:							
Material Score:	-	Priority Score	-	Total Score:	0	Risk Rating:	N/A
Recommended action:	-						
Recommendation comments:	-						
Comments:	-

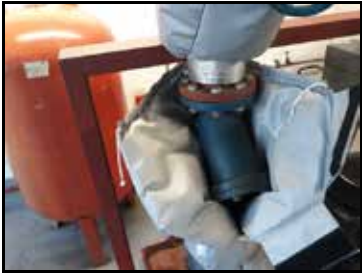
Item description:	Gasket to pipework flange					
	Material description:	Gasket					
	Quantity / Extent:	16 Number					
	Accessibility	Easy Access					
	Analysis:	No asbestos detected					
	Material identification:	Non-asbestos material					
Material Assessment Scoring:							
Product Type:	-	Condition:	-	Surface Treatment:	-	Asbestos Type:	-
Priority Assessment Scoring:							
Occupant Activity:	-	Disturbance:	-	Human Exposure:	-	Maintenance Activity:	-
Total Scores:							
Material Score:	-	Priority Score	-	Total Score:	0	Risk Rating:	N/A
Recommended action:	-						
Recommendation comments:	-						
Comments:	-

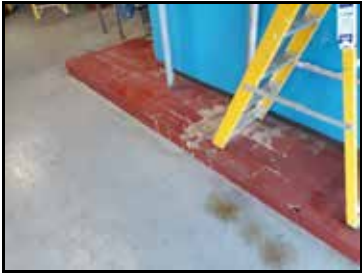
Item description:	Beneath ceramic floor tiles					
	Material description:	Cement product					
	Quantity / Extent:	36 m ²					
	Accessibility	Medium Access					
	Analysis:	No asbestos detected					
	Material identification:	Non-asbestos material					
Material Assessment Scoring:							
Product Type:	-	Condition:	-	Surface Treatment:	-	Asbestos Type:	-
Priority Assessment Scoring:							
Occupant Activity:	-	Disturbance:	-	Human Exposure:	-	Maintenance Activity:	-
Total Scores:							
Material Score:	-	Priority Score	-	Total Score:	0	Risk Rating:	N/A
Recommended action:	-						
Recommendation comments:	-						
Comments:	Cement product present beneath the ceramic tiles

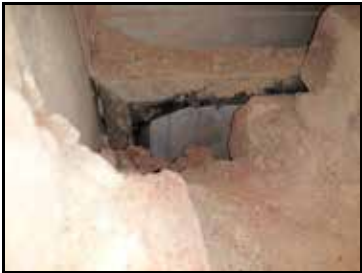
Item description:	Panel beneath windows to the rear of the blockwork wall					
	Material description:	Insulating board					
	Quantity / Extent:	110 m ²					
	Accessibility						
	Analysis:	Amosite Chrysotile					
	Material identification:	Asbestos insulating board					
Material Assessment Scoring:							
Product Type:	2	Condition:	0	Surface Treatment:	2	Asbestos Type:	2
Priority Assessment Scoring:							
Occupant Activity:	0	Disturbance:	2	Human Exposure:	1	Maintenance Activity:	1
Total Scores:							
Material Score:	6	Priority Score	4	Total Score:	6	Risk Rating:	Low
Recommended action:	Remove if likely to be disturbed by the refurbishment, otherwise monitor condition.						
Recommendation comments:	-

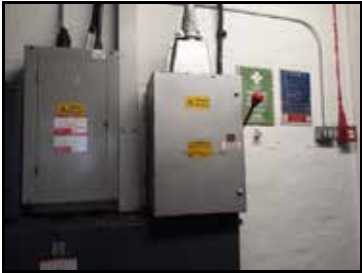
Item description:	Flash guards					
	Material description:	Woven product					
	Quantity / Extent:	1 Number					
	Accessibility	Difficult Access					
	Analysis:	Presumed to contain asbestos					
	Material identification:	Asbestos woven material					
Material Assessment Scoring:							
Product Type:	2	Condition:	0	Surface Treatment:	1	Asbestos Type:	3
Priority Assessment Scoring:							
Occupant Activity:	0	Disturbance:	1	Human Exposure:	1	Maintenance Activity:	1
Total Scores:							
Material Score:	6	Priority Score	3	Total Score:	6	Risk Rating:	Low
Recommended action:	Remove if likely to be disturbed by the refurbishment, otherwise monitor condition.						
Recommendation comments:	-						
Comments:	Presumed flash guards within electrical mains unit, no access due to live electrics.

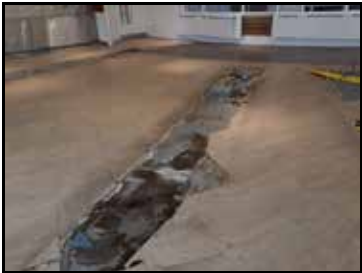
Item description:	Screed/adhesive to the floor					
	Material description:	Floor screed					
	Quantity / Extent:	800 m ²					
	Accessibility	Medium Access					
	Analysis:	No asbestos detected					
	Material identification:	Non-asbestos material					
Material Assessment Scoring:							
Product Type:	-	Condition:	-	Surface Treatment:	-	Asbestos Type:	-
Priority Assessment Scoring:							
Occupant Activity:	-	Disturbance:	-	Human Exposure:	-	Maintenance Activity:	-
Total Scores:							
Material Score:	-	Priority Score	-	Total Score:	0	Risk Rating:	N/A
Recommended action:	-						
Recommendation comments:	-						
Comments:	Sample is representative of the screed/adhesive present throughout

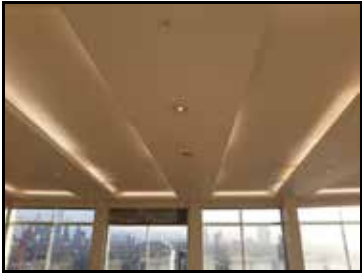
Item description:	Ceiling panels adjacent lighting units					
	Material description:	Insulating board					
	Quantity / Extent:	100 m ²					
	Accessibility	Easy Access					
	Analysis:	No asbestos detected					
	Material identification:	Non-asbestos material					
Material Assessment Scoring:							
Product Type:	-	Condition:	-	Surface Treatment:	-	Asbestos Type:	-
Priority Assessment Scoring:							
Occupant Activity:	-	Disturbance:	-	Human Exposure:	-	Maintenance Activity:	-
Total Scores:							
Material Score:	-	Priority Score	-	Total Score:	0	Risk Rating:	N/A
Recommended action:	-						
Recommendation comments:	-						
Comments:	-

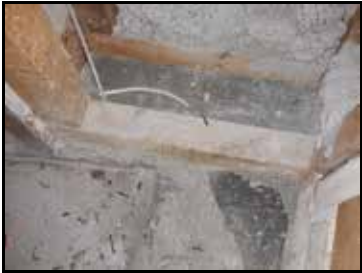
Item description:	Floor tile debris within cupboard					
	Material description:	Thermoplastic product					
	Quantity / Extent:	1 m ²					
	Accessibility	Easy Access					
	Analysis:	Chrysotile					
	Material identification:	Asbestos thermoplastic/adhesive					
Material Assessment Scoring:							
Product Type:	1	Condition:	3	Surface Treatment:	0	Asbestos Type:	1
Priority Assessment Scoring:							
Occupant Activity:	1	Disturbance:	1	Human Exposure:	3	Maintenance Activity:	1
Total Scores:							
Material Score:	5	Priority Score	6	Total Score:	5	Risk Rating:	Low
Recommended action:	Remove.						
Recommendation comments:	-						
Comments:	-

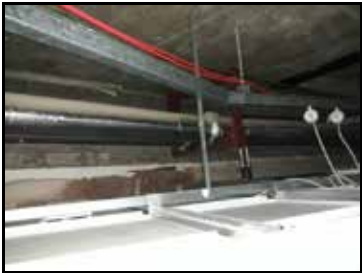
Item description:	Gasket to pipework					
	Material description:	Gasket					
	Quantity / Extent:	10 Number					
	Accessibility	Easy Access					
	Analysis:	No asbestos detected					
	Material identification:	Non-asbestos material					
Material Assessment Scoring:							
Product Type:	-	Condition:	-	Surface Treatment:	-	Asbestos Type:	-
Priority Assessment Scoring:							
Occupant Activity:	-	Disturbance:	-	Human Exposure:	-	Maintenance Activity:	-
Total Scores:							
Material Score:	-	Priority Score	-	Total Score:	0	Risk Rating:	N/A
Recommended action:	-						
Recommendation comments:	-						
Comments:	-

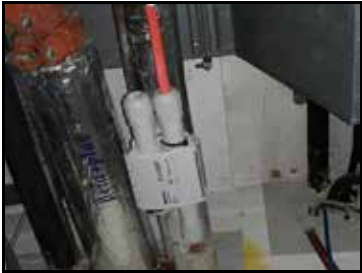
Item description:	Panel to ceiling					
	Material description:	Insulating board					
	Quantity / Extent:	2 m linear					
	Accessibility	Easy Access					
	Analysis:	Amosite Chrysotile					
	Material identification:	Asbestos insulating board					
Material Assessment Scoring:							
Product Type:	2	Condition:	1	Surface Treatment:	1	Asbestos Type:	2
Priority Assessment Scoring:							
Occupant Activity:	0	Disturbance:	2	Human Exposure:	1	Maintenance Activity:	1
Total Scores:							
Material Score:	6	Priority Score	4	Total Score:	6	Risk Rating:	Low
Recommended action:	Remove if likely to be disturbed by the refurbishment, otherwise monitor condition.						
Recommendation comments:	-						
Comments:	-

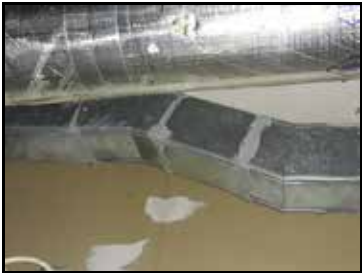
Item description:	Mastic to ducting joints					
	Material description:	Mastics					
	Quantity / Extent:	4 m linear					
	Accessibility	Easy Access					
	Analysis:	No asbestos detected					
	Material identification:	Non-asbestos material					
Material Assessment Scoring:							
Product Type:	-	Condition:	-	Surface Treatment:	-	Asbestos Type:	-
Priority Assessment Scoring:							
Occupant Activity:	-	Disturbance:	-	Human Exposure:	-	Maintenance Activity:	-
Total Scores:							
Material Score:	-	Priority Score	-	Total Score:	0	Risk Rating:	N/A
Recommended action:	-						
Recommendation comments:	-						
Comments:	-

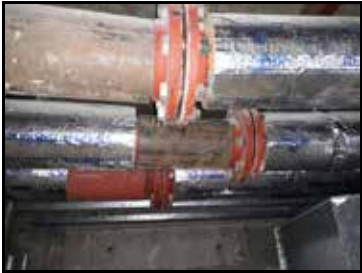
Item description:	Gasket to pipework flange					
	Material description:	Gasket					
	Quantity / Extent:	12 Number					
	Accessibility	Easy Access					
	Analysis:	No asbestos detected					
	Material identification:	Non-asbestos material					
Material Assessment Scoring:							
Product Type:	-	Condition:	-	Surface Treatment:	-	Asbestos Type:	-
Priority Assessment Scoring:							
Occupant Activity:	-	Disturbance:	-	Human Exposure:	-	Maintenance Activity:	-
Total Scores:							
Material Score:	-	Priority Score	-	Total Score:	0	Risk Rating:	N/A
Recommended action:	-						
Recommendation comments:	-						
Comments:	-

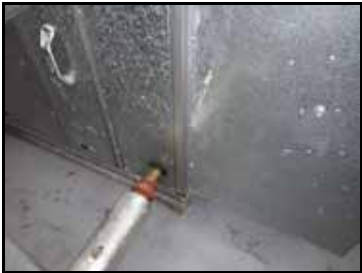
Item description:	Mastic to ducting joints					
	Material description:	Mastics					
	Quantity / Extent:	4 m linear					
	Accessibility	Easy Access					
	Analysis:	No asbestos detected					
	Material identification:	Non-asbestos material					
Material Assessment Scoring:							
Product Type:	-	Condition:	-	Surface Treatment:	-	Asbestos Type:	-
Priority Assessment Scoring:							
Occupant Activity:	-	Disturbance:	-	Human Exposure:	-	Maintenance Activity:	-
Total Scores:							
Material Score:	-	Priority Score	-	Total Score:	0	Risk Rating:	N/A
Recommended action:	-						
Recommendation comments:	-						
Comments:	-

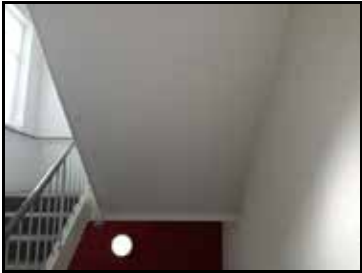
Item description:	Textured coating to concrete ceiling					
	Material description:	Textured coatings					
	Quantity / Extent:	18 m ²					
	Accessibility	Easy Access					
	Analysis:	No asbestos detected					
	Material identification:	Non-asbestos material					
Material Assessment Scoring:							
Product Type:	-	Condition:	-	Surface Treatment:	-	Asbestos Type:	-
Priority Assessment Scoring:							
Occupant Activity:	-	Disturbance:	-	Human Exposure:	-	Maintenance Activity:	-
Total Scores:							
Material Score:	-	Priority Score	-	Total Score:	0	Risk Rating:	N/A
Recommended action:	-						
Recommendation comments:	-						
Comments:	-

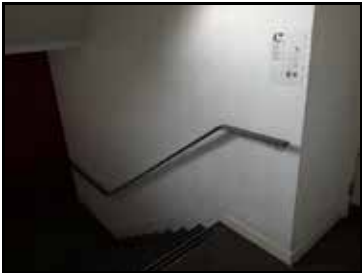
Item description:	Textured coating to walls					
	Material description:	Textured coatings					
	Quantity / Extent:	40 m ²					
	Accessibility	Easy Access					
	Analysis:	No asbestos detected					
	Material identification:	Non-asbestos material					
Material Assessment Scoring:							
Product Type:	-	Condition:	-	Surface Treatment:	-	Asbestos Type:	-
Priority Assessment Scoring:							
Occupant Activity:	-	Disturbance:	-	Human Exposure:	-	Maintenance Activity:	-
Total Scores:							
Material Score:	-	Priority Score	-	Total Score:	0	Risk Rating:	N/A
Recommended action:	-						
Recommendation comments:	-						
Comments:	-

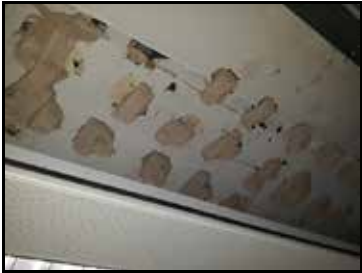
Item description:	Adhesive patches to ceiling					
	Material description:	Bituminous products					
	Quantity / Extent:	20 m ²					
	Accessibility	Easy Access					
	Analysis:	No asbestos detected					
	Material identification:	Non-asbestos material					
Material Assessment Scoring:							
Product Type:	-	Condition:	-	Surface Treatment:	-	Asbestos Type:	-
Priority Assessment Scoring:							
Occupant Activity:	-	Disturbance:	-	Human Exposure:	-	Maintenance Activity:	-
Total Scores:							
Material Score:	-	Priority Score	-	Total Score:	0	Risk Rating:	N/A
Recommended action:	-						
Recommendation comments:	-						
Comments:	-

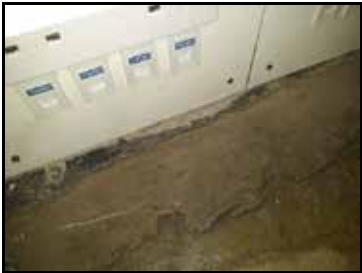
Item description:	Adhesive beneath floor screed					
	Material description:	Bituminous products					
	Quantity / Extent:	800 m ²					
	Accessibility	Easy Access					
	Analysis:	Chrysotile					
	Material identification:	Asbestos bitumen					
Material Assessment Scoring:							
Product Type:	1	Condition:	0	Surface Treatment:	0	Asbestos Type:	1
Priority Assessment Scoring:							
Occupant Activity:	1	Disturbance:	2	Human Exposure:	3	Maintenance Activity:	1
Total Scores:							
Material Score:	2	Priority Score	7	Total Score:	2	Risk Rating:	Very Low
Recommended action:	Remove if likely to be disturbed by the refurbishment, otherwise monitor condition.						
Recommendation comments:	-						
Comments:	The material is representative throughout the floor

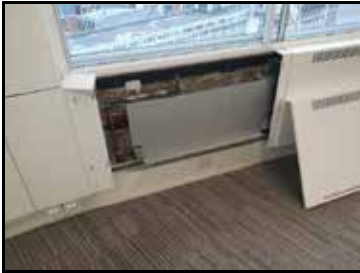
Item description:	Panels beneath windows to the rear of blockwork wall					
	Material description:	Insulating board					
	Quantity / Extent:	110 m ²					
	Accessibility	Medium Access					
	Analysis:	Amosite Chrysotile					
	Material identification:	Asbestos insulating board					
Material Assessment Scoring:							
Product Type:	2	Condition:	0	Surface Treatment:	2	Asbestos Type:	2
Priority Assessment Scoring:							
Occupant Activity:	1	Disturbance:	2	Human Exposure:	3	Maintenance Activity:	1
Total Scores:							
Material Score:	6	Priority Score	7	Total Score:	6	Risk Rating:	Low
Recommended action:	Remove if likely to be disturbed by the refurbishment, otherwise monitor condition.

Recommendation comments:	-						
Comments:	Material should be presumed to be present beneath all perimeter windows

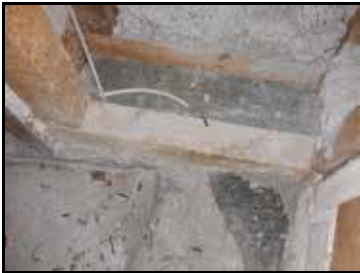
Item description:	Floor tile debris within cupboard					
	Material description:	Thermoplastic product					
	Quantity / Extent:	1 m ²					
	Accessibility	Easy Access					
	Analysis:	Chrysotile					
	Material identification:	Asbestos thermoplastic/adhesive					
Material Assessment Scoring:							
Product Type:	1	Condition:	3	Surface Treatment:	0	Asbestos Type:	1
Priority Assessment Scoring:							
Occupant Activity:	1	Disturbance:	1	Human Exposure:	3	Maintenance Activity:	1
Total Scores:							
Material Score:	5	Priority Score	6	Total Score:	5	Risk Rating:	Low
Recommended action:	Remove.						
Recommendation comments:	-						
Comments:	-

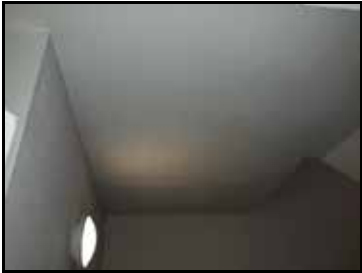
Item description:	Textured coating to the concrete ceiling					
	Material description:	Textured coatings					
	Quantity / Extent:	18 m ²					
	Accessibility	Easy Access					
	Analysis:	No asbestos detected					
	Material identification:	Non-asbestos material					
Material Assessment Scoring:							
Product Type:	-	Condition:	-	Surface Treatment:	-	Asbestos Type:	-
Priority Assessment Scoring:							
Occupant Activity:	-	Disturbance:	-	Human Exposure:	-	Maintenance Activity:	-
Total Scores:							
Material Score:	-	Priority Score	-	Total Score:	0	Risk Rating:	N/A
Recommended action:	-						
Recommendation comments:	-						
Comments:	-

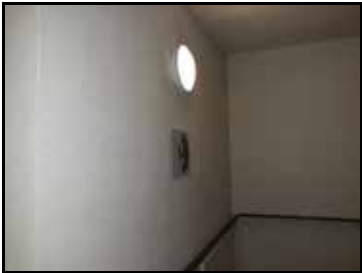
Item description:	Textured coating to the walls					
	Material description:	Textured coatings					
	Quantity / Extent:	40 m ²					
	Accessibility	Easy Access					
	Analysis:	No asbestos detected					
	Material identification:	Non-asbestos material					
Material Assessment Scoring:							
Product Type:	-	Condition:	-	Surface Treatment:	-	Asbestos Type:	-
Priority Assessment Scoring:							
Occupant Activity:	-	Disturbance:	-	Human Exposure:	-	Maintenance Activity:	-
Total Scores:							
Material Score:	-	Priority Score	-	Total Score:	0	Risk Rating:	N/A
Recommended action:	-						
Recommendation comments:	-						
Comments:	-

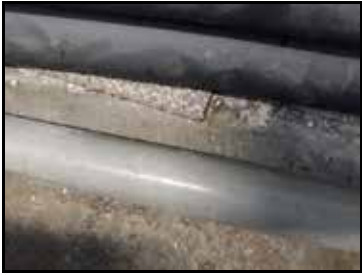
Item description:	Adhesive beneath floor screed					
	Material description:	Bituminous products					
	Quantity / Extent:	800 m ²					
	Accessibility	Easy Access					
	Analysis:	Chrysotile					
	Material identification:	Asbestos bitumen					
Material Assessment Scoring:							
Product Type:	1	Condition:	0	Surface Treatment:	0	Asbestos Type:	1
Priority Assessment Scoring:							
Occupant Activity:	1	Disturbance:	2	Human Exposure:	3	Maintenance Activity:	1
Total Scores:							
Material Score:	2	Priority Score	7	Total Score:	2	Risk Rating:	Very Low
Recommended action:	Remove if likely to be disturbed by the refurbishment, otherwise monitor condition.						
Recommendation comments:	-						
Comments:	Material is representative to the floor throughout

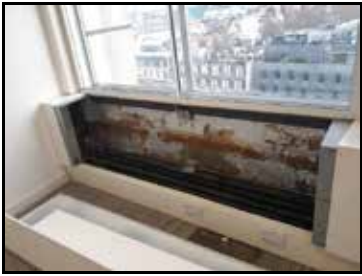
Item description:	Panels beneath windows to the rear of blockwork wall					
	Material description:	Insulating board					
	Quantity / Extent:	110 m ²					
	Accessibility	Medium Access					
	Analysis:	Amosite Chrysotile					
	Material identification:	Asbestos insulating board					
Material Assessment Scoring:							
Product Type:	2	Condition:	0	Surface Treatment:	2	Asbestos Type:	2
Priority Assessment Scoring:							
Occupant Activity:	1	Disturbance:	2	Human Exposure:	3	Maintenance Activity:	1
Total Scores:							
Material Score:	6	Priority Score	7	Total Score:	6	Risk Rating:	Low
Recommended action:	Remove if likely to be disturbed by the refurbishment, otherwise monitor condition.

Recommendation comments:	-						
Comments:	Material is presumed to be present beneath all perimeter windows

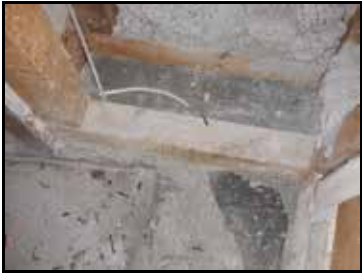
Item description:	Floor tile debris within cupboard					
	Material description:	Thermoplastic product					
	Quantity / Extent:	1 m ²					
	Accessibility	Easy Access					
	Analysis:	Chrysotile					
	Material identification:	Asbestos thermoplastic/adhesive					
Material Assessment Scoring:							
Product Type:	1	Condition:	3	Surface Treatment:	0	Asbestos Type:	1
Priority Assessment Scoring:							
Occupant Activity:	1	Disturbance:	1	Human Exposure:	3	Maintenance Activity:	1
Total Scores:							
Material Score:	5	Priority Score	6	Total Score:	5	Risk Rating:	Low
Recommended action:	Remove.						
Recommendation comments:	-						
Comments:	-

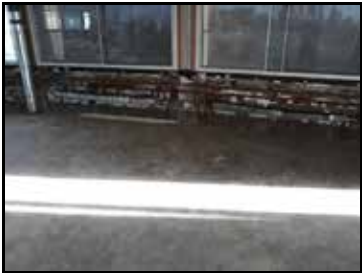
Item description:	Panels beneath windows to the rear of block work walls					
	Material description:	Insulating board					
	Quantity / Extent:	110 m ²					
	Accessibility	Medium Access					
	Analysis:	Amosite Chrysotile					
	Material identification:	Asbestos insulating board					
Material Assessment Scoring:							
Product Type:	2	Condition:	0	Surface Treatment:	2	Asbestos Type:	2
Priority Assessment Scoring:							
Occupant Activity:	1	Disturbance:	2	Human Exposure:	3	Maintenance Activity:	1
Total Scores:							
Material Score:	6	Priority Score	7	Total Score:	6	Risk Rating:	Low
Recommended action:	Remove if likely to be disturbed by the refurbishment, otherwise monitor condition.						
Recommendation comments:	-

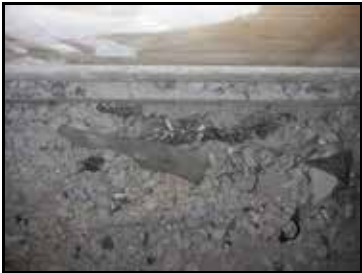
Item description:	Floor tile debris within cupboard					
	Material description:	Thermoplastic product					
	Quantity / Extent:	1 m ²					
	Accessibility	Easy Access					
	Analysis:	Chrysotile					
	Material identification:	Asbestos thermoplastic/adhesive					
Material Assessment Scoring:							
Product Type:	1	Condition:	3	Surface Treatment:	0	Asbestos Type:	1
Priority Assessment Scoring:							
Occupant Activity:	1	Disturbance:	1	Human Exposure:	3	Maintenance Activity:	1
Total Scores:							
Material Score:	5	Priority Score	6	Total Score:	5	Risk Rating:	Low
Recommended action:	Remove.						
Recommendation comments:	-						
Comments:	-

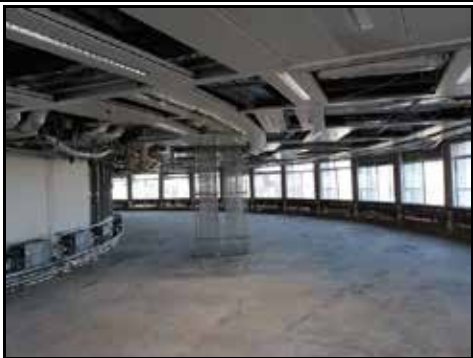
General Comments:
	<p>Concrete ceiling above suspended metal ceiling with modern ducting with MMMF insulation and modern services to void, solid brick/plasterboard walls to areas containing MMMF insulation to cavity, concrete floor beneath modern vinyl/carpet tiles, timber doors and frames with 2x metal glazing to windows, uninsulated/MMMF insulated metal pipework within heaters to walls, modern electrical units within riser cupboards, modern sink pads to sinks, plasterboard partition walls with MMMF insulation within cavity to built in offices with glass fronts to some, modern pipework and gaskets with MMMF insulation within metal boxing to outer window divides.</p>

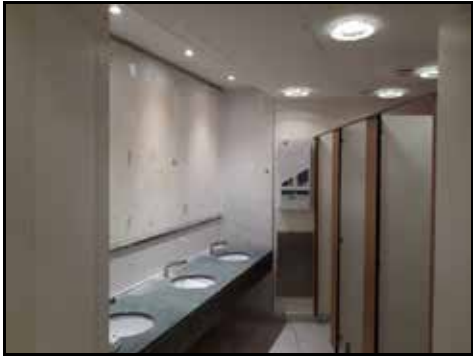
General Comments:
	<p>Concrete ceiling above plasterboard with modern uninsulated ducting and MMMF insulated metal pipework with solid/plasterboard walls and a concrete floor beneath ceramic tiles, timber door and frame, timber boxing to wall containing plastic toilet cisterns and waste pipes to toilets and urinals, timber partitions to cubicles, 2x riser cupboards with MMMF insulated metal pipework and electrical units to wall with plastic pipework.</p>
