Asbestos Refurbishment Survey Roof to 6th Floor (Kingsway)

**Space House
1 Kemble Street
London
WC2B 4AN**

Survey Date: 19 December 2019 and 06 January 2020 - 07 January 2020

Project Reference: P-358070B

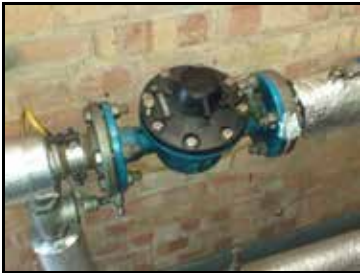
Item description:	Pipework flange					
	Material description:	Gasket					
	Quantity / Extent:	1 Number					
	Accessibility	Easy Access					
	Analysis:	Chrysotile					
	Material identification:	Asbestos gasket					
Material Assessment Scoring:							
Product Type:	2	Condition:	1	Surface Treatment:	2	Asbestos Type:	1
Priority Assessment Scoring:							
Occupant Activity:	0	Disturbance:	1	Human Exposure:	0	Maintenance Activity:	0
Total Scores:							
Material Score:	6	Priority Score	1	Total Score:	6	Risk Rating:	Low
Recommended action:	Remove if likely to be disturbed by the refurbishment, otherwise encapsulate and then monitor condition						
Recommendation comments:	-						
Comments:	-

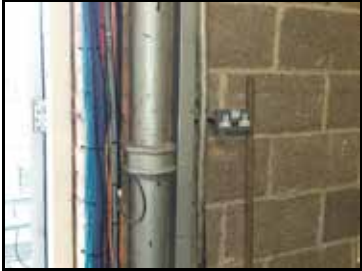
Item description:	Electrical intake cables					
	Material description:	Woven product					
	Quantity / Extent:	6 m linear					
	Accessibility	Easy Access					
	Analysis:	Presumed to contain asbestos					
	Material identification:	Asbestos woven material					
Material Assessment Scoring:							
Product Type:	2	Condition:	1	Surface Treatment:	1	Asbestos Type:	3
Priority Assessment Scoring:							
Occupant Activity:	0	Disturbance:	2	Human Exposure:	0	Maintenance Activity:	0
Total Scores:							
Material Score:	7	Priority Score	2	Total Score:	7	Risk Rating:	Medium
Recommended action:	Remove if likely to be disturbed by the refurbishment, otherwise monitor condition.						
Recommendation comments:	-

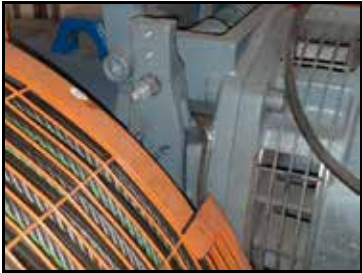
Item description:	Lift brake shoes						
	Material description:	Resin						
	Quantity / Extent:	4 Number						
	Accessibility	Easy Access						
	Analysis:	Presumed to contain asbestos						
	Material identification:	Asbestos resin material						
Material Assessment Scoring:								
Product Type:	1	Condition:	1	Surface Treatment:	0	Asbestos Type:	3	
Priority Assessment Scoring:								
Occupant Activity:	0	Disturbance:	2	Human Exposure:	0	Maintenance Activity:	0	
Total Scores:								
Material Score:	5	Priority Score	2	Total Score:	5	Risk Rating:	Low	
Recommended action:	Remove if likely to be disturbed by the refurbishment, otherwise monitor condition.							
Recommendation comments:	-

Comments:	Unsafe to sample.

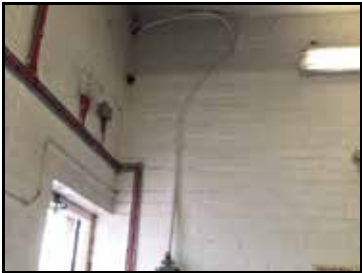
Item description:	Electrical intake cables						
	Material description:	Woven product						
	Quantity / Extent:	2 m linear						
	Accessibility	Medium Access						
	Analysis:	Presumed to contain asbestos						
	Material identification:	Asbestos woven material						
Material Assessment Scoring:								
Product Type:	2	Condition:	1	Surface Treatment:	1	Asbestos Type:	3	
Priority Assessment Scoring:								
Occupant Activity:	0	Disturbance:	2	Human Exposure:	0	Maintenance Activity:	0	
Total Scores:								
Material Score:	7	Priority Score	2	Total Score:	7	Risk Rating:	Medium	
Recommended action:	Remove if likely to be disturbed by the refurbishment, otherwise monitor condition.

Recommendation comments:	-							
Comments:	Live electrics - unable to sample.

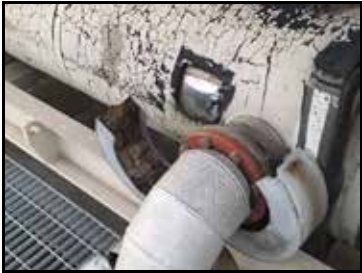
Item description:	Plant pipework flange					
	Material description:	Gasket					
	Quantity / Extent:	6 Number					
	Accessibility	Easy Access					
	Analysis:	Chrysotile					
	Material identification:	Asbestos gasket					
Material Assessment Scoring:							
Product Type:	2	Condition:	1	Surface Treatment:	2	Asbestos Type:	1
Priority Assessment Scoring:							
Occupant Activity:	0	Disturbance:	1	Human Exposure:	0	Maintenance Activity:	0
Total Scores:							
Material Score:	6	Priority Score	1	Total Score:	6	Risk Rating:	Low
Recommended action:	Remove if likely to be disturbed by the refurbishment, otherwise monitor condition.						
Recommendation comments:	-						
Comments:	-

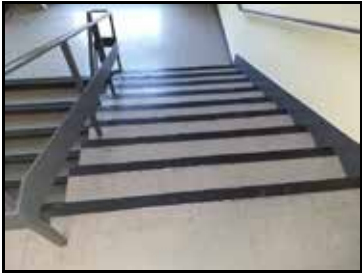
Item description:	Step nosings					
	Material description:	Thermoplastic product					
	Quantity / Extent:	9 Number					
	Accessibility	Easy Access					
	Analysis:	Chrysotile					
	Material identification:	Asbestos thermoplastic material					
Material Assessment Scoring:							
Product Type:	1	Condition:	1	Surface Treatment:	0	Asbestos Type:	1
Priority Assessment Scoring:							
Occupant Activity:	0	Disturbance:	2	Human Exposure:	0	Maintenance Activity:	0
Total Scores:							
Material Score:	3	Priority Score	2	Total Score:	3	Risk Rating:	Very Low
Recommended action:	Remove if likely to be disturbed by the refurbishment, otherwise monitor condition.						
Recommendation comments:	-

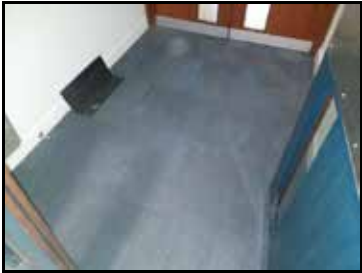
Item description:	Adhesive residue beneath carpet tiles					
	Material description:	Bituminous products					
	Quantity / Extent:	890 m ²					
	Accessibility	Easy Access					
	Analysis:	Chrysotile					
	Material identification:	Asbestos bitumen					
Material Assessment Scoring:							
Product Type:	1	Condition:	1	Surface Treatment:	0	Asbestos Type:	1
Priority Assessment Scoring:							
Occupant Activity:	0	Disturbance:	2	Human Exposure:	0	Maintenance Activity:	0
Total Scores:							
Material Score:	3	Priority Score	2	Total Score:	3	Risk Rating:	Very Low
Recommended action:	Remove if likely to be disturbed by the refurbishment, otherwise monitor condition.						
Recommendation comments:	-

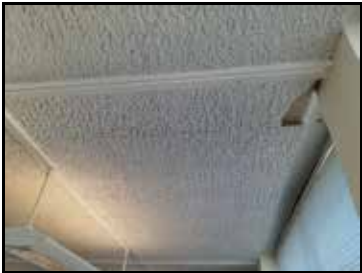
Item description:	Ceiling above MMMF tiles					
	Material description:	Insulating board					
	Quantity / Extent:	80 m ²					
	Accessibility	Difficult Access					
	Analysis:	Chrysotile					
	Material identification:	Asbestos insulating board					
Material Assessment Scoring:							
Product Type:	2	Condition:	1	Surface Treatment:	1	Asbestos Type:	1
Priority Assessment Scoring:							
Occupant Activity:	0	Disturbance:	2	Human Exposure:	0	Maintenance Activity:	0
Total Scores:							
Material Score:	5	Priority Score	2	Total Score:	5	Risk Rating:	Low
Recommended action:	Remove if likely to be disturbed by the refurbishment, otherwise monitor condition.						
Recommendation comments:	It is strongly presumed after discussions on site that asbestos packing material will also be present above.

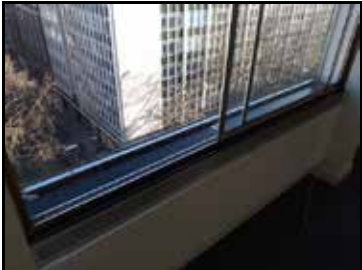
Item description:	Window sills					
	Material description:	Cement product					
	Quantity / Extent:	82 m linear					
	Accessibility	Easy Access					
	Analysis:	Chrysotile					
	Material identification:	Asbestos cement					
Material Assessment Scoring:							
Product Type:	1	Condition:	1	Surface Treatment:	1	Asbestos Type:	1
Priority Assessment Scoring:							
Occupant Activity:	0	Disturbance:	2	Human Exposure:	0	Maintenance Activity:	0
Total Scores:							
Material Score:	4	Priority Score	2	Total Score:	4	Risk Rating:	Very Low
Recommended action:	Remove if likely to be disturbed by the refurbishment, otherwise monitor condition.						
Recommendation comments:	-

Comments:	Material is common to all perimeter windows. It is strongly presumed, after discussions on site, that asbestos packing material and/or AIB panels may be present beneath the window. No inspection could be made beneath the window sill to inspect the cavity/void due to the damage that this would cause to the asbestos. The window cavity/void will be inspected as part of the pilot window removal exercise.

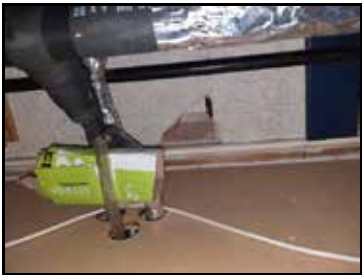
Item description:	Packing above ceiling timber beams					
	Material description:	Insulating board					
	Quantity / Extent:	650 m linear					
	Accessibility	Difficult Access					
	Analysis:	Chrysotile					
	Material identification:	Asbestos insulating board					
Material Assessment Scoring:							
Product Type:	2	Condition:	1	Surface Treatment:	1	Asbestos Type:	1
Priority Assessment Scoring:							
Occupant Activity:	0	Disturbance:	1	Human Exposure:	0	Maintenance Activity:	0
Total Scores:							
Material Score:	5	Priority Score	1	Total Score:	5	Risk Rating:	Low
Recommended action:	Remove if likely to be disturbed by the refurbishment, otherwise monitor condition.

Recommendation comments:	-						
Comments:	Material located above original MMMF ceiling tiles sporadically throughout area. It should be presumed to be present above all timber beams. Instances of floor tile & cement have also been observed to be used as packers.

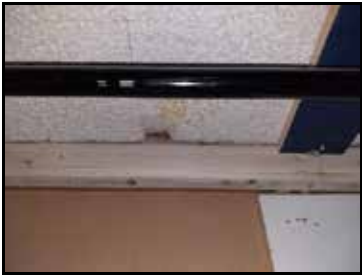
Item description:	Packing above ceiling timber beams					
	Material description:	Insulation					
	Quantity / Extent:	650 m linear					
	Accessibility	Difficult Access					
	Analysis:	Amosite					
	Material identification:	Asbestos insulation					
Material Assessment Scoring:							
Product Type:	3	Condition:	2	Surface Treatment:	3	Asbestos Type:	2
Priority Assessment Scoring:							
Occupant Activity:	0	Disturbance:	1	Human Exposure:	0	Maintenance Activity:	0
Total Scores:							
Material Score:	10	Priority Score	1	Total Score:	10	Risk Rating:	High
Recommended action:	Remove.						
Recommendation comments:	-						
Comments:	Material found to be sporadically used, it should be presumed to be present throughout above the timber beams. Instances of floor tile & cement have also been observed to be used as packers.

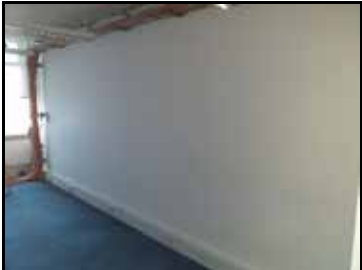
Item description:	Wall lining beneath plasterboard lining (kitchen)					
	Material description:	Insulating board					
	Quantity / Extent:	18 m ²					
	Accessibility	Difficult Access					
	Analysis:	Chrysotile					
	Material identification:	Asbestos insulating board					
Material Assessment Scoring:							
Product Type:	2	Condition:	1	Surface Treatment:	1	Asbestos Type:	1
Priority Assessment Scoring:							
Occupant Activity:	0	Disturbance:	1	Human Exposure:	0	Maintenance Activity:	0
Total Scores:							
Material Score:	5	Priority Score	1	Total Score:	5	Risk Rating:	Low
Recommended action:	Remove if likely to be disturbed by the refurbishment, otherwise monitor condition.

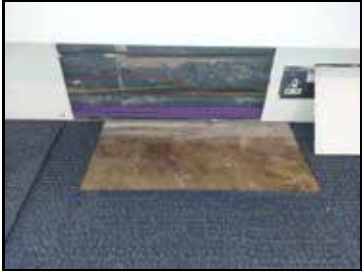
Item description:	Floor tiles (grey) & bitumen adhesive					
	Material description:	Thermoplastic product					
	Quantity / Extent:	1 m ²					
	Accessibility	Medium Access					
	Analysis:	Chrysotile					
	Material identification:	Asbestos thermoplastic/adhesive					
Material Assessment Scoring:							
Product Type:	1	Condition:	3	Surface Treatment:	0	Asbestos Type:	1
Priority Assessment Scoring:							
Occupant Activity:	0	Disturbance:	1	Human Exposure:	0	Maintenance Activity:	0
Total Scores:							
Material Score:	5	Priority Score	1	Total Score:	5	Risk Rating:	Low
Recommended action:	Remove if likely to be disturbed by the refurbishment, otherwise monitor condition.

Recommendation comments:	-						
Comments:	Material located within plasterboard boxing outside risers at Kemble Street Staircase end of building. Also includes small pieces present beneath perimeter electrical trunking & skirting boards.

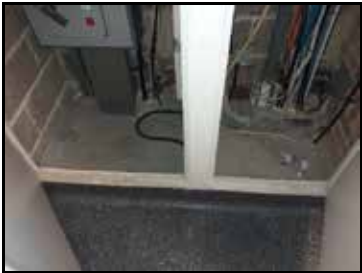
Item description:	Panel beneath floor screed within risers (x3)					
	Material description:	Insulating board					
	Quantity / Extent:	3 Number					
	Accessibility	Difficult Access					
	Analysis:	Chrysotile					
	Material identification:	Asbestos insulating board					
Material Assessment Scoring:							
Product Type:	2	Condition:	1	Surface Treatment:	1	Asbestos Type:	1
Priority Assessment Scoring:							
Occupant Activity:	0	Disturbance:	1	Human Exposure:	0	Maintenance Activity:	0
Total Scores:							
Material Score:	5	Priority Score	1	Total Score:	5	Risk Rating:	Low
Recommended action:	Remove if likely to be disturbed by the refurbishment, otherwise monitor condition.						
Recommendation comments:	-

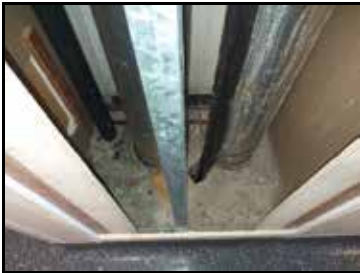
Item description:	Floor tiles (grey) & bitumen adhesive					
	Material description:	Thermoplastic product					
	Quantity / Extent:	1 m ²					
	Accessibility	Medium Access					
	Analysis:	Chrysotile					
	Material identification:	Asbestos thermoplastic/adhesive					
Material Assessment Scoring:							
Product Type:	1	Condition:	1	Surface Treatment:	0	Asbestos Type:	1
Priority Assessment Scoring:							
Occupant Activity:	0	Disturbance:	2	Human Exposure:	0	Maintenance Activity:	0
Total Scores:							
Material Score:	3	Priority Score	2	Total Score:	3	Risk Rating:	Very Low
Recommended action:	Remove if likely to be disturbed by the refurbishment, otherwise monitor condition.						
Recommendation comments:	-

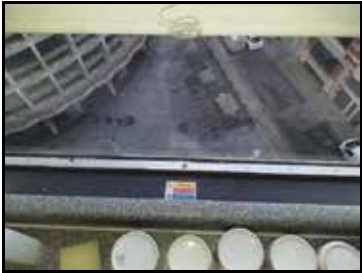
Item description:	Window sill					
	Material description:	Cement product					
	Quantity / Extent:	2 m linear					
	Accessibility	Easy Access					
	Analysis:	Chrysotile					
	Material identification:	Asbestos cement					
Material Assessment Scoring:							
Product Type:	1	Condition:	1	Surface Treatment:	1	Asbestos Type:	1
Priority Assessment Scoring:							
Occupant Activity:	0	Disturbance:	2	Human Exposure:	0	Maintenance Activity:	0
Total Scores:							
Material Score:	4	Priority Score	2	Total Score:	4	Risk Rating:	Very Low
Recommended action:	Remove if likely to be disturbed by the refurbishment, otherwise monitor condition.						
Recommendation comments:	-						
Comments:	Material is common to all perimeter windows. It is strongly presumed, after discussions on site, that asbestos packing material and/or AIB panels may be present beneath the window. No inspection could be made beneath the window sill to inspect the cavity/void due to the damage that this would cause to the asbestos. The window cavity/void will be inspected as part of the pilot window removal exercise.

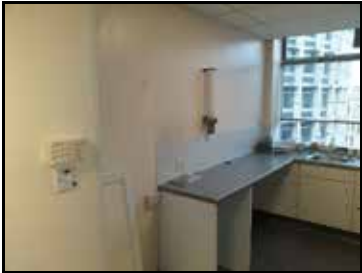
Item description:	Wall lining					
	Material description:	Insulating board					
	Quantity / Extent:	20 m ²					
	Accessibility	Easy Access					
	Analysis:	Chrysotile					
	Material identification:	Asbestos insulating board					
Material Assessment Scoring:							
Product Type:	2	Condition:	1	Surface Treatment:	1	Asbestos Type:	1
Priority Assessment Scoring:							
Occupant Activity:	0	Disturbance:	2	Human Exposure:	0	Maintenance Activity:	0
Total Scores:							
Material Score:	5	Priority Score	2	Total Score:	5	Risk Rating:	Low
Recommended action:	Remove if likely to be disturbed by the refurbishment, otherwise monitor condition.						
Recommendation comments:	-						
Comments:	Material also forms cupboard walls.

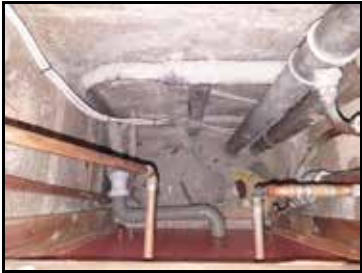
Item description:	Debris within cistern & hand dryer voids					
	Material description:	Cement product					
	Quantity / Extent:	1 m ²					
	Accessibility	Medium Access					
	Analysis:	Amosite Chrysotile					
	Material identification:	Asbestos cement					
Material Assessment Scoring:							
Product Type:	1	Condition:	3	Surface Treatment:	1	Asbestos Type:	2
Priority Assessment Scoring:							
Occupant Activity:	0	Disturbance:	1	Human Exposure:	0	Maintenance Activity:	0
Total Scores:							
Material Score:	7	Priority Score	1	Total Score:	7	Risk Rating:	Medium
Recommended action:	Remove.						
Recommendation comments:	-						
Comments:	-

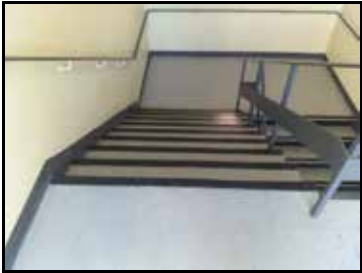
Item description:	Step nosings					
	Material description:	Thermoplastic product					
	Quantity / Extent:	9 Number					
	Accessibility	Easy Access					
	Analysis:	Chrysotile					
	Material identification:	Asbestos thermoplastic material					
Material Assessment Scoring:							
Product Type:	1	Condition:	1	Surface Treatment:	0	Asbestos Type:	1
Priority Assessment Scoring:							
Occupant Activity:	0	Disturbance:	2	Human Exposure:	0	Maintenance Activity:	0
Total Scores:							
Material Score:	3	Priority Score	2	Total Score:	3	Risk Rating:	Very Low
Recommended action:	Remove if likely to be disturbed by the refurbishment, otherwise monitor condition.						
Recommendation comments:	-

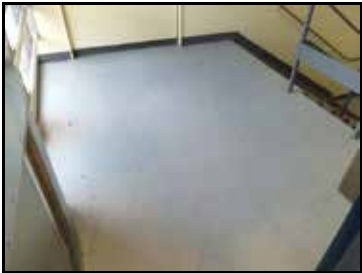
Item description:	Floor tiles (grey & black) & bitumen adhesive					
	Material description:	Thermoplastic product					
	Quantity / Extent:	12 m ²					
	Accessibility	Easy Access					
	Analysis:	Chrysotile					
	Material identification:	Asbestos thermoplastic/adhesive					
Material Assessment Scoring:							
Product Type:	1	Condition:	1	Surface Treatment:	0	Asbestos Type:	1
Priority Assessment Scoring:							
Occupant Activity:	0	Disturbance:	2	Human Exposure:	0	Maintenance Activity:	0
Total Scores:							
Material Score:	3	Priority Score	2	Total Score:	3	Risk Rating:	Very Low
Recommended action:	Remove if likely to be disturbed by the refurbishment, otherwise monitor condition.

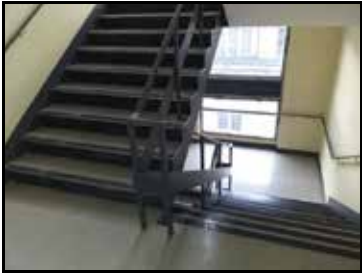
Item description:	Step nosings					
	Material description:	Thermoplastic product					
	Quantity / Extent:	18 Number					
	Accessibility	Easy Access					
	Analysis:	Chrysotile					
	Material identification:	Asbestos thermoplastic material					
Material Assessment Scoring:							
Product Type:	1	Condition:	1	Surface Treatment:	0	Asbestos Type:	1
Priority Assessment Scoring:							
Occupant Activity:	0	Disturbance:	2	Human Exposure:	0	Maintenance Activity:	0
Total Scores:							
Material Score:	3	Priority Score	2	Total Score:	3	Risk Rating:	Very Low
Recommended action:	Remove if likely to be disturbed by the refurbishment, otherwise monitor condition.						
Recommendation comments:	-

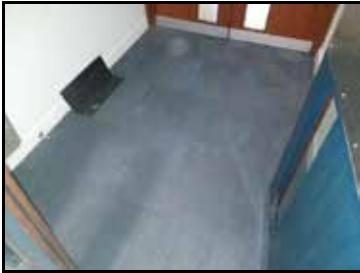
Item description:	Adhesive residue beneath carpet tiles					
	Material description:	Bituminous products					
	Quantity / Extent:	890 m ²					
	Accessibility	Easy Access					
	Analysis:	Chrysotile					
	Material identification:	Asbestos bitumen					
Material Assessment Scoring:							
Product Type:	1	Condition:	1	Surface Treatment:	0	Asbestos Type:	1
Priority Assessment Scoring:							
Occupant Activity:	0	Disturbance:	2	Human Exposure:	0	Maintenance Activity:	0
Total Scores:							
Material Score:	3	Priority Score	2	Total Score:	3	Risk Rating:	Very Low
Recommended action:	Remove if likely to be disturbed by the refurbishment, otherwise monitor condition.						
Recommendation comments:	-

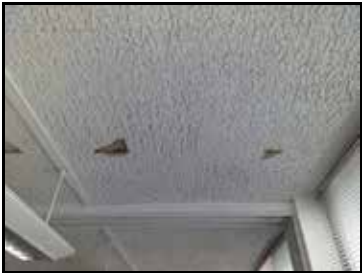
Item description:	Ceiling above MMMF tiles					
	Material description:	Insulating board					
	Quantity / Extent:	80 m ²					
	Accessibility	Difficult Access					
	Analysis:	Chrysotile					
	Material identification:	Asbestos insulating board					
Material Assessment Scoring:							
Product Type:	2	Condition:	1	Surface Treatment:	1	Asbestos Type:	1
Priority Assessment Scoring:							
Occupant Activity:	0	Disturbance:	2	Human Exposure:	0	Maintenance Activity:	0
Total Scores:							
Material Score:	5	Priority Score	2	Total Score:	5	Risk Rating:	Low
Recommended action:	Remove if likely to be disturbed by the refurbishment, otherwise monitor condition.						
Recommendation comments:	-

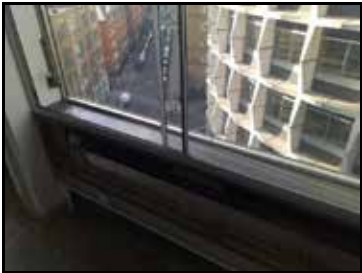
Item description:	Window sills					
	Material description:	Cement product					
	Quantity / Extent:	82 m linear					
	Accessibility	Easy Access					
	Analysis:	Chrysotile					
	Material identification:	Asbestos cement					
Material Assessment Scoring:							
Product Type:	1	Condition:	1	Surface Treatment:	1	Asbestos Type:	1
Priority Assessment Scoring:							
Occupant Activity:	0	Disturbance:	2	Human Exposure:	0	Maintenance Activity:	0
Total Scores:							
Material Score:	4	Priority Score	2	Total Score:	4	Risk Rating:	Very Low
Recommended action:	Remove if likely to be disturbed by the refurbishment, otherwise monitor condition.						
Recommendation comments:	It is strongly presumed after discussions on site that asbestos packing material and/or AIB panels beneath the window may also be present.

Comments:	Material is common to all perimeter windows. It is strongly presumed, after discussions on site, that asbestos packing material and/or AIB panels may be present beneath the window. No inspection could be made beneath the window sill to inspect the cavity/void due to the damage that this would cause to the asbestos. The window cavity/void will be inspected as part of the pilot window removal exercise.

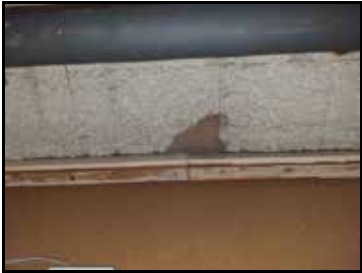
Item description:	Packing above ceiling timber beams					
	Material description:	Insulating board					
	Quantity / Extent:	650 m linear					
	Accessibility	Difficult Access					
	Analysis:	Chrysotile					
	Material identification:	Asbestos insulating board					
Material Assessment Scoring:							
Product Type:	2	Condition:	1	Surface Treatment:	1	Asbestos Type:	1
Priority Assessment Scoring:							
Occupant Activity:	0	Disturbance:	1	Human Exposure:	0	Maintenance Activity:	0
Total Scores:							
Material Score:	5	Priority Score	1	Total Score:	5	Risk Rating:	Low
Recommended action:	Remove if likely to be disturbed by the refurbishment, otherwise monitor condition.

Recommendation comments:	-						
Comments:	Material located above original MMMF ceiling tiles sporadically throughout area. It should be presumed to be present above all timber beams. Instances of floor tile & cement have also been observed to be used as packers.

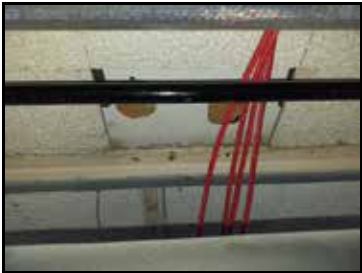
Item description:	Packing above ceiling timber beams					
	Material description:	Insulation					
	Quantity / Extent:	650 m linear					
	Accessibility	Difficult Access					
	Analysis:	Amosite					
	Material identification:	Asbestos insulation					
Material Assessment Scoring:							
Product Type:	3	Condition:	2	Surface Treatment:	3	Asbestos Type:	2
Priority Assessment Scoring:							
Occupant Activity:	0	Disturbance:	1	Human Exposure:	0	Maintenance Activity:	0
Total Scores:							
Material Score:	10	Priority Score	1	Total Score:	10	Risk Rating:	High
Recommended action:	Remove.						
Recommendation comments:	-						
Comments:	Material located above original MMMF ceiling tiles sporadically throughout area. It should be presumed to be present above all timber beams. Instances of floor tile & cement have also been observed to be used as packers.

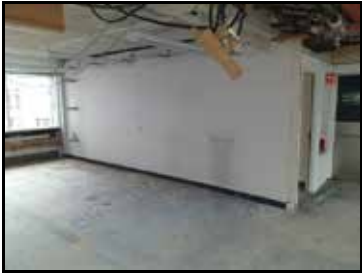
Item description:	Wall lining beneath plasterboard lining (kitchen)					
	Material description:	Insulating board					
	Quantity / Extent:	18 m ²					
	Accessibility	Difficult Access					
	Analysis:	Chrysotile					
	Material identification:	Asbestos insulating board					
Material Assessment Scoring:							
Product Type:	2	Condition:	1	Surface Treatment:	1	Asbestos Type:	1
Priority Assessment Scoring:							
Occupant Activity:	0	Disturbance:	1	Human Exposure:	0	Maintenance Activity:	0
Total Scores:							
Material Score:	5	Priority Score	1	Total Score:	5	Risk Rating:	Low
Recommended action:	Remove if likely to be disturbed by the refurbishment, otherwise encapsulate and then monitor condition

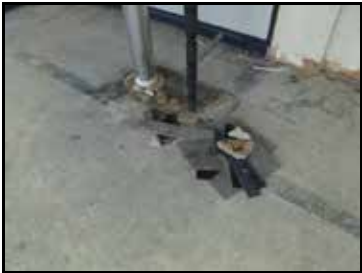
Item description:	Floor tiles (grey) & bitumen adhesive debris					
	Material description:	Thermoplastic product					
	Quantity / Extent:	1 m ²					
	Accessibility	Easy Access					
	Analysis:	Chrysotile					
	Material identification:	Asbestos thermoplastic/adhesive					
Material Assessment Scoring:							
Product Type:	1	Condition:	3	Surface Treatment:	0	Asbestos Type:	1
Priority Assessment Scoring:							
Occupant Activity:	0	Disturbance:	1	Human Exposure:	0	Maintenance Activity:	0
Total Scores:							
Material Score:	5	Priority Score	1	Total Score:	5	Risk Rating:	Low
Recommended action:	Remove.						
Recommendation comments:	-						
Comments:	Material located outside risers at Kemble Street Staircase end of building. Also includes small pieces present beneath perimeter electrical trunking & skirting boards.

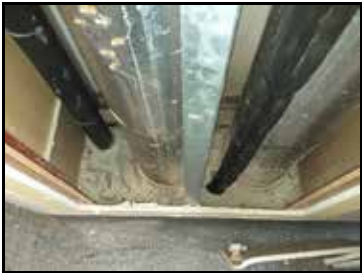
Item description:	Floor tiles (grey) & bitumen adhesive					
	Material description:	Thermoplastic product					
	Quantity / Extent:	1 m ²					
	Accessibility	Medium Access					
	Analysis:	Chrysotile					
	Material identification:	Asbestos thermoplastic/adhesive					
Material Assessment Scoring:							
Product Type:	1	Condition:	1	Surface Treatment:	0	Asbestos Type:	1
Priority Assessment Scoring:							
Occupant Activity:	0	Disturbance:	2	Human Exposure:	0	Maintenance Activity:	0
Total Scores:							
Material Score:	3	Priority Score	2	Total Score:	3	Risk Rating:	Very Low
Recommended action:	Remove if likely to be disturbed by the refurbishment, otherwise monitor condition.						
Recommendation comments:	-

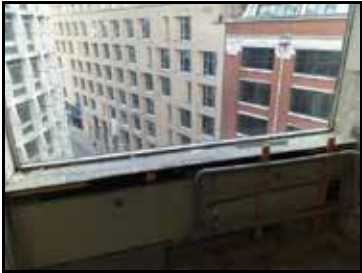
Item description:	Window sill					
	Material description:	Cement product					
	Quantity / Extent:	2 m linear					
	Accessibility	Easy Access					
	Analysis:	Chrysotile					
	Material identification:	Asbestos cement					
Material Assessment Scoring:							
Product Type:	1	Condition:	1	Surface Treatment:	1	Asbestos Type:	1
Priority Assessment Scoring:							
Occupant Activity:	0	Disturbance:	2	Human Exposure:	0	Maintenance Activity:	0
Total Scores:							
Material Score:	4	Priority Score	2	Total Score:	4	Risk Rating:	Very Low
Recommended action:	Remove if likely to be disturbed by the refurbishment, otherwise monitor condition.						
Recommendation comments:	-						
Comments:	Material is common to all perimeter windows. It is strongly presumed, after discussions on site, that asbestos packing material and/or AIB panels may be present beneath the window. No inspection could be made beneath the window sill to inspect the cavity/void due to the damage that this would cause to the asbestos. The window cavity/void will be inspected as part of the pilot window removal exercise.

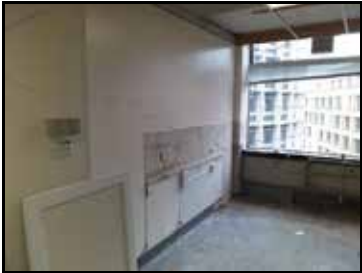
Item description:	Wall lining					
	Material description:	Insulating board					
	Quantity / Extent:	20 m ²					
	Accessibility	Easy Access					
	Analysis:	Chrysotile					
	Material identification:	Asbestos insulating board					
Material Assessment Scoring:							
Product Type:	2	Condition:	2	Surface Treatment:	1	Asbestos Type:	1
Priority Assessment Scoring:							
Occupant Activity:	0	Disturbance:	2	Human Exposure:	0	Maintenance Activity:	0
Total Scores:							
Material Score:	6	Priority Score	2	Total Score:	6	Risk Rating:	Low
Recommended action:	Remove if likely to be disturbed by the refurbishment, otherwise encapsulate and then monitor condition						
Recommendation comments:	-

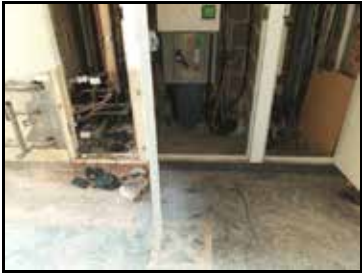
Item description:	Panel beneath floor screed within risers (x3)					
	Material description:	Insulating board					
	Quantity / Extent:	3 Number					
	Accessibility	Difficult Access					
	Analysis:	Chrysotile					
	Material identification:	Asbestos insulating board					
Material Assessment Scoring:							
Product Type:	2	Condition:	1	Surface Treatment:	1	Asbestos Type:	1
Priority Assessment Scoring:							
Occupant Activity:	0	Disturbance:	1	Human Exposure:	0	Maintenance Activity:	0
Total Scores:							
Material Score:	5	Priority Score	1	Total Score:	5	Risk Rating:	Low
Recommended action:	Remove if likely to be disturbed by the refurbishment, otherwise monitor condition.						
Recommendation comments:	-

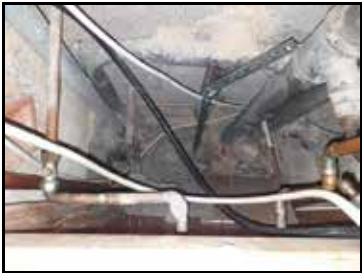
Item description:	Debris within hand dryer void					
	Material description:	Cement product					
	Quantity / Extent:	1 m ²					
	Accessibility	Medium Access					
	Analysis:	Amosite Chrysotile					
	Material identification:	Asbestos cement					
Material Assessment Scoring:							
Product Type:	1	Condition:	3	Surface Treatment:	1	Asbestos Type:	2
Priority Assessment Scoring:							
Occupant Activity:	0	Disturbance:	1	Human Exposure:	0	Maintenance Activity:	0
Total Scores:							
Material Score:	7	Priority Score	1	Total Score:	7	Risk Rating:	Medium
Recommended action:	Remove.						
Recommendation comments:	-						
Comments:	-

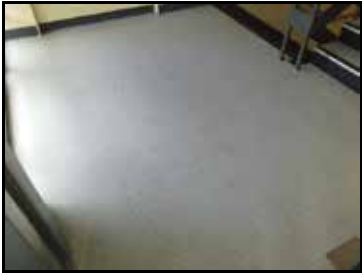
Item description:	Floor tiles (grey & black) & bitumen adhesive					
	Material description:	Thermoplastic product					
	Quantity / Extent:	12 m ²					
	Accessibility	Easy Access					
	Analysis:	Chrysotile					
	Material identification:	Asbestos thermoplastic/adhesive					
Material Assessment Scoring:							
Product Type:	1	Condition:	1	Surface Treatment:	0	Asbestos Type:	1
Priority Assessment Scoring:							
Occupant Activity:	0	Disturbance:	2	Human Exposure:	0	Maintenance Activity:	0
Total Scores:							
Material Score:	3	Priority Score	2	Total Score:	3	Risk Rating:	Very Low
Recommended action:	Remove if likely to be disturbed by the refurbishment, otherwise monitor condition.

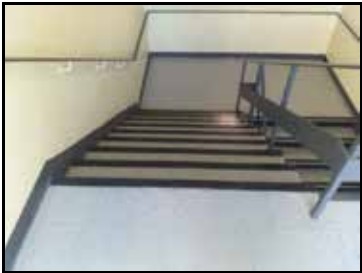
Item description:	Step nosings					
	Material description:	Thermoplastic product					
	Quantity / Extent:	18 Number					
	Accessibility	Easy Access					
	Analysis:	Chrysotile					
	Material identification:	Asbestos thermoplastic material					
Material Assessment Scoring:							
Product Type:	1	Condition:	1	Surface Treatment:	0	Asbestos Type:	1
Priority Assessment Scoring:							
Occupant Activity:	0	Disturbance:	2	Human Exposure:	0	Maintenance Activity:	0
Total Scores:							
Material Score:	3	Priority Score	2	Total Score:	3	Risk Rating:	Very Low
Recommended action:	Remove if likely to be disturbed by the refurbishment, otherwise monitor condition.						
Recommendation comments:	-
