Asbestos Refurbishment Survey **11th Floor to Basement**

SLQR Trustee No 1 Limited and SLQR Trustee No 2 Limited
as Co Trustees of SLQR Unit Trust No 3

Space House (Tower)
1 Kemble Street
London
WC2B 4AN

Project Reference: P-359273

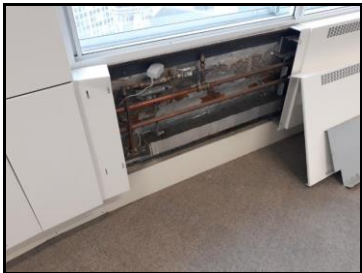
Item description:	Panel beneath the window to the rear of the blockwork wall					
	Material description:	Insulating board					
	Quantity / Extent:	110 m²					
	Accessibility	Medium Access					
	Analysis:	Amosite Chrysotile					
	Material identification:	Asbestos insulating board					
Material Assessment Scoring:							
Product Type:	2	Condition:	0	Surface Treatment:	2	Asbestos Type:	2
Priority Assessment Scoring:							
Occupant Activity:	1	Disturbance:	2	Human Exposure:	3	Maintenance Activity:	1
Total Scores:							
Material Score:	6	Priority Score	7	Total Score:	6	Risk Rating:	Low
Recommended action:	Remove if likely to be disturbed by the refurbishment, otherwise monitor condition.

Recommendation comments:	-						
Comments:	Material is representative of throughout.

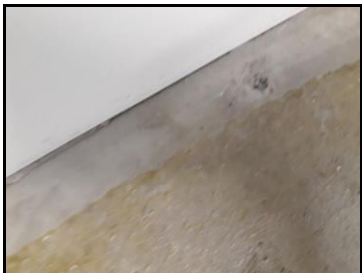
Item description:	Adhesive to floor beneath modern screed					
	Material description:	Bituminous products					
	Quantity / Extent:	800 m²					
	Accessibility	Medium Access					
	Analysis:	Chrysotile					
	Material identification:	Asbestos bitumen					
Material Assessment Scoring:							
Product Type:	1	Condition:	0	Surface Treatment:	0	Asbestos Type:	1
Priority Assessment Scoring:							
Occupant Activity:	1	Disturbance:	2	Human Exposure:	3	Maintenance Activity:	1
Total Scores:							
Material Score:	2	Priority Score	7	Total Score:	2	Risk Rating:	Very Low
Recommended action:	Remove if likely to be disturbed by the refurbishment, otherwise monitor condition.						
Recommendation comments:	-

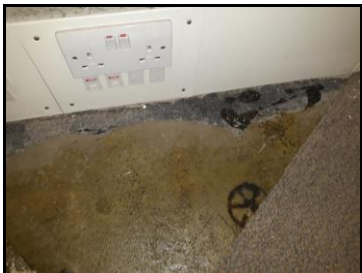
Item description:	Adhesive beneath modern screed					
	Material description:	Bituminous products					
	Quantity / Extent:	800 m ²					
	Accessibility	Medium Access					
	Analysis:	Chrysotile					
	Material identification:	Asbestos bitumen					
Material Assessment Scoring:							
Product Type:	1	Condition:	0	Surface Treatment:	0	Asbestos Type:	1
Priority Assessment Scoring:							
Occupant Activity:	1	Disturbance:	2	Human Exposure:	3	Maintenance Activity:	1
Total Scores:							
Material Score:	2	Priority Score	7	Total Score:	2	Risk Rating:	Very Low
Recommended action:	Remove if likely to be disturbed by the refurbishment, otherwise monitor condition.						
Recommendation comments:	-

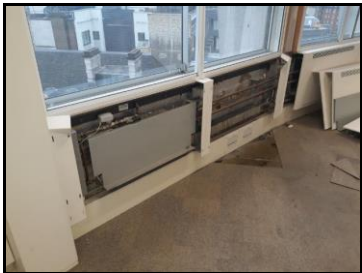
Item description:	Panel beneath the window to the rear of the blockwork wall					
	Material description:	Insulating board					
	Quantity / Extent:	110 m²					
	Accessibility	Medium Access					
	Analysis:	Amosite Chrysotile					
	Material identification:	Asbestos insulating board					
Material Assessment Scoring:							
Product Type:	2	Condition:	0	Surface Treatment:	2	Asbestos Type:	2
Priority Assessment Scoring:							
Occupant Activity:	1	Disturbance:	2	Human Exposure:	3	Maintenance Activity:	1
Total Scores:							
Material Score:	6	Priority Score	7	Total Score:	6	Risk Rating:	Low
Recommended action:	Remove if likely to be disturbed by the refurbishment, otherwise monitor condition.

Recommendation comments:	-						
Comments:	Material is representative of throughout.

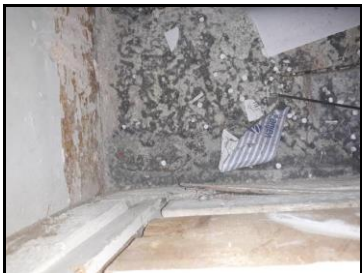
Item description:	Floor tile debris within cupboards					
	Material description:	Thermoplastic product					
	Quantity / Extent:	1 m²					
	Accessibility	Easy Access					
	Analysis:	Chrysotile					
	Material identification:	Asbestos thermoplastic/adhesive					
Material Assessment Scoring:							
Product Type:	1	Condition:	3	Surface Treatment:	0	Asbestos Type:	1
Priority Assessment Scoring:							
Occupant Activity:	1	Disturbance:	1	Human Exposure:	3	Maintenance Activity:	1
Total Scores:							
Material Score:	5	Priority Score	6	Total Score:	5	Risk Rating:	Low
Recommended action:	Remove.						
Recommendation comments:	-						
Comments:	Floor tile debris is also present to the opposite cupboard.

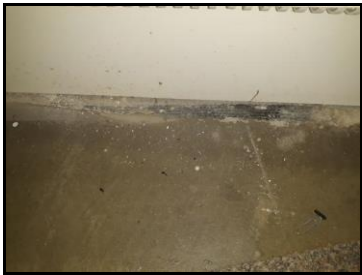
Item description:	Adhesive beneath modern screed					
	Material description:	Bituminous products					
	Quantity / Extent:	800 m²					
	Accessibility	Medium Access					
	Analysis:	Chrysotile					
	Material identification:	Asbestos bitumen					
Material Assessment Scoring:							
Product Type:	1	Condition:	0	Surface Treatment:	0	Asbestos Type:	1
Priority Assessment Scoring:							
Occupant Activity:	1	Disturbance:	2	Human Exposure:	3	Maintenance Activity:	1
Total Scores:							
Material Score:	2	Priority Score	7	Total Score:	2	Risk Rating:	Very Low
Recommended action:	Remove if likely to be disturbed by the refurbishment, otherwise monitor condition.						
Recommendation comments:	-

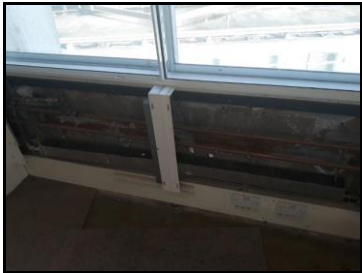
Item description:	Panel beneath the window to the rear of the blockwork wall					
	Material description:	Insulating board					
	Quantity / Extent:	110 m²					
	Accessibility	Medium Access					
	Analysis:	Amosite Chrysotile					
	Material identification:	Asbestos insulating board					
Material Assessment Scoring:							
Product Type:	2	Condition:	0	Surface Treatment:	2	Asbestos Type:	2
Priority Assessment Scoring:							
Occupant Activity:	1	Disturbance:	2	Human Exposure:	3	Maintenance Activity:	1
Total Scores:							
Material Score:	6	Priority Score	7	Total Score:	6	Risk Rating:	Low
Recommended action:	Remove if likely to be disturbed by the refurbishment, otherwise monitor condition.

Recommendation comments:	-						
Comments:	Material is representative of throughout.

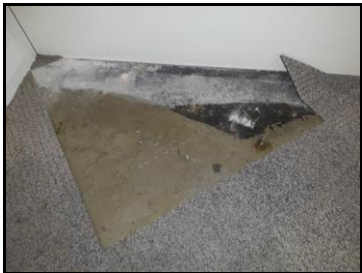
Item description:	Adhesive beneath modern screed					
	Material description:	Bituminous products					
	Quantity / Extent:	800 m²					
	Accessibility	Medium Access					
	Analysis:	Chrysotile					
	Material identification:	Asbestos bitumen					
Material Assessment Scoring:							
Product Type:	1	Condition:	0	Surface Treatment:	0	Asbestos Type:	1
Priority Assessment Scoring:							
Occupant Activity:	1	Disturbance:	2	Human Exposure:	3	Maintenance Activity:	1
Total Scores:							
Material Score:	2	Priority Score	7	Total Score:	2	Risk Rating:	Very Low
Recommended action:	Remove if likely to be disturbed by the refurbishment, otherwise monitor condition.						
Recommendation comments:	-

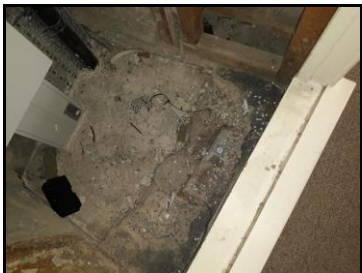
Item description:	Floor tile debris within cupboard					
	Material description:	Thermoplastic product					
	Quantity / Extent:	1 m²					
	Accessibility	Easy Access					
	Analysis:	Chrysotile					
	Material identification:	Asbestos thermoplastic/adhesive					
Material Assessment Scoring:							
Product Type:	1	Condition:	3	Surface Treatment:	0	Asbestos Type:	1
Priority Assessment Scoring:							
Occupant Activity:	1	Disturbance:	1	Human Exposure:	3	Maintenance Activity:	1
Total Scores:							
Material Score:	5	Priority Score	6	Total Score:	5	Risk Rating:	Low
Recommended action:	Remove.						
Recommendation comments:	-						
Comments:	Floor tile debris is also present to the opposite cupboard.

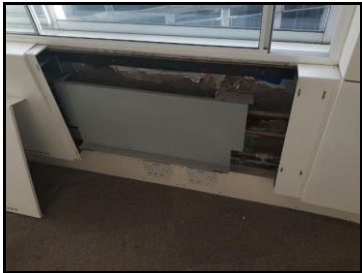
Item description:	Panel beneath the window to the rear of the blockwork wall					
	Material description:	Insulating board					
	Quantity / Extent:	110 m²					
	Accessibility	Medium Access					
	Analysis:	Amosite Chrysotile					
	Material identification:	Asbestos insulating board					
Material Assessment Scoring:							
Product Type:	2	Condition:	0	Surface Treatment:	2	Asbestos Type:	2
Priority Assessment Scoring:							
Occupant Activity:	1	Disturbance:	2	Human Exposure:	3	Maintenance Activity:	1
Total Scores:							
Material Score:	6	Priority Score	7	Total Score:	6	Risk Rating:	Low
Recommended action:	Remove if likely to be disturbed by the refurbishment, otherwise monitor condition.

Recommendation comments:	-						
Comments:	Material is representative of throughout.

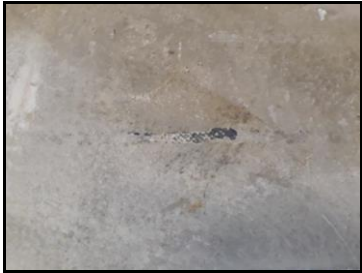
Item description:	Adhesive to floor beneath modern screed					
	Material description:	Bituminous products					
	Quantity / Extent:	800 m²					
	Accessibility	Medium Access					
	Analysis:	Chrysotile					
	Material identification:	Asbestos bitumen					
Material Assessment Scoring:							
Product Type:	1	Condition:	0	Surface Treatment:	0	Asbestos Type:	1
Priority Assessment Scoring:							
Occupant Activity:	1	Disturbance:	2	Human Exposure:	3	Maintenance Activity:	1
Total Scores:							
Material Score:	2	Priority Score	7	Total Score:	2	Risk Rating:	Very Low
Recommended action:	Remove if likely to be disturbed by the refurbishment, otherwise monitor condition.						
Recommendation comments:	-

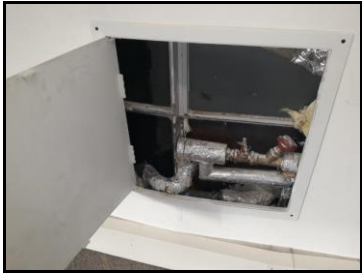
Item description:	Mastic to windows behind plasterboard					
	Material description:	Mastics					
	Quantity / Extent:	30 m linear					
	Accessibility	Medium Access					
	Analysis:	Chrysotile					
	Material identification:	Asbestos mastic					
Material Assessment Scoring:							
Product Type:	1	Condition:	1	Surface Treatment:	0	Asbestos Type:	1
Priority Assessment Scoring:							
Occupant Activity:	1	Disturbance:	1	Human Exposure:	3	Maintenance Activity:	1
Total Scores:							
Material Score:	3	Priority Score	6	Total Score:	3	Risk Rating:	Very Low
Recommended action:	Remove if likely to be disturbed by the refurbishment, otherwise monitor condition.						
Recommendation comments:	-

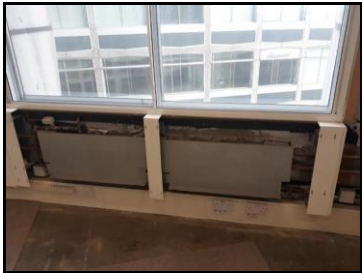
Item description:	Panel beneath the window to the rear of the blockwork wall					
	Material description:	Insulating board					
	Quantity / Extent:	110 m²					
	Accessibility	Medium Access					
	Analysis:	Amosite Chrysotile					
	Material identification:	Asbestos insulating board					
Material Assessment Scoring:							
Product Type:	2	Condition:	0	Surface Treatment:	2	Asbestos Type:	2
Priority Assessment Scoring:							
Occupant Activity:	1	Disturbance:	2	Human Exposure:	3	Maintenance Activity:	1
Total Scores:							
Material Score:	6	Priority Score	7	Total Score:	6	Risk Rating:	Low
Recommended action:	Remove if likely to be disturbed by the refurbishment, otherwise monitor condition.

Recommendation comments:	-						
Comments:	Material is representative of throughout.

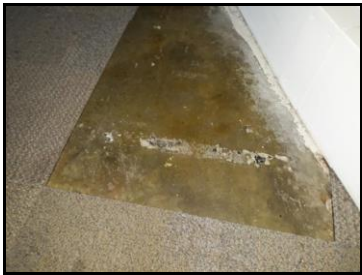
Item description:	Adhesive beneath modern screed					
	Material description:	Bituminous products					
	Quantity / Extent:	800 m²					
	Accessibility	Easy Access					
	Analysis:	Chrysotile					
	Material identification:	Asbestos bitumen					
Material Assessment Scoring:							
Product Type:	1	Condition:	0	Surface Treatment:	0	Asbestos Type:	1
Priority Assessment Scoring:							
Occupant Activity:	1	Disturbance:	2	Human Exposure:	3	Maintenance Activity:	1
Total Scores:							
Material Score:	2	Priority Score	7	Total Score:	2	Risk Rating:	Very Low
Recommended action:	Remove if likely to be disturbed by the refurbishment, otherwise monitor condition.						
Recommendation comments:	-

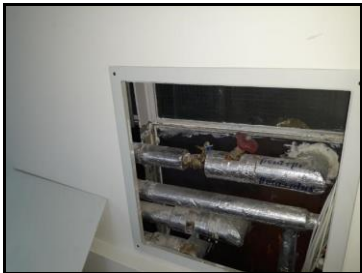
Item description:	Mastic to internal windows behind plasterboard					
	Material description:	Mastics					
	Quantity / Extent:	30 m linear					
	Accessibility	Medium Access					
	Analysis:	Chrysotile					
	Material identification:	Asbestos mastic					
Material Assessment Scoring:							
Product Type:	1	Condition:	1	Surface Treatment:	0	Asbestos Type:	1
Priority Assessment Scoring:							
Occupant Activity:	1	Disturbance:	1	Human Exposure:	3	Maintenance Activity:	1
Total Scores:							
Material Score:	3	Priority Score	6	Total Score:	3	Risk Rating:	Very Low
Recommended action:	Remove if likely to be disturbed by the refurbishment, otherwise monitor condition.						
Recommendation comments:	-

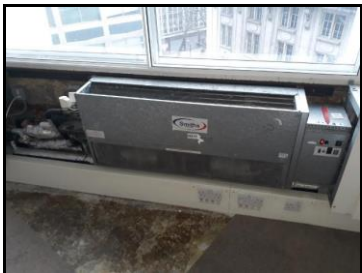
Item description:	Panel beneath the window to the rear of the blockwork wall					
	Material description:	Insulating board					
	Quantity / Extent:	110 m²					
	Accessibility	Medium Access					
	Analysis:	Amosite Chrysotile					
	Material identification:	Asbestos insulating board					
Material Assessment Scoring:							
Product Type:	2	Condition:	0	Surface Treatment:	2	Asbestos Type:	2
Priority Assessment Scoring:							
Occupant Activity:	1	Disturbance:	2	Human Exposure:	3	Maintenance Activity:	1
Total Scores:							
Material Score:	6	Priority Score	7	Total Score:	6	Risk Rating:	Low
Recommended action:	Remove if likely to be disturbed by the refurbishment, otherwise monitor condition.

Recommendation comments:	-						
Comments:	Material is representative of throughout.

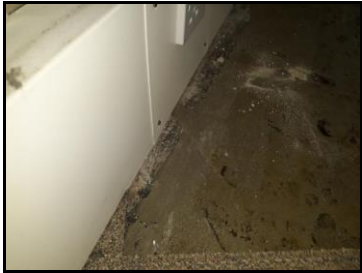
Item description:	Adhesive to floor beneath modern screed					
	Material description:	Bituminous products					
	Quantity / Extent:	800 m²					
	Accessibility	Medium Access					
	Analysis:	Chrysotile					
	Material identification:	Asbestos bitumen					
Material Assessment Scoring:							
Product Type:	1	Condition:	0	Surface Treatment:	0	Asbestos Type:	1
Priority Assessment Scoring:							
Occupant Activity:	1	Disturbance:	2	Human Exposure:	3	Maintenance Activity:	1
Total Scores:							
Material Score:	2	Priority Score	7	Total Score:	2	Risk Rating:	Very Low
Recommended action:	Remove if likely to be disturbed by the refurbishment, otherwise monitor condition.						
Recommendation comments:	-

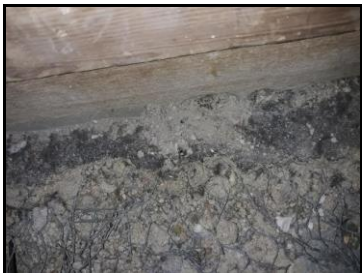
Item description:	Floor tile debris within cupboard					
	Material description:	Thermoplastic product					
	Quantity / Extent:	1 m²					
	Accessibility	Easy Access					
	Analysis:	Chrysotile					
	Material identification:	Asbestos thermoplastic/adhesive					
Material Assessment Scoring:							
Product Type:	1	Condition:	3	Surface Treatment:	0	Asbestos Type:	1
Priority Assessment Scoring:							
Occupant Activity:	1	Disturbance:	1	Human Exposure:	3	Maintenance Activity:	1
Total Scores:							
Material Score:	5	Priority Score	6	Total Score:	5	Risk Rating:	Low
Recommended action:	Remove.						
Recommendation comments:	-						
Comments:	Floor tile debris is also present to the opposite cupboard.

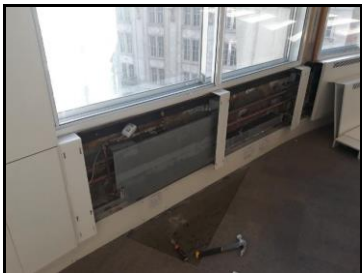
Item description:	Panel beneath the window to the rear of the blockwork wall					
	Material description:	Insulating board					
	Quantity / Extent:	110 m²					
	Accessibility	Medium Access					
	Analysis:	Amosite Chrysotile					
	Material identification:	Asbestos insulating board					
Material Assessment Scoring:							
Product Type:	2	Condition:	0	Surface Treatment:	2	Asbestos Type:	2
Priority Assessment Scoring:							
Occupant Activity:	1	Disturbance:	2	Human Exposure:	3	Maintenance Activity:	1
Total Scores:							
Material Score:	6	Priority Score	7	Total Score:	6	Risk Rating:	Low
Recommended action:	Remove if likely to be disturbed by the refurbishment, otherwise monitor condition.

Recommendation comments:	-						
Comments:	Item is representative of throughout.

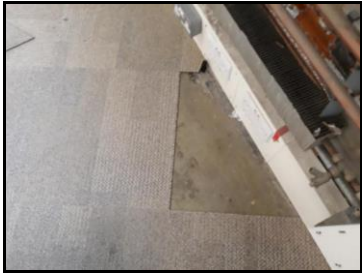
Item description:	Adhesive to floor beneath modern screed					
	Material description:	Bituminous products					
	Quantity / Extent:	800 m²					
	Accessibility	Easy Access					
	Analysis:	Chrysotile					
	Material identification:	Asbestos bitumen					
Material Assessment Scoring:							
Product Type:	1	Condition:	0	Surface Treatment:	0	Asbestos Type:	1
Priority Assessment Scoring:							
Occupant Activity:	1	Disturbance:	2	Human Exposure:	3	Maintenance Activity:	1
Total Scores:							
Material Score:	2	Priority Score	7	Total Score:	2	Risk Rating:	Very Low
Recommended action:	Remove if likely to be disturbed by the refurbishment, otherwise monitor condition.						
Recommendation comments:	-

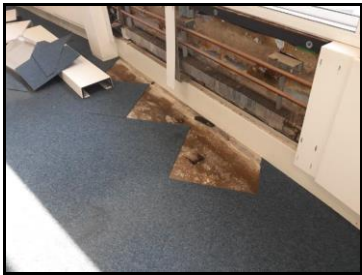
Item description:	Adhesive to floor beneath modern screed					
	Material description:	Bituminous products					
	Quantity / Extent:	800 m²					
	Accessibility	Medium Access					
	Analysis:	Chrysotile					
	Material identification:	Asbestos bitumen					
Material Assessment Scoring:							
Product Type:	1	Condition:	0	Surface Treatment:	0	Asbestos Type:	1
Priority Assessment Scoring:							
Occupant Activity:	1	Disturbance:	2	Human Exposure:	3	Maintenance Activity:	1
Total Scores:							
Material Score:	2	Priority Score	7	Total Score:	2	Risk Rating:	Very Low
Recommended action:	Remove if likely to be disturbed by the refurbishment, otherwise monitor condition.						
Recommendation comments:	-

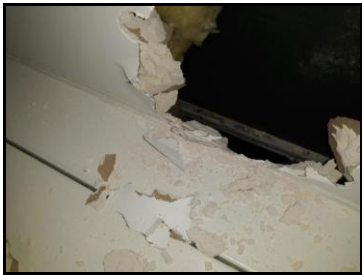
Item description:	Mastic to internal windows behind plasterboard					
	Material description:	Mastics					
	Quantity / Extent:	30 m linear					
	Accessibility	Medium Access					
	Analysis:	Chrysotile					
	Material identification:	Asbestos mastic					
Material Assessment Scoring:							
Product Type:	1	Condition:	1	Surface Treatment:	0	Asbestos Type:	1
Priority Assessment Scoring:							
Occupant Activity:	1	Disturbance:	1	Human Exposure:	3	Maintenance Activity:	1
Total Scores:							
Material Score:	3	Priority Score	6	Total Score:	3	Risk Rating:	Very Low
Recommended action:	Remove if likely to be disturbed by the refurbishment, otherwise monitor condition.						
Recommendation comments:	-

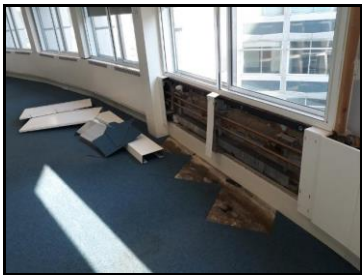
Item description:	Panel beneath the window to the rear of the blockwork wall					
	Material description:	Insulating board					
	Quantity / Extent:	110 m²					
	Accessibility	Medium Access					
	Analysis:	Amosite Chrysotile					
	Material identification:	Asbestos insulating board					
Material Assessment Scoring:							
Product Type:	2	Condition:	0	Surface Treatment:	2	Asbestos Type:	2
Priority Assessment Scoring:							
Occupant Activity:	1	Disturbance:	2	Human Exposure:	3	Maintenance Activity:	1
Total Scores:							
Material Score:	6	Priority Score	7	Total Score:	6	Risk Rating:	Low
Recommended action:	Remove if likely to be disturbed by the refurbishment, otherwise monitor condition.

Recommendation comments:	-						
Comments:	Material is representative of throughout.

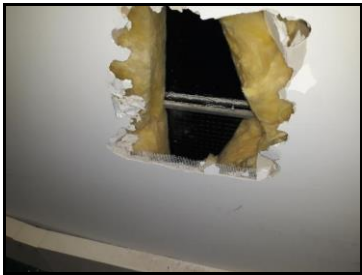
Item description:	Mastic to internal windows behind plasterboard					
	Material description:	Mastics					
	Quantity / Extent:	30 m linear					
	Accessibility	Medium Access					
	Analysis:	Chrysotile					
	Material identification:	Asbestos mastic					
Material Assessment Scoring:							
Product Type:	1	Condition:	1	Surface Treatment:	0	Asbestos Type:	1
Priority Assessment Scoring:							
Occupant Activity:	1	Disturbance:	1	Human Exposure:	3	Maintenance Activity:	1
Total Scores:							
Material Score:	3	Priority Score	6	Total Score:	3	Risk Rating:	Very Low
Recommended action:	Remove if likely to be disturbed by the refurbishment, otherwise monitor condition.						
Recommendation comments:	-

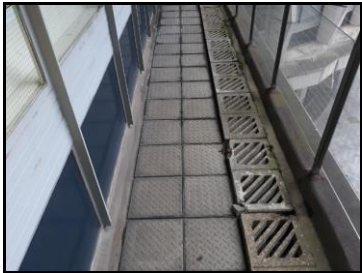
Item description:	Promenade tiles					
	Material description:	Cement product					
	Quantity / Extent:	20 m²					
	Accessibility	Easy Access					
	Analysis:	No asbestos detected					
	Material identification:	Non-asbestos material					
Material Assessment Scoring:							
Product Type:	-	Condition:	-	Surface Treatment:	-	Asbestos Type:	-
Priority Assessment Scoring:							
Occupant Activity:	-	Disturbance:	-	Human Exposure:	-	Maintenance Activity:	-
Total Scores:							
Material Score:	-	Priority Score	-	Total Score:	0	Risk Rating:	N/A
Recommended action:	-						
Recommendation comments:	-						
Comments:	-

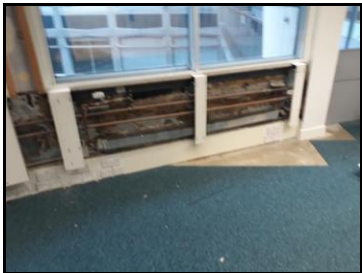
Item description:	Panel beneath the window to the rear of the blockwork wall					
	Material description:	Insulating board					
	Quantity / Extent:	110 m²					
	Accessibility	Medium Access					
	Analysis:	Amosite Chrysotile					
	Material identification:	Asbestos insulating board					
Material Assessment Scoring:							
Product Type:	2	Condition:	0	Surface Treatment:	2	Asbestos Type:	2
Priority Assessment Scoring:							
Occupant Activity:	1	Disturbance:	2	Human Exposure:	3	Maintenance Activity:	1
Total Scores:							
Material Score:	6	Priority Score	7	Total Score:	6	Risk Rating:	Low
Recommended action:	Remove if likely to be disturbed by the refurbishment, otherwise monitor condition.

Recommendation comments:	-						
Comments:	Material is representative of throughout.

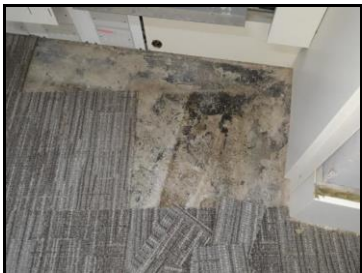
Item description:	Adhesive to floor beneath modern screed					
	Material description:	Bituminous products					
	Quantity / Extent:	800 m²					
	Accessibility	Medium Access					
	Analysis:	Chrysotile					
	Material identification:	Asbestos bitumen					
Material Assessment Scoring:							
Product Type:	1	Condition:	0	Surface Treatment:	0	Asbestos Type:	1
Priority Assessment Scoring:							
Occupant Activity:	1	Disturbance:	2	Human Exposure:	3	Maintenance Activity:	1
Total Scores:							
Material Score:	2	Priority Score	7	Total Score:	2	Risk Rating:	Very Low
Recommended action:	Remove if likely to be disturbed by the refurbishment, otherwise monitor condition.						
Recommendation comments:	-

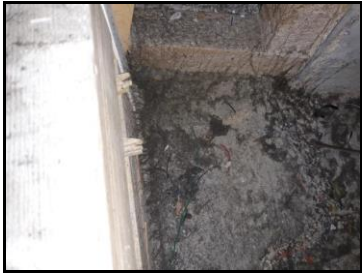
Item description:	Floor tiles debris within cupboard					
	Material description:	Thermoplastic product					
	Quantity / Extent:	1 m ²					
	Accessibility	Easy Access					
	Analysis:	Chrysotile					
	Material identification:	Asbestos thermoplastic/adhesive					
Material Assessment Scoring:							
Product Type:	1	Condition:	3	Surface Treatment:	0	Asbestos Type:	1
Priority Assessment Scoring:							
Occupant Activity:	1	Disturbance:	1	Human Exposure:	3	Maintenance Activity:	1
Total Scores:							
Material Score:	5	Priority Score	6	Total Score:	5	Risk Rating:	Low
Recommended action:	Remove.						
Recommendation comments:	-						
Comments:	Floor tile debris is also present to the opposite cupboard.

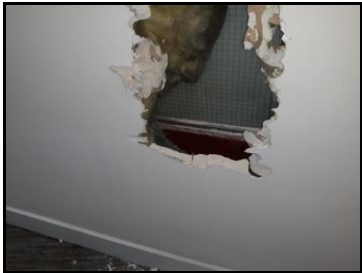
Item description:	Mastic to internal windows behind plasterboard					
	Material description:	Mastics					
	Quantity / Extent:	30 m linear					
	Accessibility	Medium Access					
	Analysis:	No asbestos detected					
	Material identification:	Non-asbestos material					
Material Assessment Scoring:							
Product Type:	-	Condition:	-	Surface Treatment:	-	Asbestos Type:	-
Priority Assessment Scoring:							
Occupant Activity:	-	Disturbance:	-	Human Exposure:	-	Maintenance Activity:	-
Total Scores:							
Material Score:	-	Priority Score	-	Total Score:	0	Risk Rating:	N/A
Recommended action:	-						
Recommendation comments:	-						
Comments:	-

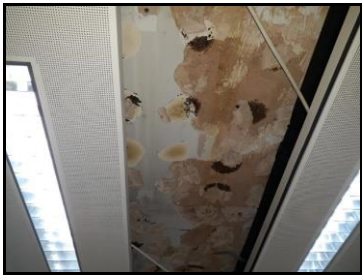
Item description:	Adhesive above suspended ceiling					
	Material description:	Adhesive					
	Quantity / Extent:	800 m²					
	Accessibility	Medium Access					
	Analysis:	No asbestos detected					
	Material identification:	Non-asbestos material					
Material Assessment Scoring:							
Product Type:	-	Condition:	-	Surface Treatment:	-	Asbestos Type:	-
Priority Assessment Scoring:							
Occupant Activity:	-	Disturbance:	-	Human Exposure:	-	Maintenance Activity:	-
Total Scores:							
Material Score:	-	Priority Score	-	Total Score:	0	Risk Rating:	N/A
Recommended action:	-						
Recommendation comments:	-						
Comments:	Material is representative of throughout.

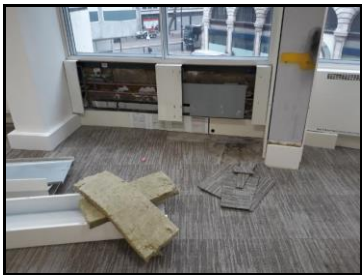
Item description:	Panel beneath the window to the rear of the blockwork wall					
	Material description:	Insulating board					
	Quantity / Extent:	110 m²					
	Accessibility	Medium Access					
	Analysis:	Amosite Chrysotile					
	Material identification:	Asbestos insulating board					
Material Assessment Scoring:							
Product Type:	2	Condition:	0	Surface Treatment:	2	Asbestos Type:	2
Priority Assessment Scoring:							
Occupant Activity:	1	Disturbance:	2	Human Exposure:	3	Maintenance Activity:	1
Total Scores:							
Material Score:	6	Priority Score	7	Total Score:	6	Risk Rating:	Low
Recommended action:	Remove if likely to be disturbed by the refurbishment, otherwise monitor condition.

Recommendation comments:	-						
Comments:	Material is representative of throughout.

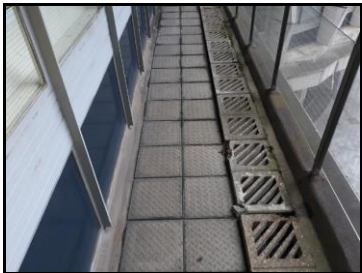
Item description:	Promenade tiles	
	Material description:	Cement product	
	Quantity / Extent:	20 m²	
	Accessibility	Easy Access	
	Analysis:	No asbestos detected	
	Material identification:	Non-asbestos material	
Material Assessment Scoring:			
Product Type:	-	Condition:	-
Surface Treatment:	-	Asbestos Type:	-
Priority Assessment Scoring:			
Occupant Activity:	-	Disturbance:	-
Human Exposure:	-	Maintenance Activity:	-
Total Scores:			
Material Score:	-	Priority Score	-
Total Score:	0	Risk Rating:	N/A
Recommended action:	-		
Recommendation comments:	-		
Comments:	-

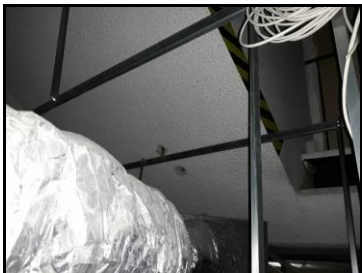
Item description:	Textured coating to ceiling within ceiling void	
	Material description:	Textured coatings	
	Quantity / Extent:	20 m²	
	Accessibility	Medium Access	
	Analysis:	No asbestos detected	
	Material identification:	Non-asbestos material	
Material Assessment Scoring:			
Product Type:	-	Condition:	-
Surface Treatment:	-	Asbestos Type:	-
Priority Assessment Scoring:			
Occupant Activity:	-	Disturbance:	-
Human Exposure:	-	Maintenance Activity:	-
Total Scores:			
Material Score:	-	Priority Score	-
Total Score:	0	Risk Rating:	N/A
Recommended action:	-		
Recommendation comments:	-		
Comments:	-

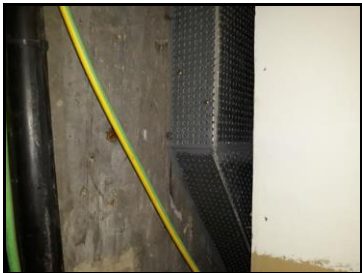
Item description:	Board to ducting	
	Material description:	Insulating board	
	Quantity / Extent:	4 m ²	
	Accessibility	Medium Access	
	Analysis:	No asbestos detected	
	Material identification:	Non-asbestos material	
Material Assessment Scoring:			
Product Type:	-	Condition:	-
Surface Treatment:	-	Asbestos Type:	-
Priority Assessment Scoring:			
Occupant Activity:	-	Disturbance:	-
Human Exposure:	-	Maintenance Activity:	-
Total Scores:			
Material Score:	-	Priority Score	-
Total Score:	0	Risk Rating:	N/A
Recommended action:	-		
Recommendation comments:	-		
Comments:	-

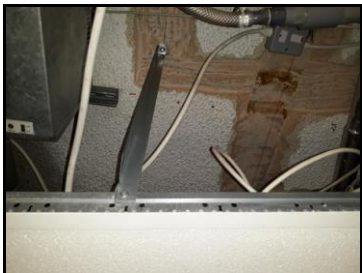
Item description:	Textured coating to ceiling	
	Material description:	Textured coatings	
	Quantity / Extent:	2 m ²	
	Accessibility	Medium Access	
	Analysis:	No asbestos detected	
	Material identification:	Non-asbestos material	
Material Assessment Scoring:			
Product Type:	-	Condition:	-
Surface Treatment:	-	Asbestos Type:	-
Priority Assessment Scoring:			
Occupant Activity:	-	Disturbance:	-
Human Exposure:	-	Maintenance Activity:	-
Total Scores:			
Material Score:	-	Priority Score	-
Total Score:	0	Risk Rating:	N/A
Recommended action:	-		
Recommendation comments:	-		
Comments:	-

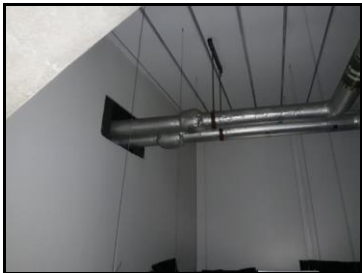
Item description:	Pipework collars					
	Material description:	Gasket					
	Quantity / Extent:	4 Number					
	Accessibility	Difficult Access					
	Analysis:	Presumed to contain asbestos					
	Material identification:	Asbestos gasket					
Material Assessment Scoring:							
Product Type:	2	Condition:	0	Surface Treatment:	1	Asbestos Type:	3
Priority Assessment Scoring:							
Occupant Activity:	0	Disturbance:	1	Human Exposure:	1	Maintenance Activity:	1
Total Scores:							
Material Score:	6	Priority Score	3	Total Score:	6	Risk Rating:	Low
Recommended action:	Remove if likely to be disturbed by the refurbishment, otherwise monitor condition.						
Recommendation comments:	-						
Comments:	Unable to sample due to height restrictions.

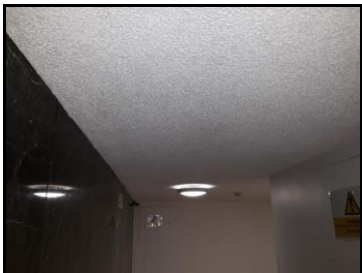
Item description:	Textured coating to ceiling					
	Material description:	Textured coatings					
	Quantity / Extent:	12 m²					
	Accessibility	Medium Access					
	Analysis:	No asbestos detected					
	Material identification:	Non-asbestos material					
Material Assessment Scoring:							
Product Type:	-	Condition:	-	Surface Treatment:	-	Asbestos Type:	-
Priority Assessment Scoring:							
Occupant Activity:	-	Disturbance:	-	Human Exposure:	-	Maintenance Activity:	-
Total Scores:							
Material Score:	-	Priority Score	-	Total Score:	0	Risk Rating:	N/A
Recommended action:	-						
Recommendation comments:	-						
Comments:	-

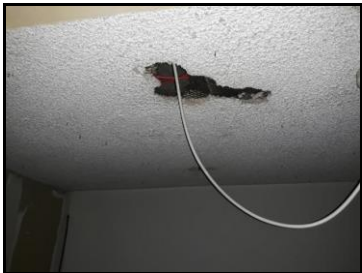
Item description:	Textured coating to ceiling	
	Material description:	Textured coatings	
	Quantity / Extent:	20 m²	
	Accessibility	Easy Access	
	Analysis:	No asbestos detected	
	Material identification:	Non-asbestos material	
Material Assessment Scoring:			
Product Type:	-	Condition:	-
Surface Treatment:	-	Asbestos Type:	-
Priority Assessment Scoring:			
Occupant Activity:	-	Disturbance:	-
Human Exposure:	-	Maintenance Activity:	-
Total Scores:			
Material Score:	-	Priority Score	-
Total Score:	0	Risk Rating:	N/A
Recommended action:	-		
Recommendation comments:	-		
Comments:	-

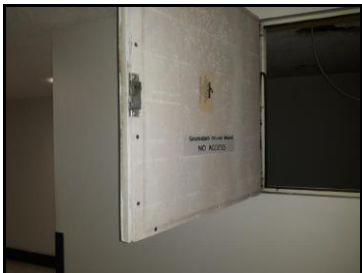
Item description:	Board to the rear of the access hatches	
	Material description:	Insulating board	
	Quantity / Extent:	2 m²	
	Accessibility	Easy Access	
	Analysis:	No asbestos detected	
	Material identification:	Non-asbestos material	
Material Assessment Scoring:			
Product Type:	-	Condition:	-
Surface Treatment:	-	Asbestos Type:	-
Priority Assessment Scoring:			
Occupant Activity:	-	Disturbance:	-
Human Exposure:	-	Maintenance Activity:	-
Total Scores:			
Material Score:	-	Priority Score	-
Total Score:	0	Risk Rating:	N/A
Recommended action:	-		
Recommendation comments:	-		
Comments:	-

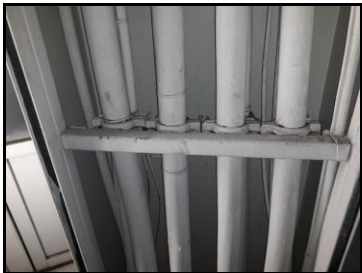
Item description:	Packing within brackets to electrical cables					
	Material description:	Woven product					
	Quantity / Extent:	24 Number					
	Accessibility	Easy Access					
	Analysis:	No asbestos detected					
	Material identification:	Non-asbestos material					
Material Assessment Scoring:							
Product Type:	-	Condition:	-	Surface Treatment:	-	Asbestos Type:	-
Priority Assessment Scoring:							
Occupant Activity:	-	Disturbance:	-	Human Exposure:	-	Maintenance Activity:	-
Total Scores:							
Material Score:	-	Priority Score	-	Total Score:	0	Risk Rating:	N/A
Recommended action:	-						
Recommendation comments:	-						
Comments:	-

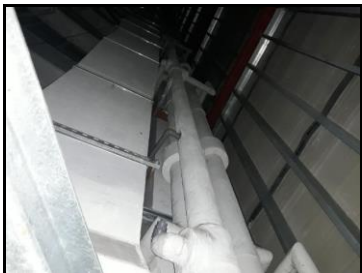
Item description:	Pipework collars					
	Material description:	Gasket					
	Quantity / Extent:	12 Number					
	Accessibility	Difficult Access					
	Analysis:	Presumed to contain asbestos					
	Material identification:	Asbestos gasket					
Material Assessment Scoring:							
Product Type:	2	Condition:	0	Surface Treatment:	1	Asbestos Type:	3
Priority Assessment Scoring:							
Occupant Activity:	0	Disturbance:	1	Human Exposure:	1	Maintenance Activity:	1
Total Scores:							
Material Score:	6	Priority Score	3	Total Score:	6	Risk Rating:	Low
Recommended action:	Remove if likely to be disturbed by the refurbishment, otherwise monitor condition.						
Recommendation comments:	-						
Comments:	No access to sample due to height restrictions and location of collars.

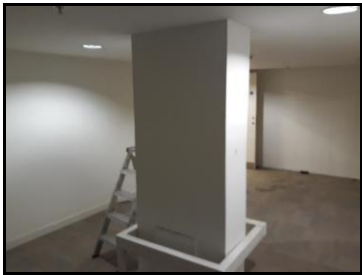
Item description:	Cladding to beam	
	Material description:	Insulating board	
	Quantity / Extent:	2 m²	
	Accessibility	Easy Access	
	Analysis:	No asbestos detected	
	Material identification:	Non-asbestos material	
Material Assessment Scoring:			
Product Type:	-	Condition:	-
Surface Treatment:	-	Asbestos Type:	-
Priority Assessment Scoring:			
Occupant Activity:	-	Disturbance:	-
Human Exposure:	-	Maintenance Activity:	-
Total Scores:			
Material Score:	-	Priority Score	-
Total Score:	0	Risk Rating:	N/A
Recommended action:	-		
Recommendation comments:	-		
Comments:	-

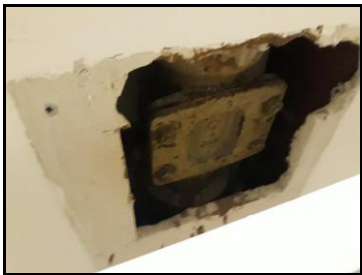
Item description:	Gasket to pipework	
	Material description:	Gasket	
	Quantity / Extent:	2 Number	
	Accessibility	Medium Access	
	Analysis:	No asbestos detected	
	Material identification:	Non-asbestos material	
Material Assessment Scoring:			
Product Type:	-	Condition:	-
Surface Treatment:	-	Asbestos Type:	-
Priority Assessment Scoring:			
Occupant Activity:	-	Disturbance:	-
Human Exposure:	-	Maintenance Activity:	-
Total Scores:			
Material Score:	-	Priority Score	-
Total Score:	0	Risk Rating:	N/A
Recommended action:	-		
Recommendation comments:	-		
Comments:	-

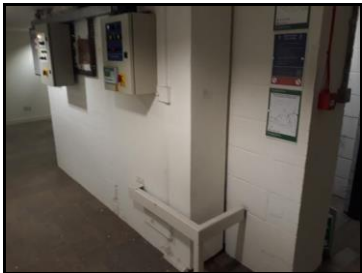
Item description:	Cladding to beam					
	Material description:	Insulating board					
	Quantity / Extent:	2 m²					
	Accessibility	Easy Access					
	Analysis:	No asbestos detected					
	Material identification:	Non-asbestos material					
Material Assessment Scoring:							
Product Type:	-	Condition:	-	Surface Treatment:	-	Asbestos Type:	-
Priority Assessment Scoring:							
Occupant Activity:	-	Disturbance:	-	Human Exposure:	-	Maintenance Activity:	-
Total Scores:							
Material Score:	-	Priority Score	-	Total Score:	0	Risk Rating:	N/A
Recommended action:	-						
Recommendation comments:	-						
Comments:	-

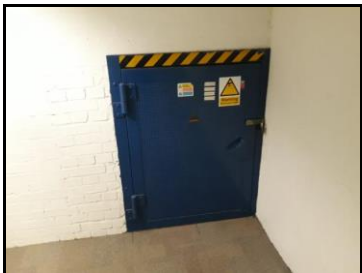
Item description:	Durasteel doors					
	Material description:	Insulating board					
	Quantity / Extent:	2 Number					
	Accessibility	Medium Access					
	Analysis:	Crocidolite Amosite Chrysotile					
	Material identification:	Asbestos insulating board					
Material Assessment Scoring:							
Product Type:	2	Condition:	0	Surface Treatment:	1	Asbestos Type:	3
Priority Assessment Scoring:							
Occupant Activity:	1	Disturbance:	2	Human Exposure:	2	Maintenance Activity:	1
Total Scores:							
Material Score:	6	Priority Score	6	Total Score:	6	Risk Rating:	Low
Recommended action:	Remove if likely to be disturbed by the refurbishment, otherwise monitor condition.						
Recommendation comments:	-

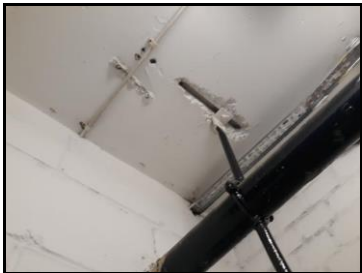
Item description:	Sprayed coating debris to the ceiling	
	Material description:	Sprayed coating	
	Quantity / Extent:	1 m ²	
	Accessibility	Easy Access	
	Analysis:	No asbestos detected	
	Material identification:	Non-asbestos material	
Material Assessment Scoring:			
Product Type:	-	Condition:	-
Surface Treatment:	-	Asbestos Type:	-
Priority Assessment Scoring:			
Occupant Activity:	-	Disturbance:	-
Human Exposure:	-	Maintenance Activity:	-
Total Scores:			
Material Score:	-	Priority Score	-
Total Score:	0	Risk Rating:	N/A
Recommended action:	-		
Recommendation comments:	-		
Comments:	-

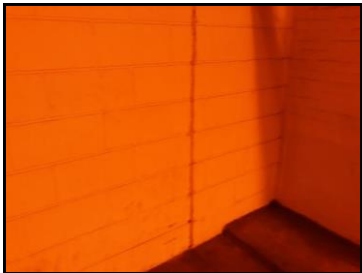
Item description:	Mastic to expansion joint in wall					
	Material description:	Mastics					
	Quantity / Extent:	2 m linear					
	Accessibility	Easy Access					
	Analysis:	No asbestos detected					
	Material identification:	Non-asbestos material					
Material Assessment Scoring:							
Product Type:	-	Condition:	-	Surface Treatment:	-	Asbestos Type:	-
Priority Assessment Scoring:							
Occupant Activity:	-	Disturbance:	-	Human Exposure:	-	Maintenance Activity:	-
Total Scores:							
Material Score:	-	Priority Score	-	Total Score:	0	Risk Rating:	N/A
Recommended action:	-						
Recommendation comments:	-						
Comments:	-

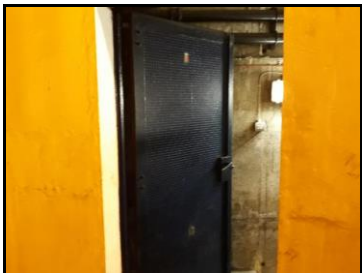
Item description:	Durasteel door					
	Material description:	Insulating board					
	Quantity / Extent:	2 m ²					
	Accessibility	Easy Access					
	Analysis:	Crocidolite Amosite Chrysotile					
	Material identification:	Asbestos insulating board					
Material Assessment Scoring:							
Product Type:	2	Condition:	0	Surface Treatment:	1	Asbestos Type:	3
Priority Assessment Scoring:							
Occupant Activity:	0	Disturbance:	2	Human Exposure:	1	Maintenance Activity:	1
Total Scores:							
Material Score:	6	Priority Score	4	Total Score:	6	Risk Rating:	Low
Recommended action:	Remove if likely to be disturbed by the refurbishment, otherwise monitor condition.						
Recommendation comments:	-

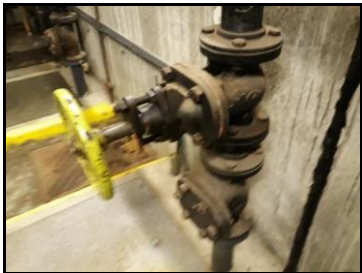
Item description:	Gasket to pipework					
	Material description:	Gasket					
	Quantity / Extent:	8 Number					
	Accessibility	Easy Access					
	Analysis:	Chrysotile					
	Material identification:	Asbestos gasket					
Material Assessment Scoring:							
Product Type:	2	Condition:	0	Surface Treatment:	1	Asbestos Type:	1
Priority Assessment Scoring:							
Occupant Activity:	0	Disturbance:	1	Human Exposure:	1	Maintenance Activity:	1
Total Scores:							
Material Score:	4	Priority Score	3	Total Score:	4	Risk Rating:	Very Low
Recommended action:	Remove if likely to be disturbed by the refurbishment, otherwise monitor condition.						
Recommendation comments:	-						
Comments:	-

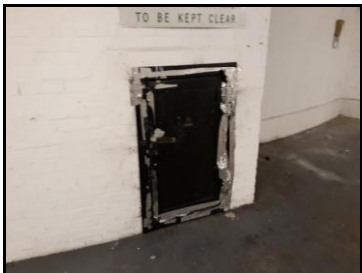
Item description:	Durasteel door					
	Material description:	Insulating board					
	Quantity / Extent:	1 m²					
	Accessibility	Easy Access					
	Analysis:	Crocidolite Amosite Chrysotile					
	Material identification:	Asbestos insulating board					
Material Assessment Scoring:							
Product Type:	2	Condition:	0	Surface Treatment:	1	Asbestos Type:	3
Priority Assessment Scoring:							
Occupant Activity:	0	Disturbance:	2	Human Exposure:	1	Maintenance Activity:	1
Total Scores:							
Material Score:	6	Priority Score	4	Total Score:	6	Risk Rating:	Low
Recommended action:	Remove if likely to be disturbed by the refurbishment, otherwise monitor condition.						
Recommendation comments:	-

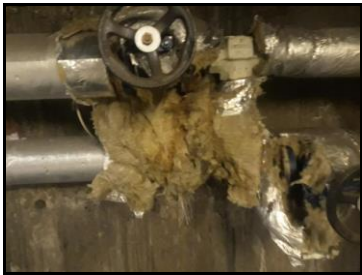
Item description:	Gaskets to pipework					
	Material description:	Gasket					
	Quantity / Extent:	6 Number					
	Accessibility	Easy Access					
	Analysis:	Chrysotile					
	Material identification:	Asbestos gasket					
Material Assessment Scoring:							
Product Type:	2	Condition:	0	Surface Treatment:	1	Asbestos Type:	1
Priority Assessment Scoring:							
Occupant Activity:	0	Disturbance:	1	Human Exposure:	1	Maintenance Activity:	1
Total Scores:							
Material Score:	4	Priority Score	3	Total Score:	4	Risk Rating:	Very Low
Recommended action:	Remove if likely to be disturbed by the refurbishment, otherwise monitor condition.						
Recommendation comments:	-						
Comments:	-
