Asbestos Refurbishment Survey 5th Floor to Ground Floor (Kingsway)

**Space House
1 Kemble Street
London
WC2B 4AN**

Survey Date: 14 -17 January 2020, 20-24 January 2020 and 29 January 2020

Project Reference: P-359298

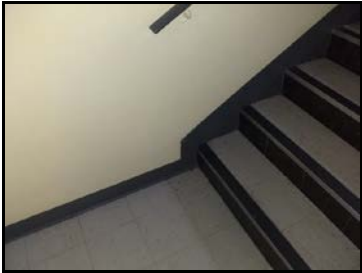
Item description:	Skirting board					
	Material description:	Vinyl product					
	Quantity / Extent:	200 m linear					
	Accessibility	Easy Access					
	Analysis:	No asbestos detected					
	Material identification:	Non-asbestos material					
Material Assessment Scoring:							
Product Type:	-	Condition:	-	Surface Treatment:	-	Asbestos Type:	-
Priority Assessment Scoring:							
Occupant Activity:	-	Disturbance:	-	Human Exposure:	-	Maintenance Activity:	-
Total Scores:							
Material Score:	-	Priority Score	-	Total Score:	0	Risk Rating:	N/A
Recommended action:	-						
Recommendation comments:	-						
Comments:	Material observed to continue from top to bottom of both staircases.

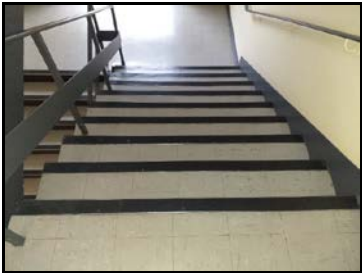
Item description:	Stair nosings					
	Material description:	Thermoplastic product					
	Quantity / Extent:	18 Number					
	Accessibility	Easy Access					
	Analysis:	Chrysotile					
	Material identification:	Asbestos thermoplastic material					
Material Assessment Scoring:							
Product Type:	1	Condition:	1	Surface Treatment:	0	Asbestos Type:	1
Priority Assessment Scoring:							
Occupant Activity:	0	Disturbance:	2	Human Exposure:	0	Maintenance Activity:	0
Total Scores:							
Material Score:	3	Priority Score	2	Total Score:	3	Risk Rating:	Very Low
Recommended action:	Remove if likely to be disturbed by the refurbishment, otherwise monitor condition.						
Recommendation comments:	-

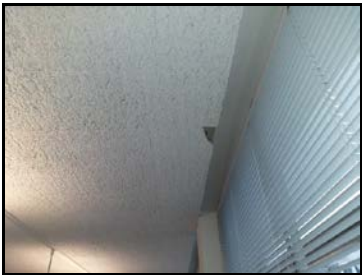
Item description:	Ceiling above MMMF tiles					
	Material description:	Insulating board					
	Quantity / Extent:	80 m ²					
	Accessibility	Difficult Access					
	Analysis:	Chrysotile					
	Material identification:	Asbestos insulating board					
Material Assessment Scoring:							
Product Type:	2	Condition:	1	Surface Treatment:	1	Asbestos Type:	1
Priority Assessment Scoring:							
Occupant Activity:	0	Disturbance:	2	Human Exposure:	0	Maintenance Activity:	0
Total Scores:							
Material Score:	5	Priority Score	2	Total Score:	5	Risk Rating:	Low
Recommended action:	Remove if likely to be disturbed by the refurbishment, otherwise monitor condition.						
Recommendation comments:	It is strongly presumed after discussions on site that asbestos packing material will also be present above.

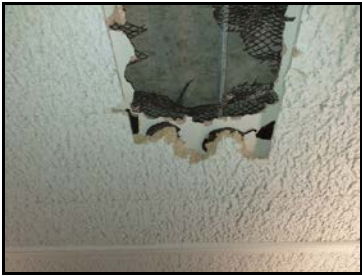
Item description:	MMMF ceiling tile adhesive					
	Material description:	Bituminous products					
	Quantity / Extent:	800 m ²					
	Accessibility	Difficult Access					
	Analysis:	No asbestos detected					
	Material identification:	Non-asbestos material					
Material Assessment Scoring:							
Product Type:	-	Condition:	-	Surface Treatment:	-	Asbestos Type:	-
Priority Assessment Scoring:							
Occupant Activity:	-	Disturbance:	-	Human Exposure:	-	Maintenance Activity:	-
Total Scores:							
Material Score:	-	Priority Score	-	Total Score:	0	Risk Rating:	N/A
Recommended action:	-						
Recommendation comments:	-						
Comments:	Material present throughout MMMF ceiling tiled areas.

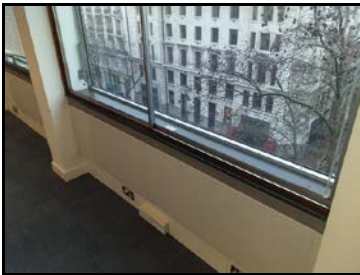
Item description:	Window sills					
	Material description:	Cement product					
	Quantity / Extent:	82 m linear					
	Accessibility:	Easy Access					
	Analysis:	Chrysotile					
	Material identification:	Asbestos cement					
Material Assessment Scoring:							
Product Type:	1	Condition:	1	Surface Treatment:	1	Asbestos Type:	1
Priority Assessment Scoring:							
Occupant Activity:	0	Disturbance:	2	Human Exposure:	0	Maintenance Activity:	0
Total Scores:							
Material Score:	4	Priority Score	2	Total Score:	4	Risk Rating:	Very Low
Recommended action:	Remove if likely to be disturbed by the refurbishment, otherwise monitor condition.						
Recommendation comments:	It is strongly presumed after discussions on site that asbestos packing material and/or AIB panels beneath the window may also be present.

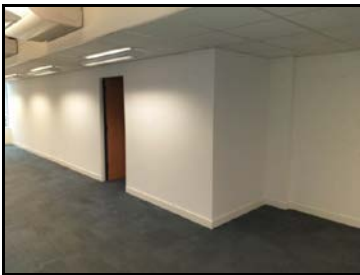
Item description:	Wall lining beneath plasterboard lining (risers)					
	Material description:	Insulating board					
	Quantity / Extent:	10 m ²					
	Accessibility:	Difficult Access					
	Analysis:	No asbestos detected					
	Material identification:	Non-asbestos material					
Material Assessment Scoring:							
Product Type:	-	Condition:	-	Surface Treatment:	-	Asbestos Type:	-
Priority Assessment Scoring:							
Occupant Activity:	-	Disturbance:	-	Human Exposure:	-	Maintenance Activity:	-
Total Scores:							
Material Score:	-	Priority Score	-	Total Score:	0	Risk Rating:	N/A
Recommended action:	-						
Recommendation comments:	-						
Comments:	-

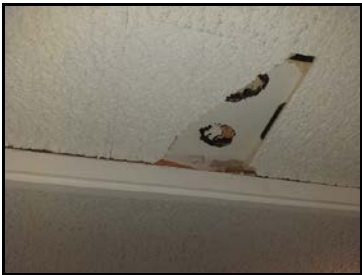
Item description:	Packing above ceiling timber beams					
	Material description:	Insulating board					
	Quantity / Extent:	650 m linear					
	Accessibility	Difficult Access					
	Analysis:	Chrysotile					
	Material identification:	Asbestos insulating board					
Material Assessment Scoring:							
Product Type:	2	Condition:	1	Surface Treatment:	1	Asbestos Type:	1
Priority Assessment Scoring:							
Occupant Activity:	0	Disturbance:	2	Human Exposure:	0	Maintenance Activity:	0
Total Scores:							
Material Score:	5	Priority Score	2	Total Score:	5	Risk Rating:	Low
Recommended action:	Remove if likely to be disturbed by the refurbishment, otherwise encapsulate and then monitor condition

Recommendation comments:	-						
Comments:	Material located above original MMMF ceiling tiles sporadically throughout area. It should be presumed to be present throughout above all timber beams.

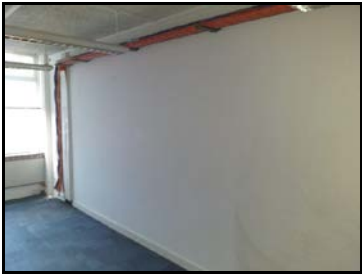
Item description:	Wall lining beneath plasterboard lining (kitchen)					
	Material description:	Insulating board					
	Quantity / Extent:	18 m ²					
	Accessibility	Difficult Access					
	Analysis:	Chrysotile					
	Material identification:	Asbestos insulating board					
Material Assessment Scoring:							
Product Type:	2	Condition:	1	Surface Treatment:	1	Asbestos Type:	1
Priority Assessment Scoring:							
Occupant Activity:	0	Disturbance:	1	Human Exposure:	0	Maintenance Activity:	0
Total Scores:							
Material Score:	5	Priority Score	1	Total Score:	5	Risk Rating:	Low
Recommended action:	Remove if likely to be disturbed by the refurbishment, otherwise monitor condition.

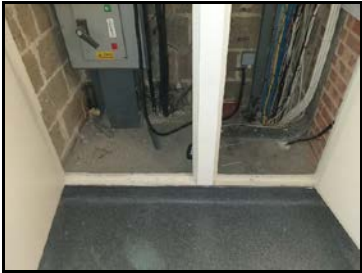
Item description:	Panel beneath floor screed within risers (x3)					
	Material description:	Insulating board					
	Quantity / Extent:	3 Number					
	Accessibility	Difficult Access					
	Analysis:	Chrysotile					
	Material identification:	Asbestos insulating board					
Material Assessment Scoring:							
Product Type:	2	Condition:	1	Surface Treatment:	1	Asbestos Type:	1
Priority Assessment Scoring:							
Occupant Activity:	0	Disturbance:	1	Human Exposure:	0	Maintenance Activity:	0
Total Scores:							
Material Score:	5	Priority Score	1	Total Score:	5	Risk Rating:	Low
Recommended action:	Remove if likely to be disturbed by the refurbishment, otherwise monitor condition.						
Recommendation comments:	-

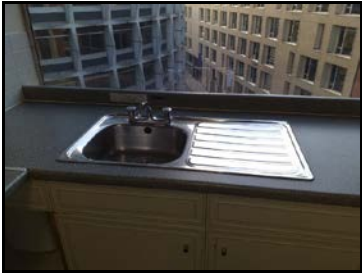
Item description:	Sink pad					
	Material description:	Bituminous products					
	Quantity / Extent:	1 Number					
	Accessibility	Easy Access					
	Analysis:	No asbestos detected					
	Material identification:	Non-asbestos material					
Material Assessment Scoring:							
Product Type:	-	Condition:	-	Surface Treatment:	-	Asbestos Type:	-
Priority Assessment Scoring:							
Occupant Activity:	-	Disturbance:	-	Human Exposure:	-	Maintenance Activity:	-
Total Scores:							
Material Score:	-	Priority Score	-	Total Score:	0	Risk Rating:	N/A
Recommended action:	-						
Recommendation comments:	-						
Comments:	-

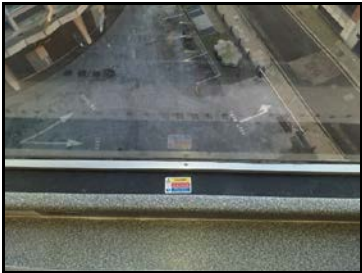
Item description:	Window sill					
	Material description:	Cement product					
	Quantity / Extent:	2 m linear					
	Accessibility	Easy Access					
	Analysis:	Chrysotile					
	Material identification:	Asbestos cement					
Material Assessment Scoring:							
Product Type:	1	Condition:	1	Surface Treatment:	1	Asbestos Type:	1
Priority Assessment Scoring:							
Occupant Activity:	0	Disturbance:	2	Human Exposure:	0	Maintenance Activity:	0
Total Scores:							
Material Score:	4	Priority Score	2	Total Score:	4	Risk Rating:	Very Low
Recommended action:	Remove if likely to be disturbed by the refurbishment, otherwise monitor condition.						
Recommendation comments:	It is strongly presumed after discussions on site that asbestos packing material and/or AIB panels beneath the window may also be present.

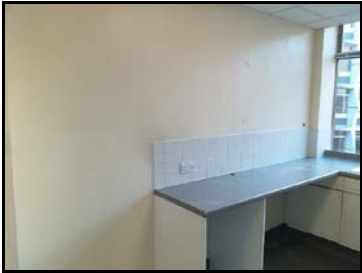
Item description:	Wall lining					
	Material description:	Insulating board					
	Quantity / Extent:	20 m ²					
	Accessibility	Easy Access					
	Analysis:	Chrysotile					
	Material identification:	Asbestos insulating board					
Material Assessment Scoring:							
Product Type:	2	Condition:	1	Surface Treatment:	1	Asbestos Type:	1
Priority Assessment Scoring:							
Occupant Activity:	0	Disturbance:	2	Human Exposure:	0	Maintenance Activity:	0
Total Scores:							
Material Score:	5	Priority Score	2	Total Score:	5	Risk Rating:	Low
Recommended action:	Remove if likely to be disturbed by the refurbishment, otherwise monitor condition.						
Recommendation comments:	-						
Comments:	Material also forms cupboard walls.

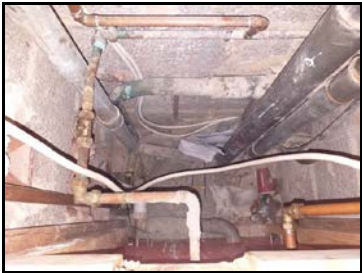
Item description:	Debris within hand dryer voids					
	Material description:	Cement product					
	Quantity / Extent:	<1 m ²					
	Accessibility	Medium Access					
	Analysis:	Chrysotile Amosite					
	Material identification:	Asbestos cement					
Material Assessment Scoring:							
Product Type:	1	Condition:	3	Surface Treatment:	1	Asbestos Type:	2
Priority Assessment Scoring:							
Occupant Activity:	0	Disturbance:	1	Human Exposure:	0	Maintenance Activity:	0
Total Scores:							
Material Score:	7	Priority Score	1	Total Score:	7	Risk Rating:	Medium
Recommended action:	Remove.						
Recommendation comments:	-						
Comments:	-

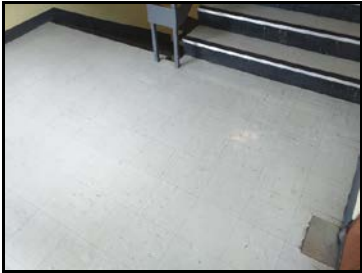
Item description:	Floor tiles (grey & black) & bitumen adhesive					
	Material description:	Thermoplastic product					
	Quantity / Extent:	12 m ²					
	Accessibility	Easy Access					
	Analysis:	Chrysotile					
	Material identification:	Asbestos thermoplastic/adhesive					
Material Assessment Scoring:							
Product Type:	1	Condition:	1	Surface Treatment:	0	Asbestos Type:	1
Priority Assessment Scoring:							
Occupant Activity:	0	Disturbance:	2	Human Exposure:	0	Maintenance Activity:	0
Total Scores:							
Material Score:	3	Priority Score	2	Total Score:	3	Risk Rating:	Very Low
Recommended action:	Remove if likely to be disturbed by the refurbishment, otherwise monitor condition.

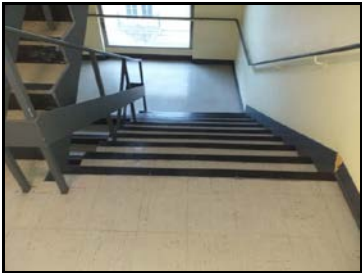
Item description:	Stair nosings					
	Material description:	Thermoplastic product					
	Quantity / Extent:	18 Number					
	Accessibility	Easy Access					
	Analysis:	Chrysotile					
	Material identification:	Asbestos thermoplastic material					
Material Assessment Scoring:							
Product Type:	1	Condition:	1	Surface Treatment:	0	Asbestos Type:	1
Priority Assessment Scoring:							
Occupant Activity:	0	Disturbance:	2	Human Exposure:	0	Maintenance Activity:	0
Total Scores:							
Material Score:	3	Priority Score	2	Total Score:	3	Risk Rating:	Very Low
Recommended action:	Remove if likely to be disturbed by the refurbishment, otherwise monitor condition.						
Recommendation comments:	-

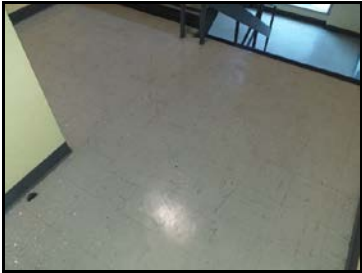
Item description:	Floor tiles (grey & black) & bitumen adhesive					
	Material description:	Thermoplastic product					
	Quantity / Extent:	12 m ²					
	Accessibility	Easy Access					
	Analysis:	Chrysotile					
	Material identification:	Asbestos thermoplastic/adhesive					
Material Assessment Scoring:							
Product Type:	1	Condition:	1	Surface Treatment:	0	Asbestos Type:	1
Priority Assessment Scoring:							
Occupant Activity:	0	Disturbance:	2	Human Exposure:	0	Maintenance Activity:	0
Total Scores:							
Material Score:	3	Priority Score	2	Total Score:	3	Risk Rating:	Very Low
Recommended action:	Remove if likely to be disturbed by the refurbishment, otherwise monitor condition.

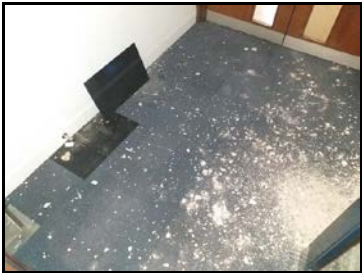
Item description:	Adhesive residue beneath carpet tiles					
	Material description:	Bituminous products					
	Quantity / Extent:	890 m ²					
	Accessibility	Medium Access					
	Analysis:	Chrysotile					
	Material identification:	Asbestos bitumen					
Material Assessment Scoring:							
Product Type:	1	Condition:	1	Surface Treatment:	0	Asbestos Type:	1
Priority Assessment Scoring:							
Occupant Activity:	0	Disturbance:	2	Human Exposure:	0	Maintenance Activity:	0
Total Scores:							
Material Score:	3	Priority Score	2	Total Score:	3	Risk Rating:	Very Low
Recommended action:	Remove if likely to be disturbed by the refurbishment, otherwise monitor condition.						
Recommendation comments:	-

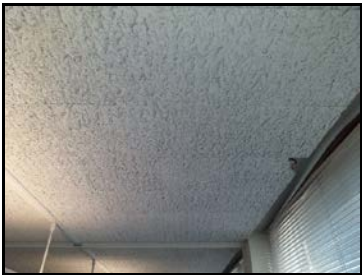
Item description:	Ceiling above MMMF tiles					
	Material description:	Insulating board					
	Quantity / Extent:	80 m ²					
	Accessibility	Difficult Access					
	Analysis:	Chrysotile					
	Material identification:	Asbestos insulating board					
Material Assessment Scoring:							
Product Type:	2	Condition:	1	Surface Treatment:	1	Asbestos Type:	1
Priority Assessment Scoring:							
Occupant Activity:	0	Disturbance:	2	Human Exposure:	0	Maintenance Activity:	0
Total Scores:							
Material Score:	5	Priority Score	2	Total Score:	5	Risk Rating:	Low
Recommended action:	Remove if likely to be disturbed by the refurbishment, otherwise monitor condition.						
Recommendation comments:	It is strongly presumed after discussions on site that asbestos packing material will also be present above.

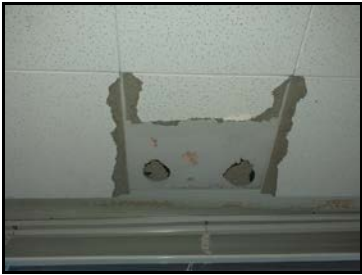
Item description:	MMMF ceiling tile adhesive					
	Material description:	Bituminous products					
	Quantity / Extent:	800 m ²					
	Accessibility	Difficult Access					
	Analysis:	No asbestos detected					
	Material identification:	Non-asbestos material					
Material Assessment Scoring:							
Product Type:	-	Condition:	-	Surface Treatment:	-	Asbestos Type:	-
Priority Assessment Scoring:							
Occupant Activity:	-	Disturbance:	-	Human Exposure:	-	Maintenance Activity:	-
Total Scores:							
Material Score:	-	Priority Score	-	Total Score:	0	Risk Rating:	N/A
Recommended action:	-						
Recommendation comments:	-						
Comments:	Material present throughout MMMF ceiling tiled areas.

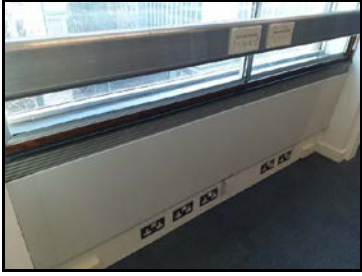
Item description:	Window sills					
	Material description:	Cement product					
	Quantity / Extent:	82 m linear					
	Accessibility	Easy Access					
	Analysis:	Chrysotile					
	Material identification:	Asbestos cement					
Material Assessment Scoring:							
Product Type:	1	Condition:	1	Surface Treatment:	1	Asbestos Type:	1
Priority Assessment Scoring:							
Occupant Activity:	0	Disturbance:	2	Human Exposure:	0	Maintenance Activity:	0
Total Scores:							
Material Score:	4	Priority Score	2	Total Score:	4	Risk Rating:	Very Low
Recommended action:	Remove if likely to be disturbed by the refurbishment, otherwise monitor condition.						
Recommendation comments:	It is strongly presumed after discussions on site that asbestos packing material and/or AIB panels beneath the window may also be present.

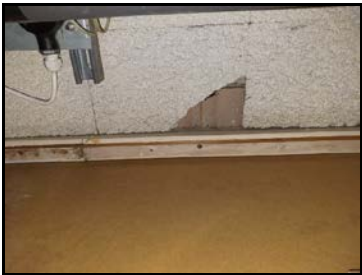
Item description:	Packing above ceiling timber beams					
	Material description:	Insulating board					
	Quantity / Extent:	650 m linear					
	Accessibility	Difficult Access					
	Analysis:	Chrysotile					
	Material identification:	Asbestos insulating board					
Material Assessment Scoring:							
Product Type:	2	Condition:	1	Surface Treatment:	1	Asbestos Type:	1
Priority Assessment Scoring:							
Occupant Activity:	0	Disturbance:	2	Human Exposure:	0	Maintenance Activity:	0
Total Scores:							
Material Score:	5	Priority Score	2	Total Score:	5	Risk Rating:	Low
Recommended action:	Remove if likely to be disturbed by the refurbishment, otherwise encapsulate and then monitor condition

Recommendation comments:	-						
Comments:	Material located above original MMMF ceiling tiles sporadically throughout area. It should be presumed to be present throughout above all timber beams.

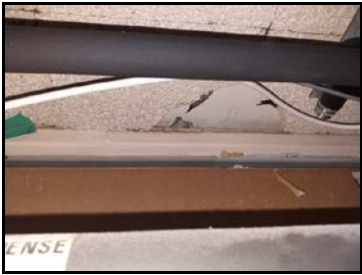
Item description:	Packing above ceiling timber beams					
	Material description:	Insulation					
	Quantity / Extent:	650 m linear					
	Accessibility	Difficult Access					
	Analysis:	Amosite					
	Material identification:	Asbestos insulation					
Material Assessment Scoring:							
Product Type:	3	Condition:	2	Surface Treatment:	3	Asbestos Type:	2
Priority Assessment Scoring:							
Occupant Activity:	0	Disturbance:	2	Human Exposure:	0	Maintenance Activity:	0
Total Scores:							
Material Score:	10	Priority Score	2	Total Score:	10	Risk Rating:	High
Recommended action:	Remove if likely to be disturbed by the refurbishment, otherwise encapsulate and then monitor condition

Recommendation comments:	-						
Comments:	Material located above original MMMF ceiling tiles sporadically throughout area. It should be presumed to be present throughout above all timber beams.

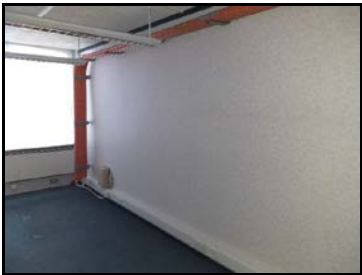
Item description:	Wall lining beneath plasterboard lining (kitchen)					
	Material description:	Insulating board					
	Quantity / Extent:	18 m ²					
	Accessibility	Medium Access					
	Analysis:	Chrysotile					
	Material identification:	Asbestos insulating board					
Material Assessment Scoring:							
Product Type:	2	Condition:	1	Surface Treatment:	1	Asbestos Type:	1
Priority Assessment Scoring:							
Occupant Activity:	0	Disturbance:	1	Human Exposure:	0	Maintenance Activity:	0
Total Scores:							
Material Score:	5	Priority Score	1	Total Score:	5	Risk Rating:	Low
Recommended action:	Remove if likely to be disturbed by the refurbishment, otherwise monitor condition.

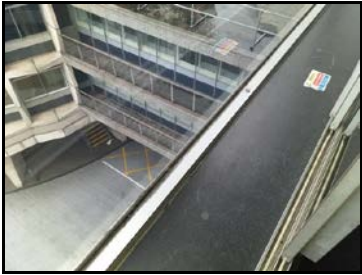
Item description:	Window glazing beading					
	Material description:	Mastics					
	Quantity / Extent:	440 m linear					
	Accessibility	Easy Access					
	Analysis:	No asbestos detected					
	Material identification:	Non-asbestos material					
Material Assessment Scoring:							
Product Type:	-	Condition:	-	Surface Treatment:	-	Asbestos Type:	-
Priority Assessment Scoring:							
Occupant Activity:	-	Disturbance:	-	Human Exposure:	-	Maintenance Activity:	-
Total Scores:							
Material Score:	-	Priority Score	-	Total Score:	0	Risk Rating:	N/A
Recommended action:	-						
Recommendation comments:	-						
Comments:	Material located throughout floor within all windows (beneath newer mastic in places).

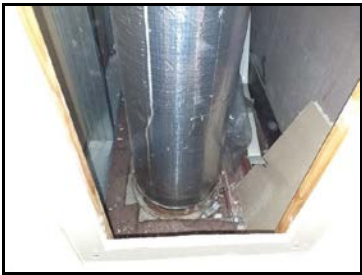
Item description:	Floor tiles (grey) & bitumen adhesive within plasterboard boxing outside risers at Kemble Street Staircase end of building					
	Material description:	Thermoplastic product					
	Quantity / Extent:	1 m ²					
	Accessibility	Medium Access					
	Analysis:	Chrysotile					
	Material identification:	Asbestos thermoplastic/adhesive					
Material Assessment Scoring:							
Product Type:	1	Condition:	1	Surface Treatment:	0	Asbestos Type:	1
Priority Assessment Scoring:							
Occupant Activity:	0	Disturbance:	1	Human Exposure:	0	Maintenance Activity:	0
Total Scores:							
Material Score:	3	Priority Score	1	Total Score:	3	Risk Rating:	Very Low

Recommended action:	Remove if likely to be disturbed by the refurbishment, otherwise monitor condition.						
Recommendation comments:	-						
Comments:	Also includes small pieces present beneath perimeter electrical trunking & skirting boards.

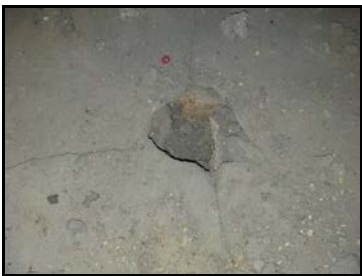
Item description:	Panel beneath floor screed within risers (x3)					
	Material description:	Insulating board					
	Quantity / Extent:	3 Number					
	Accessibility	Difficult Access					
	Analysis:	Chrysotile					
	Material identification:	Asbestos insulating board					
Material Assessment Scoring:							
Product Type:	2	Condition:	1	Surface Treatment:	1	Asbestos Type:	1
Priority Assessment Scoring:							
Occupant Activity:	0	Disturbance:	1	Human Exposure:	0	Maintenance Activity:	0
Total Scores:							
Material Score:	5	Priority Score	1	Total Score:	5	Risk Rating:	Low
Recommended action:	Remove if likely to be disturbed by the refurbishment, otherwise monitor condition.						
Recommendation comments:	-

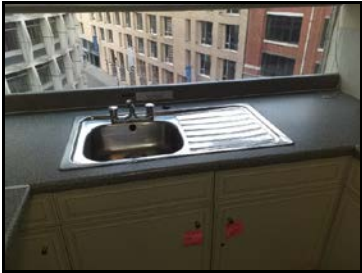
Item description:	Sink pad					
	Material description:	Bituminous products					
	Quantity / Extent:	1 Number					
	Accessibility	Easy Access					
	Analysis:	No asbestos detected					
	Material identification:	Non-asbestos material					
Material Assessment Scoring:							
Product Type:	-	Condition:	-	Surface Treatment:	-	Asbestos Type:	-
Priority Assessment Scoring:							
Occupant Activity:	-	Disturbance:	-	Human Exposure:	-	Maintenance Activity:	-
Total Scores:							
Material Score:	-	Priority Score	-	Total Score:	0	Risk Rating:	N/A
Recommended action:	-						
Recommendation comments:	-						
Comments:	-

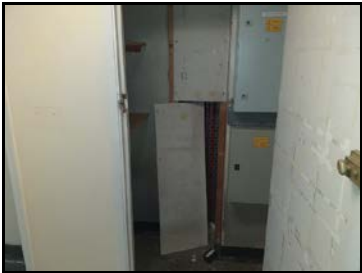
Item description:	Riser panels within cupboard					
	Material description:	Insulating board					
	Quantity / Extent:	1 m ²					
	Accessibility	Easy Access					
	Analysis:	No asbestos detected					
	Material identification:	Non-asbestos material					
Material Assessment Scoring:							
Product Type:	-	Condition:	-	Surface Treatment:	-	Asbestos Type:	-
Priority Assessment Scoring:							
Occupant Activity:	-	Disturbance:	-	Human Exposure:	-	Maintenance Activity:	-
Total Scores:							
Material Score:	-	Priority Score	-	Total Score:	0	Risk Rating:	N/A
Recommended action:	-						
Recommendation comments:	-						
Comments:	-

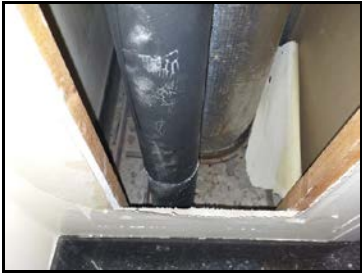
Item description:	Floor tiles (grey) & bitumen adhesive within plasterboard boxing					
	Material description:	Thermoplastic product					
	Quantity / Extent:	1 m ²					
	Accessibility	Easy Access					
	Analysis:	Chrysotile					
	Material identification:	Asbestos thermoplastic/adhesive					
Material Assessment Scoring:							
Product Type:	1	Condition:	1	Surface Treatment:	0	Asbestos Type:	1
Priority Assessment Scoring:							
Occupant Activity:	0	Disturbance:	1	Human Exposure:	0	Maintenance Activity:	0
Total Scores:							
Material Score:	3	Priority Score	1	Total Score:	3	Risk Rating:	Very Low
Recommended action:	Remove if likely to be disturbed by the refurbishment, otherwise monitor condition.

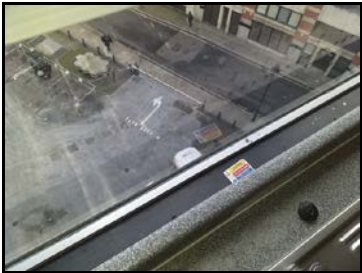
Item description:	Window sill					
	Material description:	Cement product					
	Quantity / Extent:	2 m linear					
	Accessibility	Easy Access					
	Analysis:	Chrysotile					
	Material identification:	Asbestos cement					
Material Assessment Scoring:							
Product Type:	1	Condition:	1	Surface Treatment:	1	Asbestos Type:	1
Priority Assessment Scoring:							
Occupant Activity:	0	Disturbance:	2	Human Exposure:	0	Maintenance Activity:	0
Total Scores:							
Material Score:	4	Priority Score	2	Total Score:	4	Risk Rating:	Very Low
Recommended action:	Remove if likely to be disturbed by the refurbishment, otherwise monitor condition.						
Recommendation comments:	It is strongly presumed after discussions on site that asbestos packing material and/or AIB panels beneath the window may also be present.

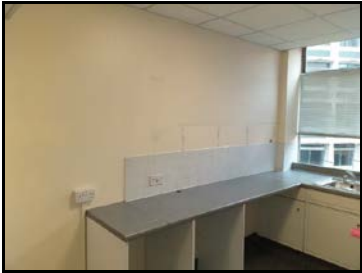
Item description:	Wall lining					
	Material description:	Insulating board					
	Quantity / Extent:	20 m ²					
	Accessibility	Easy Access					
	Analysis:	Chrysotile					
	Material identification:	Asbestos insulating board					
Material Assessment Scoring:							
Product Type:	2	Condition:	1	Surface Treatment:	1	Asbestos Type:	1
Priority Assessment Scoring:							
Occupant Activity:	0	Disturbance:	2	Human Exposure:	0	Maintenance Activity:	0
Total Scores:							
Material Score:	5	Priority Score	2	Total Score:	5	Risk Rating:	Low
Recommended action:	Remove if likely to be disturbed by the refurbishment, otherwise monitor condition.						
Recommendation comments:	-						
Comments:	Material also forms cupboard walls.

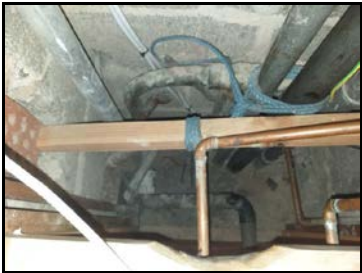
Item description:	Debris within hand dryer voids					
	Material description:	Cement product					
	Quantity / Extent:	<1 m ²					
	Accessibility	Medium Access					
	Analysis:	Amosite Chrysotile					
	Material identification:	Asbestos cement					
Material Assessment Scoring:							
Product Type:	1	Condition:	3	Surface Treatment:	1	Asbestos Type:	2
Priority Assessment Scoring:							
Occupant Activity:	0	Disturbance:	1	Human Exposure:	0	Maintenance Activity:	0
Total Scores:							
Material Score:	7	Priority Score	1	Total Score:	7	Risk Rating:	Medium
Recommended action:	Remove.						
Recommendation comments:	-						
Comments:	-

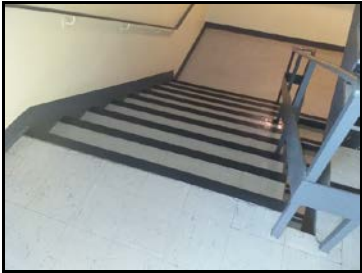
Item description:	Stair nosings					
	Material description:	Thermoplastic product					
	Quantity / Extent:	18 Number					
	Accessibility	Easy Access					
	Analysis:	Chrysotile					
	Material identification:	Asbestos thermoplastic material					
Material Assessment Scoring:							
Product Type:	1	Condition:	1	Surface Treatment:	0	Asbestos Type:	1
Priority Assessment Scoring:							
Occupant Activity:	0	Disturbance:	2	Human Exposure:	0	Maintenance Activity:	0
Total Scores:							
Material Score:	3	Priority Score	2	Total Score:	3	Risk Rating:	Very Low
Recommended action:	Remove if likely to be disturbed by the refurbishment, otherwise monitor condition.						
Recommendation comments:	-

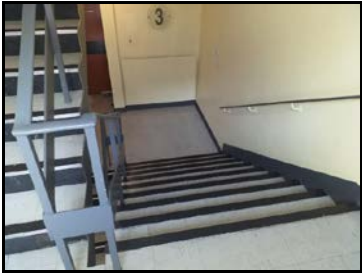
Item description:	Stair nosings					
	Material description:	Thermoplastic product					
	Quantity / Extent:	18 Number					
	Accessibility	Easy Access					
	Analysis:	Chrysotile					
	Material identification:	Asbestos thermoplastic material					
Material Assessment Scoring:							
Product Type:	1	Condition:	1	Surface Treatment:	0	Asbestos Type:	1
Priority Assessment Scoring:							
Occupant Activity:	0	Disturbance:	2	Human Exposure:	0	Maintenance Activity:	0
Total Scores:							
Material Score:	3	Priority Score	2	Total Score:	3	Risk Rating:	Very Low
Recommended action:	Remove if likely to be disturbed by the refurbishment, otherwise monitor condition.						
Recommendation comments:	-

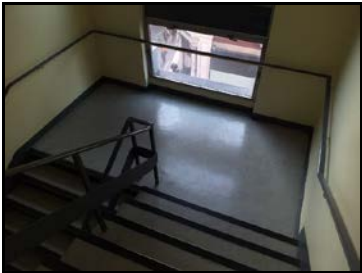
Item description:	Floor tiles (grey & black) & bitumen adhesive					
	Material description:	Thermoplastic product					
	Quantity / Extent:	12 m ²					
	Accessibility	Easy Access					
	Analysis:	Chrysotile					
	Material identification:	Asbestos thermoplastic/adhesive					
Material Assessment Scoring:							
Product Type:	1	Condition:	1	Surface Treatment:	0	Asbestos Type:	1
Priority Assessment Scoring:							
Occupant Activity:	0	Disturbance:	2	Human Exposure:	0	Maintenance Activity:	0
Total Scores:							
Material Score:	3	Priority Score	2	Total Score:	3	Risk Rating:	Very Low
Recommended action:	Remove if likely to be disturbed by the refurbishment, otherwise monitor condition.

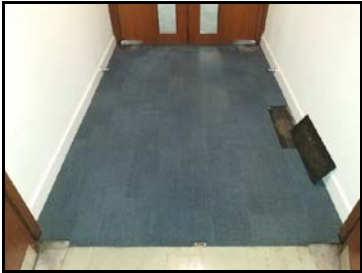
Item description:	Adhesive residue beneath carpet tiles					
	Material description:	Bituminous products					
	Quantity / Extent:	890 m ²					
	Accessibility	Medium Access					
	Analysis:	Chrysotile					
	Material identification:	Asbestos bitumen					
Material Assessment Scoring:							
Product Type:	1	Condition:	1	Surface Treatment:	0	Asbestos Type:	1
Priority Assessment Scoring:							
Occupant Activity:	0	Disturbance:	2	Human Exposure:	0	Maintenance Activity:	0
Total Scores:							
Material Score:	3	Priority Score	2	Total Score:	3	Risk Rating:	Very Low
Recommended action:	Remove if likely to be disturbed by the refurbishment, otherwise monitor condition.						
Recommendation comments:	-

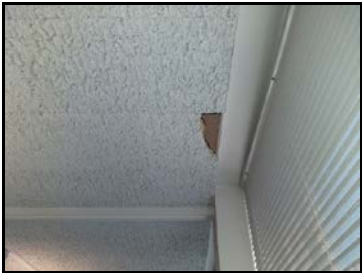
Item description:	Ceiling above MMMF tiles					
	Material description:	Insulating board					
	Quantity / Extent:	80 m ²					
	Accessibility	Difficult Access					
	Analysis:	Chrysotile					
	Material identification:	Asbestos insulating board					
Material Assessment Scoring:							
Product Type:	2	Condition:	1	Surface Treatment:	1	Asbestos Type:	1
Priority Assessment Scoring:							
Occupant Activity:	0	Disturbance:	2	Human Exposure:	0	Maintenance Activity:	0
Total Scores:							
Material Score:	5	Priority Score	2	Total Score:	5	Risk Rating:	Low
Recommended action:	Remove if likely to be disturbed by the refurbishment, otherwise monitor condition.						
Recommendation comments:	It is strongly presumed after discussions on site that asbestos packing material will also be present above.

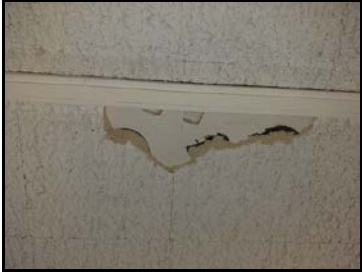
Item description:	MMMF ceiling tile adhesive					
	Material description:	Bituminous products					
	Quantity / Extent:	800 m ²					
	Accessibility	Difficult Access					
	Analysis:	No asbestos detected					
	Material identification:	Non-asbestos material					
Material Assessment Scoring:							
Product Type:	-	Condition:	-	Surface Treatment:	-	Asbestos Type:	-
Priority Assessment Scoring:							
Occupant Activity:	-	Disturbance:	-	Human Exposure:	-	Maintenance Activity:	-
Total Scores:							
Material Score:	-	Priority Score	-	Total Score:	0	Risk Rating:	N/A
Recommended action:	-						
Recommendation comments:	-						
Comments:	Material present throughout MMMF ceiling tiled areas.

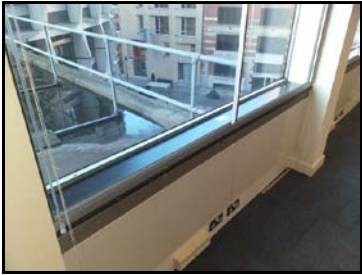
Item description:	Window sills					
	Material description:	Cement product					
	Quantity / Extent:	82 m linear					
	Accessibility	Easy Access					
	Analysis:	Chrysotile					
	Material identification:	Asbestos cement					
Material Assessment Scoring:							
Product Type:	1	Condition:	1	Surface Treatment:	1	Asbestos Type:	1
Priority Assessment Scoring:							
Occupant Activity:	0	Disturbance:	2	Human Exposure:	0	Maintenance Activity:	0
Total Scores:							
Material Score:	4	Priority Score	2	Total Score:	4	Risk Rating:	Very Low
Recommended action:	Remove if likely to be disturbed by the refurbishment, otherwise monitor condition.						
Recommendation comments:	It is strongly presumed after discussions on site that asbestos packing material and/or AIB panels beneath the window may also be present.

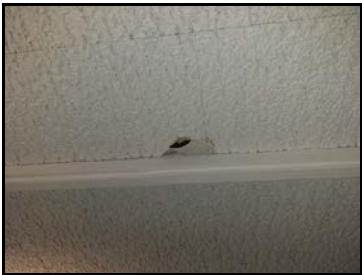
Item description:	Packing above ceiling timber beams					
	Material description:	Thermoplastic product					
	Quantity / Extent:	650 m linear					
	Accessibility	Difficult Access					
	Analysis:	Chrysotile					
	Material identification:	Asbestos thermoplastic/adhesive					
Material Assessment Scoring:							
Product Type:	1	Condition:	1	Surface Treatment:	0	Asbestos Type:	1
Priority Assessment Scoring:							
Occupant Activity:	0	Disturbance:	2	Human Exposure:	0	Maintenance Activity:	0
Total Scores:							
Material Score:	3	Priority Score	2	Total Score:	3	Risk Rating:	Very Low
Recommended action:	Remove if likely to be disturbed by the refurbishment, otherwise encapsulate and then monitor condition

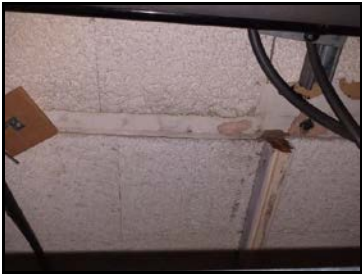
Item description:	Residue on ceiling					
	Material description:	Insulation					
	Quantity / Extent:	650 m linear					
	Accessibility	Medium Access					
	Analysis:	Amosite					
	Material identification:	Asbestos insulation					
Material Assessment Scoring:							
Product Type:	3	Condition:	3	Surface Treatment:	3	Asbestos Type:	2
Priority Assessment Scoring:							
Occupant Activity:	0	Disturbance:	2	Human Exposure:	0	Maintenance Activity:	0
Total Scores:							
Material Score:	11	Priority Score	2	Total Score:	11	Risk Rating:	High
Recommended action:	Remove.						
Recommendation comments:	-						
Comments:	Material located above original MMMF ceiling tiles sporadically throughout area. It should be presumed to be present throughout above all timber beams.

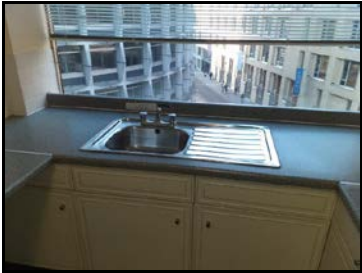
Item description:	Sink pad					
	Material description:	Bituminous products					
	Quantity / Extent:	1 Number					
	Accessibility	Easy Access					
	Analysis:	No asbestos detected					
	Material identification:	Non-asbestos material					
Material Assessment Scoring:							
Product Type:	-	Condition:	-	Surface Treatment:	-	Asbestos Type:	-
Priority Assessment Scoring:							
Occupant Activity:	-	Disturbance:	-	Human Exposure:	-	Maintenance Activity:	-
Total Scores:							
Material Score:	-	Priority Score	-	Total Score:	0	Risk Rating:	N/A
Recommended action:	-						
Recommendation comments:	-						
Comments:	-

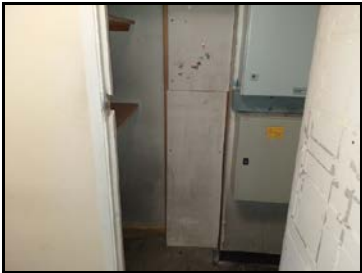
Item description:	Riser panels within cupboard					
	Material description:	Insulating board					
	Quantity / Extent:	1 m ²					
	Accessibility	Easy Access					
	Analysis:	No asbestos detected					
	Material identification:	Non-asbestos material					
Material Assessment Scoring:							
Product Type:	-	Condition:	-	Surface Treatment:	-	Asbestos Type:	-
Priority Assessment Scoring:							
Occupant Activity:	-	Disturbance:	-	Human Exposure:	-	Maintenance Activity:	-
Total Scores:							
Material Score:	-	Priority Score	-	Total Score:	0	Risk Rating:	N/A
Recommended action:	-						
Recommendation comments:	-						
Comments:	-

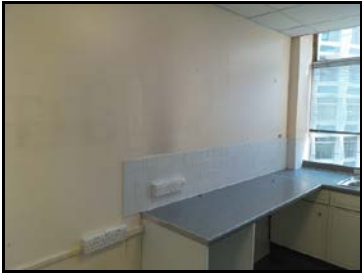
Item description:	Wall lining					
	Material description:	Insulating board					
	Quantity / Extent:	20 m ²					
	Accessibility	Easy Access					
	Analysis:	Chrysotile					
	Material identification:	Asbestos insulating board					
Material Assessment Scoring:							
Product Type:	2	Condition:	1	Surface Treatment:	1	Asbestos Type:	1
Priority Assessment Scoring:							
Occupant Activity:	0	Disturbance:	2	Human Exposure:	0	Maintenance Activity:	0
Total Scores:							
Material Score:	5	Priority Score	2	Total Score:	5	Risk Rating:	Low
Recommended action:	Remove if likely to be disturbed by the refurbishment, otherwise monitor condition.						
Recommendation comments:	-						
Comments:	Material also forms cupboard walls.

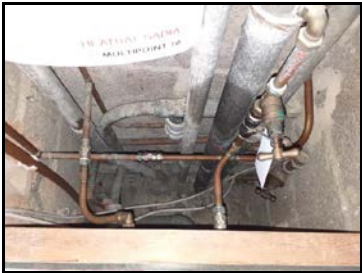
Item description:	Debris within hand dryer voids					
	Material description:	Cement product					
	Quantity / Extent:	<1 m ²					
	Accessibility	Medium Access					
	Analysis:	Amosite Chrysotile					
	Material identification:	Asbestos cement					
Material Assessment Scoring:							
Product Type:	1	Condition:	3	Surface Treatment:	1	Asbestos Type:	2
Priority Assessment Scoring:							
Occupant Activity:	0	Disturbance:	1	Human Exposure:	0	Maintenance Activity:	0
Total Scores:							
Material Score:	7	Priority Score	1	Total Score:	7	Risk Rating:	Medium
Recommended action:	Remove.						
Recommendation comments:	-						
Comments:	-

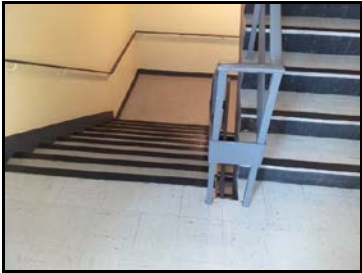
Item description:	Stair nosings					
	Material description:	Thermoplastic product					
	Quantity / Extent:	18 Number					
	Accessibility	Easy Access					
	Analysis:	Chrysotile					
	Material identification:	Asbestos thermoplastic material					
Material Assessment Scoring:							
Product Type:	1	Condition:	1	Surface Treatment:	0	Asbestos Type:	1
Priority Assessment Scoring:							
Occupant Activity:	0	Disturbance:	2	Human Exposure:	0	Maintenance Activity:	0
Total Scores:							
Material Score:	3	Priority Score	2	Total Score:	3	Risk Rating:	Very Low
Recommended action:	Remove if likely to be disturbed by the refurbishment, otherwise monitor condition.						
Recommendation comments:	-

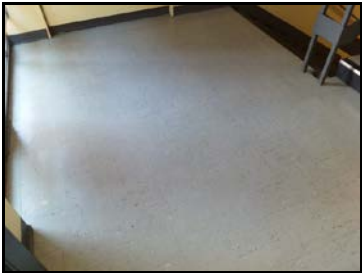
Item description:	Floor tiles (grey & black) & bitumen adhesive					
	Material description:	Thermoplastic product					
	Quantity / Extent:	12 m ²					
	Accessibility	Easy Access					
	Analysis:	Chrysotile					
	Material identification:	Asbestos thermoplastic/adhesive					
Material Assessment Scoring:							
Product Type:	1	Condition:	1	Surface Treatment:	0	Asbestos Type:	1
Priority Assessment Scoring:							
Occupant Activity:	0	Disturbance:	2	Human Exposure:	0	Maintenance Activity:	0
Total Scores:							
Material Score:	3	Priority Score	2	Total Score:	3	Risk Rating:	Very Low
Recommended action:	Remove if likely to be disturbed by the refurbishment, otherwise monitor condition.

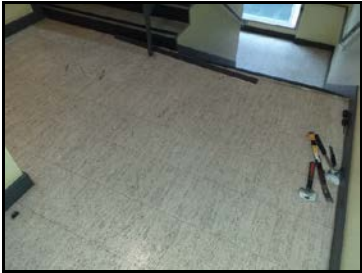
Item description:	Floor tiles (beige) & bitumen adhesive					
	Material description:	Vinyl product					
	Quantity / Extent:	12 m ²					
	Accessibility	Easy Access					
	Analysis:	Chrysotile					
	Material identification:	Non-asbestos vinyl/asbestos adhesive					
Material Assessment Scoring:							
Product Type:	1	Condition:	1	Surface Treatment:	0	Asbestos Type:	1
Priority Assessment Scoring:							
Occupant Activity:	0	Disturbance:	2	Human Exposure:	0	Maintenance Activity:	0
Total Scores:							
Material Score:	3	Priority Score	2	Total Score:	3	Risk Rating:	Very Low
Recommended action:	Remove if likely to be disturbed by the refurbishment, otherwise monitor condition.						
Recommendation comments:	-

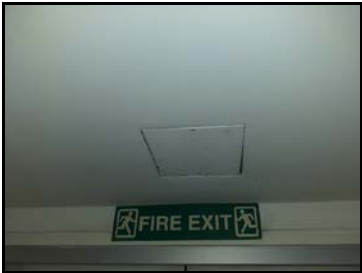
Item description:	Ceiling access panel					
	Material description:	Insulating board					
	Quantity / Extent:	1 Number					
	Accessibility	Medium Access					
	Analysis:	Amosite Chrysotile					
	Material identification:	Asbestos insulating board					
Material Assessment Scoring:							
Product Type:	2	Condition:	1	Surface Treatment:	2	Asbestos Type:	2
Priority Assessment Scoring:							
Occupant Activity:	0	Disturbance:	1	Human Exposure:	0	Maintenance Activity:	0
Total Scores:							
Material Score:	7	Priority Score	1	Total Score:	7	Risk Rating:	Medium
Recommended action:	Remove if likely to be disturbed by the refurbishment, otherwise encapsulate and then monitor condition						
Recommendation comments:	-

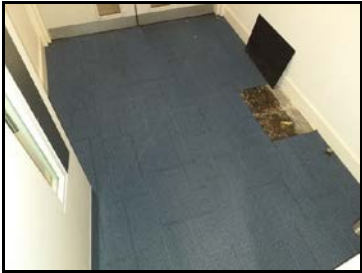
Item description:	Adhesive residue beneath carpet tiles					
	Material description:	Bituminous products					
	Quantity / Extent:	890 m ²					
	Accessibility	Medium Access					
	Analysis:	Chrysotile					
	Material identification:	Asbestos bitumen					
Material Assessment Scoring:							
Product Type:	1	Condition:	1	Surface Treatment:	0	Asbestos Type:	1
Priority Assessment Scoring:							
Occupant Activity:	0	Disturbance:	2	Human Exposure:	0	Maintenance Activity:	0
Total Scores:							
Material Score:	3	Priority Score	2	Total Score:	3	Risk Rating:	Very Low
Recommended action:	Remove if likely to be disturbed by the refurbishment, otherwise monitor condition.						
Recommendation comments:	-

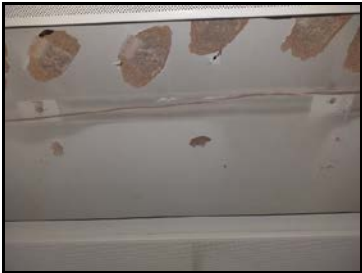
Item description:	Debris behind screw heads above suspended ceiling					
	Material description:	Insulating board					
	Quantity / Extent:	<1 m ²					
	Accessibility	Medium Access					
	Analysis:	Chrysotile					
	Material identification:	Asbestos insulating board					
Material Assessment Scoring:							
Product Type:	2	Condition:	3	Surface Treatment:	1	Asbestos Type:	1
Priority Assessment Scoring:							
Occupant Activity:	0	Disturbance:	1	Human Exposure:	0	Maintenance Activity:	0
Total Scores:							
Material Score:	7	Priority Score	1	Total Score:	7	Risk Rating:	Medium
Recommended action:	Remove.						
Recommendation comments:	-						
Comments:	Material located above metal ceiling tiles sporadically throughout area. It should be presumed to be present throughout as per the window ceiling board & packers consistent with floor levels above.
