Asbestos Refurbishment Survey Lift Shafts to Tower & Kingsway

**Space House
1 Kemble Street
London
WC2B 4AN**

Survey Date: 13 February 2020

Project Reference: P-363772

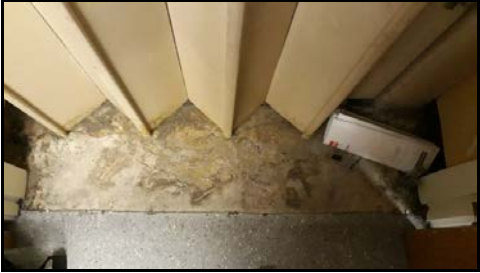
Building:	Space House (Tower & Kingsway)	Floor:	All Floors				
Location:	001 - Goods Lift - Kingsway	Sample No / ID (Type):	P-363772/001 (Sampled)				
Surveyor:	Corey Cook	Survey date:	13/02/2020				
Sample Details

Item description:	Floor screed to ground floor lift entrance					
	Material description:	Floor screed					
	Quantity / Extent:	1 m ²					
	Accessibility	Easy Access					
	Analysis:	No asbestos detected					
	Material identification:	Non-asbestos material					
Material Assessment Scoring:							
Product Type:	-	Condition:	-	Surface Treatment:	-	Asbestos Type:	-
Priority Assessment Scoring:							
Occupant Activity:	-	Disturbance:	-	Human Exposure:	-	Maintenance Activity:	-
Total Scores:							
Material Score:	-	Priority Score	-	Total Score:	0	Risk Rating:	N/A
Recommended action:	-						
Recommendation comments:	-						
Comments:	-

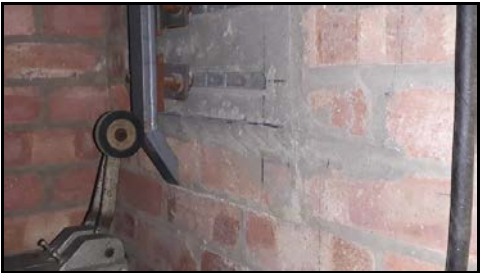
Building:	Space House (Tower & Kingsway)	Floor:	All Floors				
Location:	001 - Goods Lift - Kingsway	Sample No / ID (Type):	P-363772/002 (Sampled)				
Surveyor:	Corey Cook	Survey date:	13/02/2020				
Sample Details

Item description:	Panels below ground floor wall vents					
	Material description:	Cement product					
	Quantity / Extent:	1 m linear					
	Accessibility	Difficult Access					
	Analysis:	No asbestos detected					
	Material identification:	Non-asbestos material					
Material Assessment Scoring:							
Product Type:	-	Condition:	-	Surface Treatment:	-	Asbestos Type:	-
Priority Assessment Scoring:							
Occupant Activity:	-	Disturbance:	-	Human Exposure:	-	Maintenance Activity:	-
Total Scores:							
Material Score:	-	Priority Score	-	Total Score:	0	Risk Rating:	N/A
Recommended action:	-						
Recommendation comments:	-						
Comments:	-

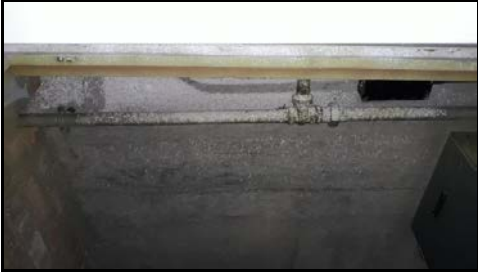
Building:	Space House (Tower & Kingsway)	Floor:	All Floors				
Location:	001 - Goods Lift - Kingsway	Sample No / ID (Type):	P-363772/003 (Sampled)				
Surveyor:	Corey Cook	Survey date:	13/02/2020				
Sample Details

Item description:	Spray to loft shaft ceiling and metal pipework					
	Material description:	Sprayed coating					
	Quantity / Extent:	1 m ²					
	Accessibility	Difficult Access					
	Analysis:	No asbestos detected					
	Material identification:	Non-asbestos material					
Material Assessment Scoring:							
Product Type:	-	Condition:	-	Surface Treatment:	-	Asbestos Type:	-
Priority Assessment Scoring:							
Occupant Activity:	-	Disturbance:	-	Human Exposure:	-	Maintenance Activity:	-
Total Scores:							
Material Score:	-	Priority Score	-	Total Score:	0	Risk Rating:	N/A
Recommended action:	-						
Recommendation comments:	-						
Comments:	-

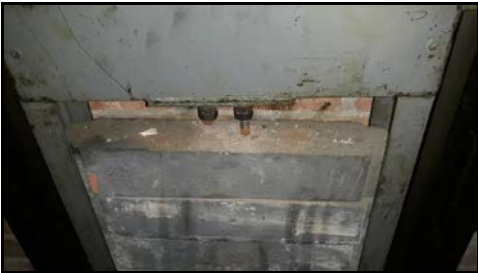
Building:	Space House (Tower & Kingsway)	Floor:	All Floors				
Location:	001 - Goods Lift - Kingsway	Sample No / ID (Type):	P-363772/004 (Sampled)				
Surveyor:	Corey Cook	Survey date:	13/02/2020				
Sample Details

Item description:	Debris to lift weight					
	Material description:	Insulation					
	Quantity / Extent:	0.1 m ²					
	Accessibility	Difficult Access					
	Analysis:	No asbestos detected					
	Material identification:	Non-asbestos material					
Material Assessment Scoring:							
Product Type:	-	Condition:	-	Surface Treatment:	-	Asbestos Type:	-
Priority Assessment Scoring:							
Occupant Activity:	-	Disturbance:	-	Human Exposure:	-	Maintenance Activity:	-
Total Scores:							
Material Score:	-	Priority Score	-	Total Score:	0	Risk Rating:	N/A
Recommended action:	-						
Recommendation comments:	-						
Comments:	-

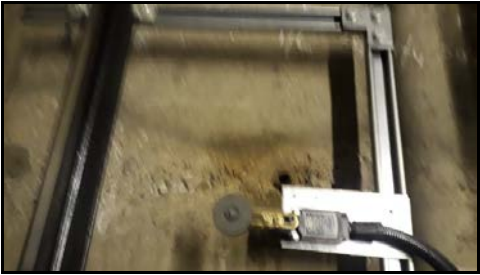
Building:	Space House (Tower & Kingsway)	Floor:	All Floors				
Location:	002 - Lift 1 - Kingsway	Sample No / ID (Type):	P-363772/005 (Sampled)				
Surveyor:	Corey Cook	Survey date:	13/02/2020				
Sample Details

Item description:	Insulation packing within left wall					
	Material description:	Insulation					
	Quantity / Extent:	0.1 m ²					
	Accessibility	Difficult Access					
	Analysis:	No asbestos detected					
	Material identification:	Non-asbestos material					
Material Assessment Scoring:							
Product Type:	-	Condition:	-	Surface Treatment:	-	Asbestos Type:	-
Priority Assessment Scoring:							
Occupant Activity:	-	Disturbance:	-	Human Exposure:	-	Maintenance Activity:	-
Total Scores:							
Material Score:	-	Priority Score	-	Total Score:	0	Risk Rating:	N/A
Recommended action:	-						
Recommendation comments:	-						
Comments:	Sampled from 7th floor. Similar holes present throughout the lift shaft.

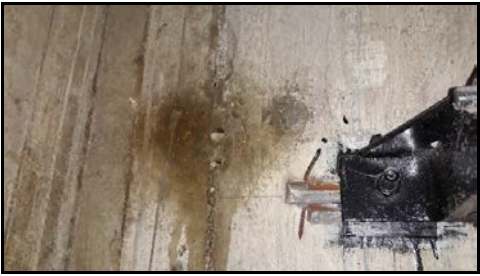
Building:	Space House (Tower & Kingsway)	Floor:	All Floors				
Location:	002 - Lift 1 - Kingsway	Sample No / ID (Type):	P-363772/006 (Sampled)				
Surveyor:	Corey Cook	Survey date:	13/02/2020				
Sample Details

Item description:	Insulation packing within rear wall holes wall					
	Material description:	Insulation					
	Quantity / Extent:	0.1 m ²					
	Accessibility	Difficult Access					
	Analysis:	No asbestos detected					
	Material identification:	Non-asbestos material					
Material Assessment Scoring:							
Product Type:	-	Condition:	-	Surface Treatment:	-	Asbestos Type:	-
Priority Assessment Scoring:							
Occupant Activity:	-	Disturbance:	-	Human Exposure:	-	Maintenance Activity:	-
Total Scores:							
Material Score:	-	Priority Score	-	Total Score:	0	Risk Rating:	N/A
Recommended action:	-						
Recommendation comments:	-						
Comments:	Sampled from 5th floor rear wall circular holes in wall. Similar holes present throughout the lift shaft.

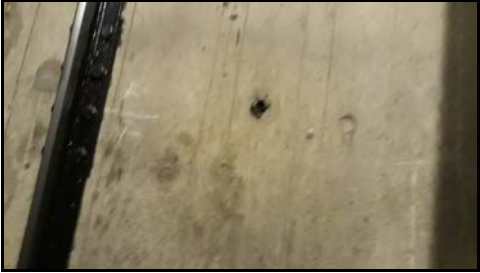
Building:	Space House (Tower & Kingsway)	Floor:	All Floors				
Location:	002 - Lift 1 - Kingsway	Sample No / ID (Type):	P-363772/007 (Sampled)				
Surveyor:	Corey Cook	Survey date:	13/02/2020				
Sample Details

Item description:	Insulation packing within left wall around pipe					
	Material description:	Insulation					
	Quantity / Extent:	0.1 m ²					
	Accessibility	Difficult Access					
	Analysis:	No asbestos detected					
	Material identification:	Non-asbestos material					
Material Assessment Scoring:							
Product Type:	-	Condition:	-	Surface Treatment:	-	Asbestos Type:	-
Priority Assessment Scoring:							
Occupant Activity:	-	Disturbance:	-	Human Exposure:	-	Maintenance Activity:	-
Total Scores:							
Material Score:	-	Priority Score	-	Total Score:	0	Risk Rating:	N/A
Recommended action:	-						
Recommendation comments:	-						
Comments:	Sampled from 1st floor.

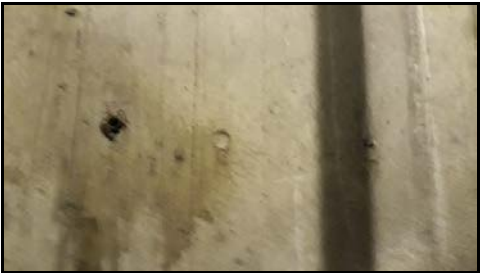
Building:	Space House (Tower & Kingsway)	Floor:	All Floors				
Location:	002 - Lift 1 - Kingsway	Sample No / ID (Type):	P-363772/008 (Sampled)				
Surveyor:	Corey Cook	Survey date:	13/02/2020				
Sample Details

Item description:	Insulation debris to left wall					
	Material description:	Insulation					
	Quantity / Extent:	0.1 m ²					
	Accessibility	Difficult Access					
	Analysis:	No asbestos detected					
	Material identification:	Non-asbestos material					
Material Assessment Scoring:							
Product Type:	-	Condition:	-	Surface Treatment:	-	Asbestos Type:	-
Priority Assessment Scoring:							
Occupant Activity:	-	Disturbance:	-	Human Exposure:	-	Maintenance Activity:	-
Total Scores:							
Material Score:	-	Priority Score	-	Total Score:	0	Risk Rating:	N/A
Recommended action:	-						
Recommendation comments:	-						
Comments:	Sampled from 1st floor

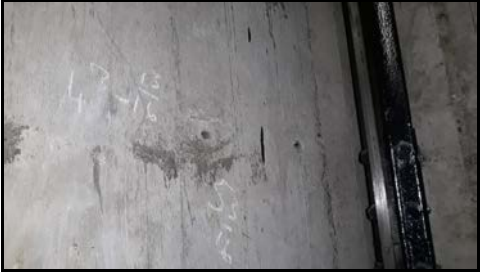
Building:	Space House (Tower & Kingsway)	Floor:	All Floors				
Location:	003 - Lift 2 - Kingsway	Sample No / ID (Type):	P-363772/009 (Sampled)				
Surveyor:	Corey Cook	Survey date:	13/02/2020				
Sample Details

Item description:	Insulation packing within rear wall holes					
	Material description:	Insulation					
	Quantity / Extent:	0.1 m ²					
	Accessibility	Difficult Access					
	Analysis:	No asbestos detected					
	Material identification:	Non-asbestos material					
Material Assessment Scoring:							
Product Type:	-	Condition:	-	Surface Treatment:	-	Asbestos Type:	-
Priority Assessment Scoring:							
Occupant Activity:	-	Disturbance:	-	Human Exposure:	-	Maintenance Activity:	-
Total Scores:							
Material Score:	-	Priority Score	-	Total Score:	0	Risk Rating:	N/A
Recommended action:	-						
Recommendation comments:	-						
Comments:	Sampled from 7th floor. Similar holes present throughout the lift shaft.

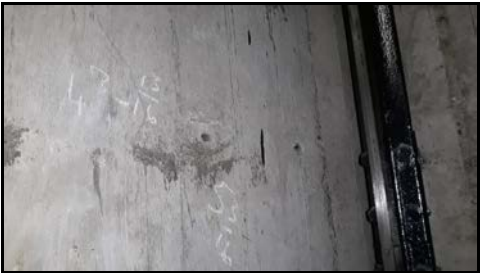
Building:	Space House (Tower & Kingsway)	Floor:	All Floors				
Location:	003 - Lift 2 - Kingsway	Sample No / ID (Type):	P-363772/010 (Sampled)				
Surveyor:	Corey Cook	Survey date:	13/02/2020				
Sample Details

Item description:	Insulation packing within right wall holes					
	Material description:	Insulation					
	Quantity / Extent:	0.1 m ²					
	Accessibility	Difficult Access					
	Analysis:	No asbestos detected					
	Material identification:	Non-asbestos material					
Material Assessment Scoring:							
Product Type:	-	Condition:	-	Surface Treatment:	-	Asbestos Type:	-
Priority Assessment Scoring:							
Occupant Activity:	-	Disturbance:	-	Human Exposure:	-	Maintenance Activity:	-
Total Scores:							
Material Score:	-	Priority Score	-	Total Score:	0	Risk Rating:	N/A
Recommended action:	-						
Recommendation comments:	-						
Comments:	Sampled from 7th floor. Similar holes present throughout the lift shaft.

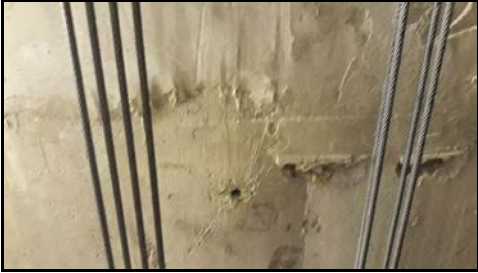
Building:	Space House (Tower & Kingsway)	Floor:	All Floors				
Location:	004 - Lift 1 - Tower	Sample No / ID (Type):	P-363772/013 (Sampled)				
Surveyor:	Corey Cook	Survey date:	13/02/2020				
Sample Details

Item description:	Insulation packing within wall holes					
	Material description:	Insulation					
	Quantity / Extent:	0.1 m ²					
	Accessibility	Difficult Access					
	Analysis:	No asbestos detected					
	Material identification:	Non-asbestos material					
Material Assessment Scoring:							
Product Type:	-	Condition:	-	Surface Treatment:	-	Asbestos Type:	-
Priority Assessment Scoring:							
Occupant Activity:	-	Disturbance:	-	Human Exposure:	-	Maintenance Activity:	-
Total Scores:							
Material Score:	-	Priority Score	-	Total Score:	0	Risk Rating:	N/A
Recommended action:	-						
Recommendation comments:	-						
Comments:	Representative sample of insulation packing. Similar holes present throughout the lift shaft.

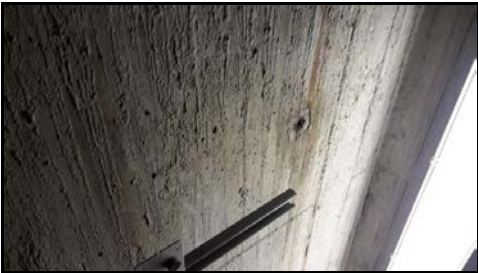
Building:	Space House (Tower & Kingsway)	Floor:	All Floors				
Location:	004 - Lift 1 - Tower	Sample No / ID (Type):	P-363772/014 (Sampled)				
Surveyor:	Corey Cook	Survey date:	13/02/2020				
Sample Details

Item description:	Insulation packing within wall holes					
	Material description:	Insulation					
	Quantity / Extent:	0.1 m ²					
	Accessibility	Difficult Access					
	Analysis:	No asbestos detected					
	Material identification:	Non-asbestos material					
Material Assessment Scoring:							
Product Type:	-	Condition:	-	Surface Treatment:	-	Asbestos Type:	-
Priority Assessment Scoring:							
Occupant Activity:	-	Disturbance:	-	Human Exposure:	-	Maintenance Activity:	-
Total Scores:							
Material Score:	-	Priority Score	-	Total Score:	0	Risk Rating:	N/A
Recommended action:	-						
Recommendation comments:	-						
Comments:	Representative sample of insulation packing. Similar holes present throughout the lift shaft.

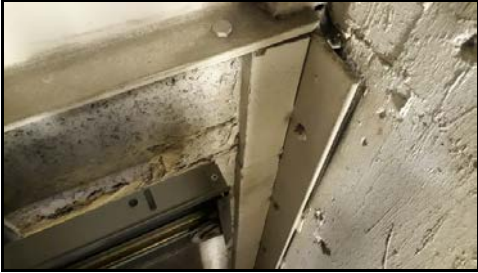
Building:	Space House (Tower & Kingsway)	Floor:	All Floors				
Location:	004 - Lift 1 - Tower	Sample No / ID (Type):	P-363772/015 (Sampled)				
Surveyor:	Corey Cook	Survey date:	13/02/2020				
Sample Details

Item description:	Wall panels running length of shaft					
	Material description:	Insulating board					
	Quantity / Extent:	20 m linear					
	Accessibility	Difficult Access					
	Analysis:	No asbestos detected					
	Material identification:	Non-asbestos material					
Material Assessment Scoring:							
Product Type:	-	Condition:	-	Surface Treatment:	-	Asbestos Type:	-
Priority Assessment Scoring:							
Occupant Activity:	-	Disturbance:	-	Human Exposure:	-	Maintenance Activity:	-
Total Scores:							
Material Score:	-	Priority Score	-	Total Score:	0	Risk Rating:	N/A
Recommended action:	-						
Recommendation comments:	-						
Comments:	-

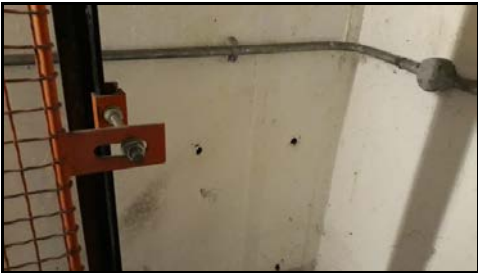
Building:	Space House (Tower & Kingsway)	Floor:	All Floors				
Location:	005 - Lift 2 - Tower	Sample No / ID (Type):	P-363772/011 (Sampled)				
Surveyor:	Corey Cook	Survey date:	13/02/2020				
Sample Details

Item description:	Insulation packing within wall holes					
	Material description:	Insulation					
	Quantity / Extent:	0.1 m ²					
	Accessibility	Difficult Access					
	Analysis:	No asbestos detected					
	Material identification:	Non-asbestos material					
Material Assessment Scoring:							
Product Type:	-	Condition:	-	Surface Treatment:	-	Asbestos Type:	-
Priority Assessment Scoring:							
Occupant Activity:	-	Disturbance:	-	Human Exposure:	-	Maintenance Activity:	-
Total Scores:							
Material Score:	-	Priority Score	-	Total Score:	0	Risk Rating:	N/A
Recommended action:	-						
Recommendation comments:	-						
Comments:	Representative sample of insulation packing. Similar holes present throughout the lift shaft.

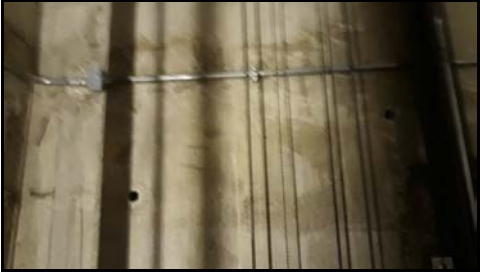
Building:	Space House (Tower & Kingsway)	Floor:	All Floors				
Location:	005 - Lift 2 - Tower	Sample No / ID (Type):	P-363772/012 (Sampled)				
Surveyor:	Corey Cook	Survey date:	13/02/2020				
Sample Details

Item description:	Insulation packing within wall holes					
	Material description:	Insulation					
	Quantity / Extent:	0.1 m ²					
	Accessibility	Difficult Access					
	Analysis:	No asbestos detected					
	Material identification:	Non-asbestos material					
Material Assessment Scoring:							
Product Type:	-	Condition:	-	Surface Treatment:	-	Asbestos Type:	-
Priority Assessment Scoring:							
Occupant Activity:	-	Disturbance:	-	Human Exposure:	-	Maintenance Activity:	-
Total Scores:							
Material Score:	-	Priority Score	-	Total Score:	0	Risk Rating:	N/A
Recommended action:	-						
Recommendation comments:	-						
Comments:	Representative sample of insulation packing. Similar holes present throughout the lift shaft.

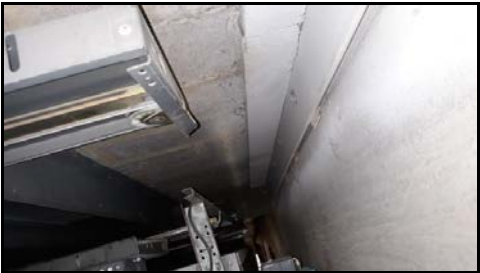
Building:	Space House (Tower & Kingsway)	Floor:	All Floors				
Location:	005 - Lift 2 - Tower	Sample No / ID (Type):	P-363772/As 015 (Cross Referenced)				
Surveyor:	Corey Cook	Survey date:	13/02/2020				
Sample Details

Item description:	Wall panels running length of shaft					
	Material description:	Insulating board					
	Quantity / Extent:	20 m linear					
	Accessibility	Difficult Access					
	Analysis:	No asbestos detected					
	Material identification:	Non-asbestos material					
Material Assessment Scoring:							
Product Type:	-	Condition:	-	Surface Treatment:	-	Asbestos Type:	-
Priority Assessment Scoring:							
Occupant Activity:	-	Disturbance:	-	Human Exposure:	-	Maintenance Activity:	-
Total Scores:							
Material Score:	-	Priority Score	-	Total Score:	0	Risk Rating:	N/A
Recommended action:	-						
Recommendation comments:	-						
Comments:	-

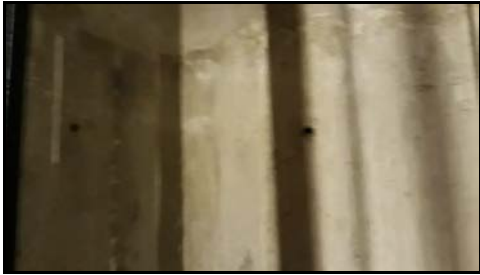
Building:	Space House (Tower & Kingsway)	Floor:	All Floors				
Location:	006 - Lift 3 - Tower	Sample No / ID (Type):	P-363772/016 (Sampled)				
Surveyor:	Corey Cook	Survey date:	13/02/2020				
Sample Details

Item description:	Insulation packing within wall holes					
	Material description:	Insulation					
	Quantity / Extent:	0.1 m ²					
	Accessibility	Difficult Access					
	Analysis:	No asbestos detected					
	Material identification:	Non-asbestos material					
Material Assessment Scoring:							
Product Type:	-	Condition:	-	Surface Treatment:	-	Asbestos Type:	-
Priority Assessment Scoring:							
Occupant Activity:	-	Disturbance:	-	Human Exposure:	-	Maintenance Activity:	-
Total Scores:							
Material Score:	-	Priority Score	-	Total Score:	0	Risk Rating:	N/A
Recommended action:	-						
Recommendation comments:	-						
Comments:	Representative sample of insulation packing. Similar holes present throughout the lift shaft.

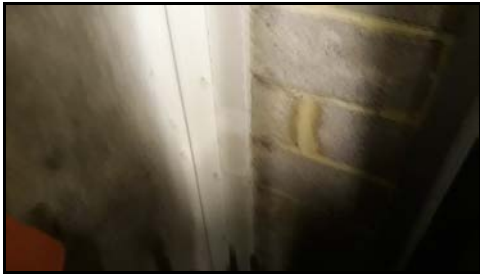
Building:	Space House (Tower & Kingsway)	Floor:	All Floors				
Location:	006 - Lift 3 - Tower	Sample No / ID (Type):	P-363772/017 (Sampled)				
Surveyor:	Corey Cook	Survey date:	13/02/2020				
Sample Details

Item description:	Wall panels running length of shaft floor 14					
	Material description:	Insulating board					
	Quantity / Extent:	2 m linear					
	Accessibility	Difficult Access					
	Analysis:	No asbestos detected					
	Material identification:	Non-asbestos material					
Material Assessment Scoring:							
Product Type:	-	Condition:	-	Surface Treatment:	-	Asbestos Type:	-
Priority Assessment Scoring:							
Occupant Activity:	-	Disturbance:	-	Human Exposure:	-	Maintenance Activity:	-
Total Scores:							
Material Score:	-	Priority Score	-	Total Score:	0	Risk Rating:	N/A
Recommended action:	-						
Recommendation comments:	-						
Comments:	-

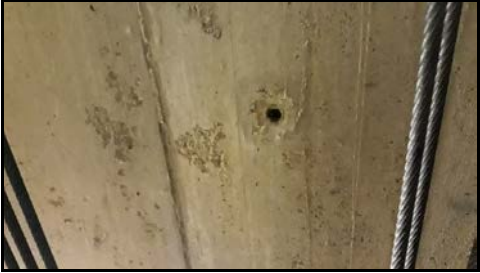
Building:	Space House (Tower & Kingsway)	Floor:	All Floors				
Location:	007 - Lift 4 - Tower	Sample No / ID (Type):	P-363772/018 (Sampled)				
Surveyor:	Corey Cook	Survey date:	13/02/2020				
Sample Details

Location No.	Location Name	Sample No.	Item / Position	Material
007	Lift 4 - Tower	P-363772/018	Insulation packing within wall holes	Asbestos insulation

Item description:	Insulation packing within wall holes					
	Material description:	Insulation					
	Quantity / Extent:	0.1 m ²					
	Accessibility	Difficult Access					
	Analysis:	Amosite					
	Material identification:	Asbestos insulation					
Material Assessment Scoring:							
Product Type:	3	Condition:	3	Surface Treatment:	3	Asbestos Type:	2
Priority Assessment Scoring:							
Occupant Activity:	0	Disturbance:	1	Human Exposure:	1	Maintenance Activity:	0
Total Scores:							
Material Score:	11	Priority Score	2	Total Score:	13	Risk Rating:	High
Recommended action:	Remove.						
Recommendation comments:	-						
Comments:	Representative sample of insulation packing. Similar holes present throughout the lift shaft.

All works, whether licensed or non-licensed, must be undertaken in accordance with the Control of Asbestos Regulations, Approved Code of Practice L143 and HSE guidance documents.

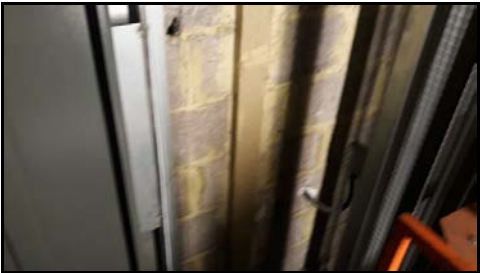
Building:	Space House (Tower & Kingsway)	Floor:	All Floors				
Location:	007 - Lift 4 - Tower	Sample No / ID (Type):	P-363772/As 017 (Cross Referenced)				
Surveyor:	Corey Cook	Survey date:	13/02/2020				
Sample Details

Item description:	Wall panels running length of shaft floor 14					
	Material description:	Insulating board					
	Quantity / Extent:	2 m linear					
	Accessibility	Difficult Access					
	Analysis:	No asbestos detected					
	Material identification:	Non-asbestos material					
Material Assessment Scoring:							
Product Type:	-	Condition:	-	Surface Treatment:	-	Asbestos Type:	-
Priority Assessment Scoring:							
Occupant Activity:	-	Disturbance:	-	Human Exposure:	-	Maintenance Activity:	-
Total Scores:							
Material Score:	-	Priority Score	-	Total Score:	0	Risk Rating:	N/A
Recommended action:	-						
Recommendation comments:	-						
Comments:	-

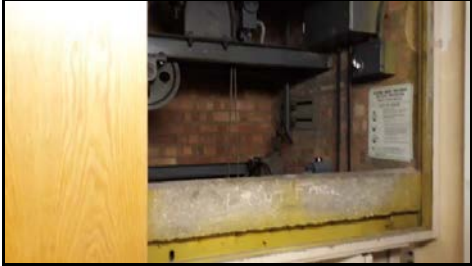
Building Name:	Space House (Tower & Kingsway)	Floor Level:	All Floors
Location Number:	001	Location Description:	Goods Lift - Kingsway
Surveyor:	Corey Cook	Survey Date:	13/02/2020
Room Data / Observations:

General Comments:	
		<p>The shaft ceiling is concrete with sampled spray. Metal pipework at high level. The shaft walls are brick with plaster render and concrete vent and sampled slate panels below. The lift car is metal with metal weight and pulley system. The lift doors are metal at both levels with timber outer doors and concrete floor at ground level with sampled screed. The electrics were live at the time of the survey. Inspected within boxes at ground level with no suspect materials.</p>

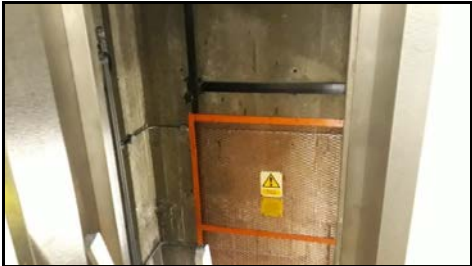
Building Name:	Space House (Tower & Kingsway)	Floor Level:	All Floors
Location Number:	002	Location Description:	Lift 1 - Kingsway
Surveyor:	Corey Cook	Survey Date:	13/02/2020
Room Data / Observations:

General Comments:	
		<p>The shaft ceiling is concrete. Visual inspection only to lift ceiling as cannot be physically reached to inspect fully. The shaft front wall is brick with concrete section above 7th floor and the right and back wall are concrete. Circular wall holes either empty or with cut off metal pipe are present to the concrete walls. Suspect insulation packing materials have been sampled from holes and are present at all levels. Metal right hand diving cage panels to adjacent shaft. The lift car is metal with metal weight and pulley system. The lift doors are metal at all levels with metal surround. The lift pit is concrete with non suspect debris.</p>

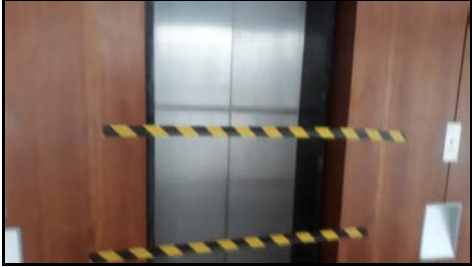
Building Name:	Space House (Tower & Kingsway)	Floor Level:	All Floors
Location Number:	003	Location Description:	Lift 2 - Kingsway
Surveyor:	Corey Cook	Survey Date:	13/02/2020
Room Data / Observations:

General Comments:	
		<p>The shaft ceiling is concrete. Visual only to lift ceiling as cannot be physically reached to inspect fully.</p> <p>The shaft front wall is brick with concrete section to 7th floor and the right and back walls are concrete. Circular wall holes either empty or with cut off metal pipe are present to the concrete walls. Suspect insulation packing materials have been sampled from holes and are present at each level.</p> <p>Metal left hand diving cage panels to adjacent shaft.</p> <p>The lift car is metal with metal weight and pulley system.</p> <p>The lift doors are metal at all levels with metal surround.</p> <p>The lift pit is concrete with non suspect debris</p>

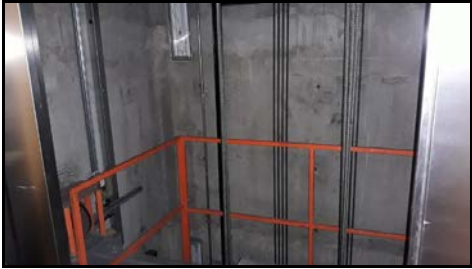
Building Name:	Space House (Tower & Kingsway)	Floor Level:	All Floors
Location Number:	004	Location Description:	Lift 1 - Tower
Surveyor:	Corey Cook	Survey Date:	13/02/2020
Room Data / Observations:

General Comments:	
		<p>The shaft ceiling is metal with steel beams and suspect packers around beams. Visual only to lift ceiling as cannot be physically reached to inspect fully.</p> <p>The shaft front wall is brick with concrete section to top and bottom and concrete right and back walls. Circular wall holes either empty or with cut off metal pipe are present to the concrete walls. Suspect insulation packing materials have been sampled from holes and are present at each level.</p> <p>Metal diving cage panels to adjacent shaft.</p> <p>The lift car is metal with metal weight and pulley system.</p> <p>The lift doors are metal at all levels with metal surround.</p> <p>The lift pit is concrete with non suspect debris</p>

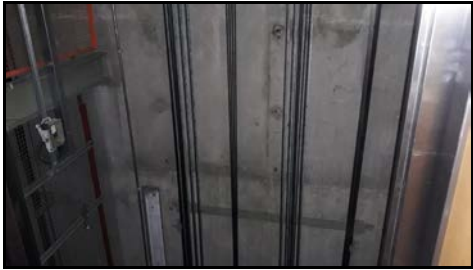
<p>The shaft ceiling is metal with steel beams and suspect packers around beams. Visual only to lift ceiling as cannot be physically reached to inspect fully.</p> <p>The front wall is brick with concrete section to top and bottom and concrete right and back walls. Circular wall holes either empty or with cut off metal pipe are present to the concrete walls. Suspect insulation packing materials have been sampled from holes and are present at each level.</p> <p>Metal diving cage panels to adjacent shaft.</p> <p>The lift car is metal with metal weight and pulley system.</p> <p>The lift doors are metal at all levels with metal surround.</p> <p>The lift pit is concrete with non suspect debris</p>

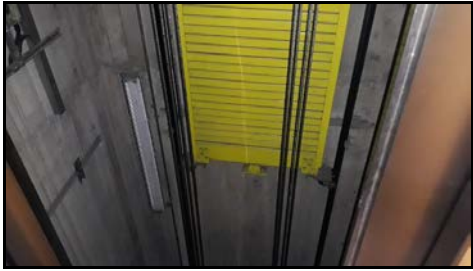
Building Name:	Space House (Tower & Kingsway)	Floor Level:	All Floors
Location Number:	006	Location Description:	Lift 3 - Tower
Surveyor:	Corey Cook	Survey Date:	13/02/2020

<p>The shaft ceiling is metal with steel beams and suspect packers around beams. Visual only to lift ceiling as cannot be physically reached to inspect fully.</p> <p>The shaft front wall is brick with concrete section to top and bottom and concrete right and back walls. Circular wall holes either empty or with cut off metal pipe are present to the concrete walls. Suspect insulation packing materials have been sampled from holes and are present at each level.</p> <p>Metal diving cage panels to adjacent shaft.</p> <p>The lift car is metal with metal weight and pulley system.</p> <p>The lift doors are metal at all levels with metal surround.</p> <p>The lift pit is concrete with non suspect debris</p>

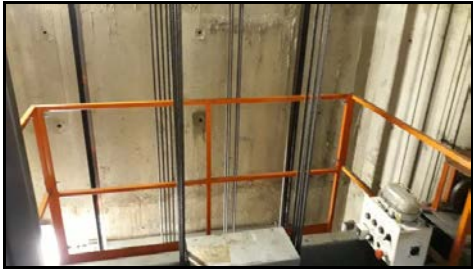
<p>General Comments:</p> <p>The shaft ceiling is metal with steel beams and suspect packers around beams. Visual only to lift ceiling as cannot be physically reached to inspect fully.</p> <p>The shaft front wall is brick with concrete section to top and bottom and concrete right and back walls. Circular wall holes either empty or with cut off metal pipe are present to the concrete walls. Suspect insulation packing materials have been sampled from holes and are present at each level.</p> <p>Metal diving cage panels to adjacent shaft.</p> <p>The lift car is metal with metal weight and pulley system.</p> <p>The lift doors are metal at all levels with metal surround.</p> <p>The lift pit is concrete with non suspect debris</p>
---	--
