## **Asbestos Refurbishment Survey** **Exterior of the Tower, Kingsway and Link Structures**

**Space House**  
**1 Kemble Street**  
**London**  
**WC2B 4AN**

**Survey Date: 03 February 2020**

**Project Reference: P-363840**

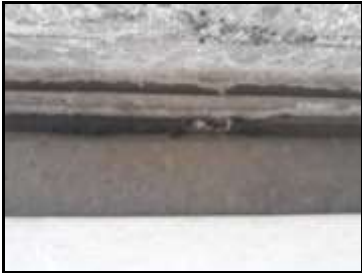
Building:	Space House	Floor:	External				
Location:	001 - Space House External	Sample No / ID (Type):	P-363840/001 (Sampled)				
Surveyor:	Martin Quigley	Survey date:	03/02/2020				
Sample Details

Item description:	Packing between canopy and soffit of building (Tower)					
	Material description:	Insulation					
	Quantity / Extent:	110 m linear					
	Accessibility	Difficult Access					
	Analysis:	No asbestos detected					
	Material identification:	Non-asbestos material					
Material Assessment Scoring:							
Product Type:	-	Condition:	-	Surface Treatment:	-	Asbestos Type:	-
Priority Assessment Scoring:							
Occupant Activity:	-	Disturbance:	-	Human Exposure:	-	Maintenance Activity:	-
Total Scores:							
Material Score:	-	Priority Score	-	Total Score:	0	Risk Rating:	N/A
Recommended action:	-						
Recommendation comments:	-						
Comments:	-

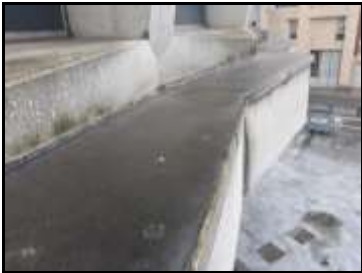
Building:	Space House	Floor:	External				
Location:	001 - Space House External	Sample No / ID (Type):	P-363840/002 (Sampled)				
Surveyor:	Martin Quigley	Survey date:	03/02/2020				
Sample Details

Item description:	Bitumen asphalt to top of canopy on 1st level (Tower)					
	Material description:	Bituminous products					
	Quantity / Extent:	110 m linear					
	Accessibility	Difficult Access					
	Analysis:	No asbestos detected					
	Material identification:	Non-asbestos material					
Material Assessment Scoring:							
Product Type:	-	Condition:	-	Surface Treatment:	-	Asbestos Type:	-
Priority Assessment Scoring:							
Occupant Activity:	-	Disturbance:	-	Human Exposure:	-	Maintenance Activity:	-
Total Scores:							
Material Score:	-	Priority Score	-	Total Score:	0	Risk Rating:	N/A
Recommended action:	-						
Recommendation comments:	-						
Comments:	-

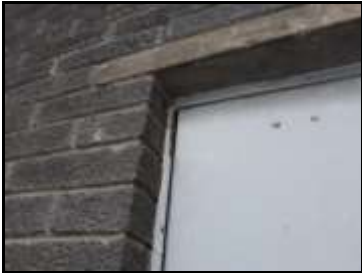
Building:	Space House	Floor:	External				
Location:	001 - Space House External	Sample No / ID (Type):	P-363840/003 (Sampled)				
Surveyor:	Martin Quigley	Survey date:	03/02/2020				
Sample Details

Location No.	Location Name	Sample No.	Item / Position	Material
001	Space House External	P-363840/003	Mastic to doorway frame (Tower)	Asbestos mastic

Item description:	Mastic to doorway frame (Tower)					
	Material description:	Mastics					
	Quantity / Extent:	20 m linear					
	Accessibility	Easy Access					
	Analysis:	Chrysotile					
	Material identification:	Asbestos mastic					
Material Assessment Scoring:							
Product Type:	1	Condition:	0	Surface Treatment:	0	Asbestos Type:	1
Priority Assessment Scoring:							
Occupant Activity:	-	Disturbance:	-	Human Exposure:	-	Maintenance Activity:	-
Total Scores:							
Material Score:	2	Priority Score	-	Total Score:	2	Risk Rating:	Very Low
Recommended action:	Remove if likely to be disturbed by the refurbishment, otherwise monitor condition.						
Recommendation comments:	-						
Comments:	-

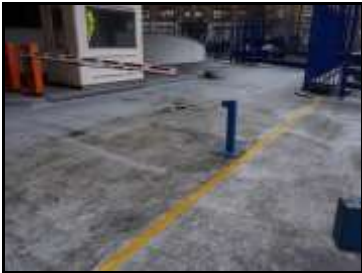
Building:	Space House	Floor:	External				
Location:	001 - Space House External	Sample No / ID (Type):	P-363840/As 002 (Cross Referenced)				
Surveyor:	Martin Quigley	Survey date:	03/02/2020				
Sample Details

Item description:	Bitumen asphalt to ground and stairs					
	Material description:	Bituminous products					
	Quantity / Extent:	120 m <sup>2</sup>					
	Accessibility	Easy Access					
	Analysis:	No asbestos detected					
	Material identification:	Non-asbestos material					
Material Assessment Scoring:							
Product Type:	-	Condition:	-	Surface Treatment:	-	Asbestos Type:	-
Priority Assessment Scoring:							
Occupant Activity:	-	Disturbance:	-	Human Exposure:	-	Maintenance Activity:	-
Total Scores:							
Material Score:	-	Priority Score	-	Total Score:	0	Risk Rating:	N/A
Recommended action:	-						
Recommendation comments:	-						
Comments:	-

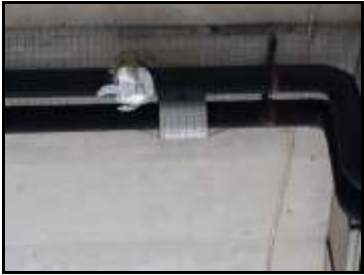
Building:	Space House	Floor:	External				
Location:	002 - Link Bridge	Sample No / ID (Type):	P-363840/004 (Sampled)				
Surveyor:	Martin Quigley	Survey date:	03/02/2020				
Sample Details

Item description:	Gasket to pipework flange at high level (Link Bridge)					
	Material description:	Gasket					
	Quantity / Extent:	4 Number					
	Accessibility	Difficult Access					
	Analysis:	No asbestos detected					
	Material identification:	Non-asbestos material					
Material Assessment Scoring:							
Product Type:	-	Condition:	-	Surface Treatment:	-	Asbestos Type:	-
Priority Assessment Scoring:							
Occupant Activity:	-	Disturbance:	-	Human Exposure:	-	Maintenance Activity:	-
Total Scores:							
Material Score:	-	Priority Score	-	Total Score:	0	Risk Rating:	N/A
Recommended action:	-						
Recommendation comments:	-						
Comments:	-

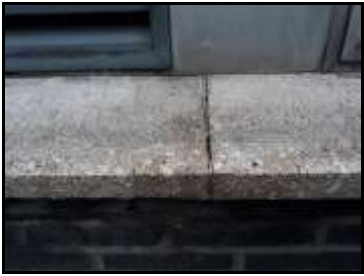
Building:	Space House	Floor:	External				
Location:	003 - Kingsway	Sample No / ID (Type):	P-363840/005 (Sampled)				
Surveyor:	Martin Quigley	Survey date:	03/02/2020				
Sample Details

Item description:	Mastic to concrete sill on top of brick wall (Kingsway)					
	Material description:	Mastics					
	Quantity / Extent:	16 m linear					
	Accessibility	Difficult Access					
	Analysis:	No asbestos detected					
	Material identification:	Non-asbestos material					
Material Assessment Scoring:							
Product Type:	-	Condition:	-	Surface Treatment:	-	Asbestos Type:	-
Priority Assessment Scoring:							
Occupant Activity:	-	Disturbance:	-	Human Exposure:	-	Maintenance Activity:	-
Total Scores:							
Material Score:	-	Priority Score	-	Total Score:	0	Risk Rating:	N/A
Recommended action:	-						
Recommendation comments:	-						
Comments:	-

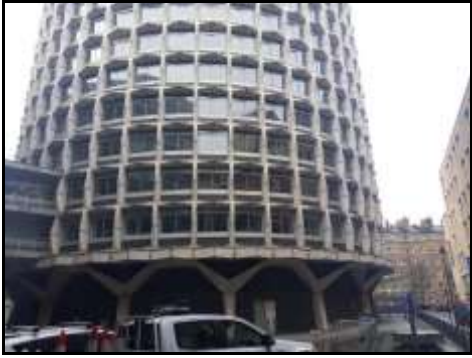
Building Name:	Space House	Floor Level:	External
Location Number:	001	Location Description:	Space House External
Surveyor:	Martin Quigley	Survey Date:	03/02/2020
<b>Room Data / Observations:</b>

General Comments:	
		<p>Concrete structure with modern mastic to expansion joints, metal glazing with glass panels beneath (Asbestos containing material behind glass as sample internally), solid brick wall to lower section, glass panelled to entrance, metal shuttering to goods in entrance, metal doors to UKPN entrances.</p>

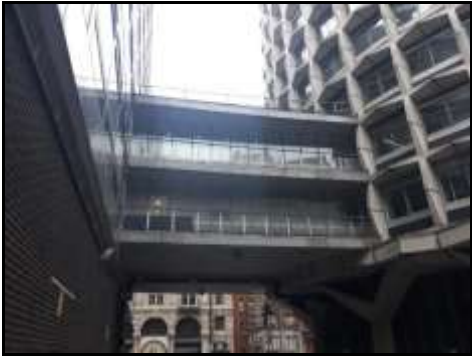
Building Name:	Space House	Floor Level:	External
Location Number:	002	Location Description:	Link Bridge
Surveyor:	Martin Quigley	Survey Date:	03/02/2020
<b>Room Data / Observations:</b>

General Comments:	
		<p>Concrete structure with modern mastic to expansion joints, marble fascia cladding to sides, MMMF insulated metal pipework with rubber membrane fixed with metal brackets attached to concrete ceiling, water shut of valves to pipework.</p>

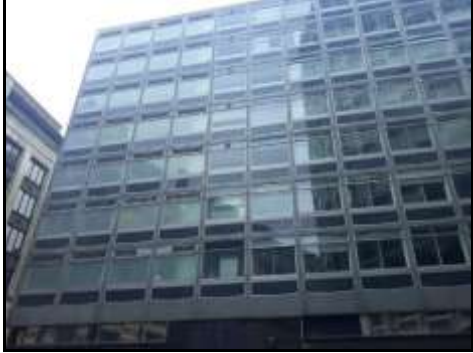
Building Name:	Space House	Floor Level:	External
Location Number:	003	Location Description:	Kingsway
Surveyor:	Martin Quigley	Survey Date:	03/02/2020

General Comments:
	<p>Solid brick walls to lower area of building with marble cladding to high level areas over concrete, timber doors and frames with metal doors and frames, metal cladding to front area of building, metal windows with glass panels beneath and modern mastic, modern mastic to expansion joints, mosaic tiles to front canopy.</p>
