Asbestos Refurbishment Survey Window Removal to Tower and Kingsway (Link Bridge)

**Space House
1 Kemble Street
London
WC2B 4AN**

Survey Date: 09 March 2020

Project Reference: P-366327

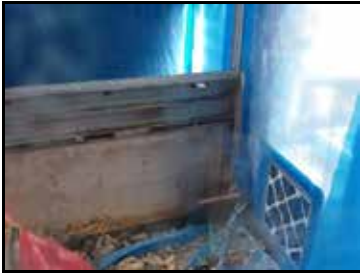
Building:	Space House	Floor:	Fourth Floor				
Location:	001 - Tower Building - Room 4B/4A	Sample No / ID (Type):	P-366327/001 (Sampled)				
Surveyor:	Adam Pullin	Survey date:	09/03/2020				
Sample Details

Item description:	Panel Beneath Window					
	Material description:	Insulating board					
	Quantity / Extent:	2 m ²					
	Accessibility	Difficult Access					
	Analysis:	Chrysotile Amosite					
	Material identification:	Asbestos insulating board					
Material Assessment Scoring:							
Product Type:	2	Condition:	1	Surface Treatment:	2	Asbestos Type:	2
Priority Assessment Scoring:							
Occupant Activity:	-	Disturbance:	-	Human Exposure:	-	Maintenance Activity:	-
Total Scores:							
Material Score:	7	Priority Score	-	Total Score:	7	Risk Rating:	Medium
Recommended action:	Remove.						
Recommendation comments:	-						
Comments:	Insulating board panel located beneath window behind breeze block walls fixed to the external facing glass panel. Assume to be present beneath all windows in the building, on all floors.

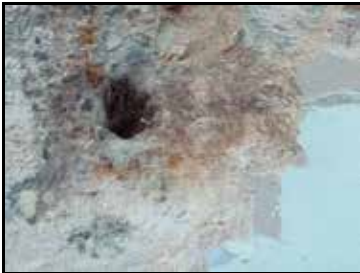
Building:	Space House	Floor:	Fourth Floor				
Location:	002 - Kingsway Building - Room 4B/4A	Sample No / ID (Type):	P-366327/002 (Sampled)				
Surveyor:	Adam Pullin	Survey date:	09/03/2020				
Sample Details

Item description:	Packing to window frame					
	Material description:	Insulating board					
	Quantity / Extent:	0.25 m ²					
	Accessibility	Difficult Access					
	Analysis:	No asbestos detected					
	Material identification:	Non-asbestos material					
Material Assessment Scoring:							
Product Type:	-	Condition:	-	Surface Treatment:	-	Asbestos Type:	-
Priority Assessment Scoring:							
Occupant Activity:	-	Disturbance:	-	Human Exposure:	-	Maintenance Activity:	-
Total Scores:							
Material Score:	-	Priority Score	-	Total Score:	0	Risk Rating:	N/A
Recommended action:	-						
Recommendation comments:	-						
Comments:	Packing material located within the concrete aperture.

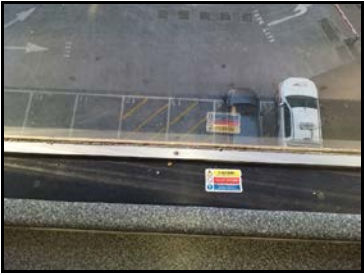
Building:	Space House	Floor:	Fourth Floor				
Location:	002 - Kingsway Building - Open Plan Area	Sample No / ID (Type):	P-366327/P001 (Presumed)				
Surveyor:	Adam Pullin	Survey date:	09/03/2020				
Sample Details

Item description:	Window sills					
	Material description:	Cement product					
	Quantity / Extent:	2 m linear					
	Accessibility	Easy Access					
	Analysis:	Presumed to contain asbestos					
	Material identification:	Asbestos cement					
Material Assessment Scoring:							
Product Type:	1	Condition:	0	Surface Treatment:	1	Asbestos Type:	3
Priority Assessment Scoring:							
Occupant Activity:	-	Disturbance:	-	Human Exposure:	-	Maintenance Activity:	-
Total Scores:							
Material Score:	5	Priority Score	-	Total Score:	5	Risk Rating:	Low
Recommended action:	Remove.						
Recommendation comments:	-						
Comments:	Extent provided (2 m linear) equates to each window section. This material has been sampled and confirmed as asbestos on previous survey report -.P-359298. The photograph shown is from the previous survey report.
