# TECHNICAL REPORT

12 Heath Hurst Road  
London  
NW3 2RX

**SUBSIDENCE CLAIM**

DATE 10 December 2018

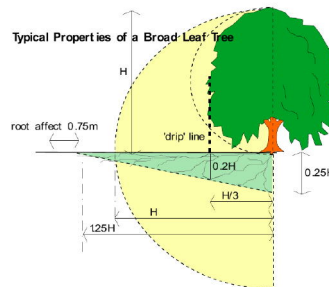
Typical proportions of an Ash. Note the potential root zone.

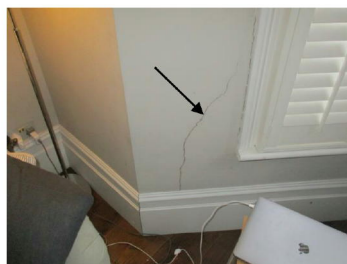
Cracking to bay in lounge

**Lounge** - 5mm diagonal cracking to right hand side of bay, cracking to coving in bay area, 1mm vertical crack above left hand side of bay, cracking to ceiling and coving along left hand party wall, various plaster cracks noted to hall partition.

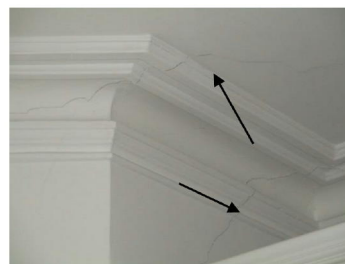
Cracking in 1st floor front bedroom

**1st Floor Front Bedroom** - Hairline diagonal crack to right hand side of bay, cracking to ceiling and coving, 2mm diagonal crack to front wall at high level in left hand corner, hairline diagonal crack above door to en-suite.

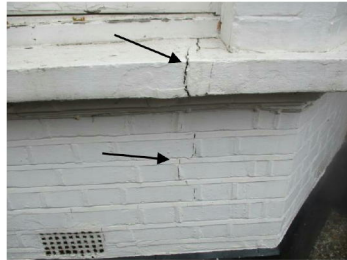
Cracking to front bay

**Front Bay** - 4mm crack to centre ground floor cill, 3mm stepped crack to centre of bay below cill level, 6mm vertical separation noted to both left hand and right hand junctions, significant historic distortion noted to bay structure.

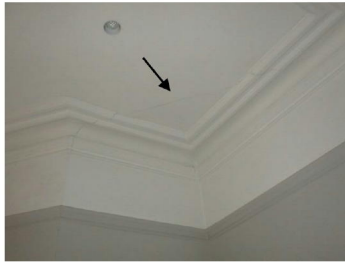
Cracking in lounge

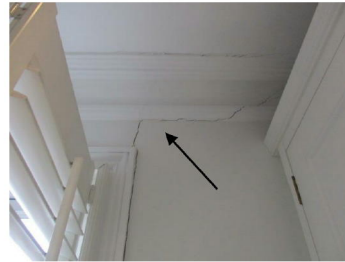
**2nd Floor Front Bedroom** - 4mm diagonal tapering cracking above and below front windows, cracking to coving, 3mm diagonal crack to bathroom partition.

Cracking in 2nd floor front bedroom

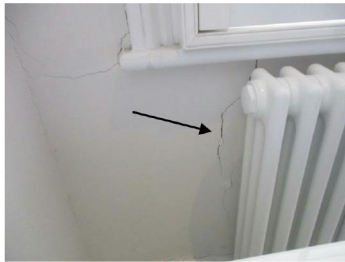
Cracking in 2nd floor front bedroom

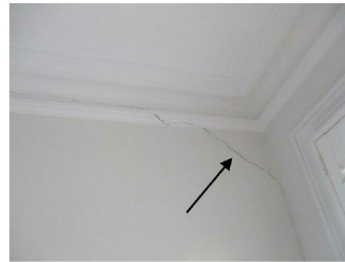
Cracking in 2nd floor front bedroom

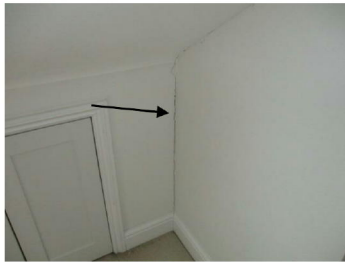
**Loft Bedroom** - 3mm vertical cracking down front left hand corner junction, wall / ceiling junction cracking along left hand party wall, cracking to ceiling around front velux, roof is leaking on front pitch due to missing roof slates.

Cracking in loft bedroom

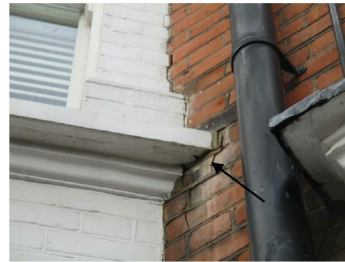
Cracking to front bay

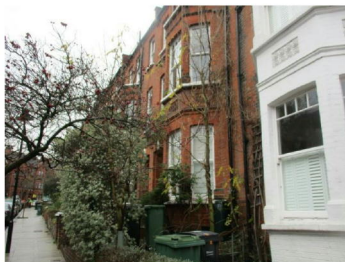
The timing of the event, the presence of shrinkable clay beneath the foundations and the proximity of vegetation where there is damage indicates the shrinkage to be root induced. This is a commonly encountered problem and probably accounts for around 70% of subsidence claims notified to insurers.

View of vegetation in front garden

Although the cause of the movement needs to be dealt with, we note that the property is located within a conservation area. Unfortunately, the council will require certain investigations to be carried out to demonstrate the influence of the vegetation.

Typically, these investigations would involve trial pit(s) to determine the depth and type of footings, boreholes to determine the nature of the subsoil/influence of any roots and monitoring to establish the rate and pattern of movement. It may also be necessary to obtain a specialist Arboricultural Report.

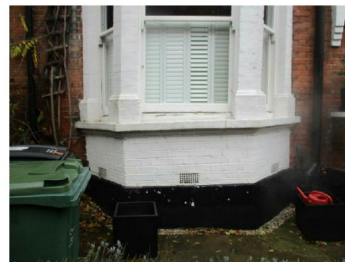
At the time of our visit we noted some significant historic distortions to the front bay structure. These are longstanding distortions and are unrelated to the relatively minor cracking which has occurred recently. The repair of the historic distortions will fall outside the scope of the repairs on this occasion.

View of historic distortion to front bay
