## Arboricultural Appraisal Report

### Subsidence Damage Investigation at:

12 Heath Hurst Road  
London  
NW3 2RX

REPORT DATE: 11/01/2020

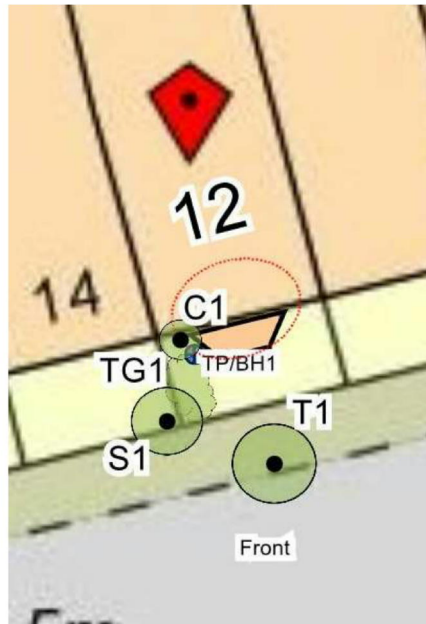
Site Plan

Approximate areas of damage

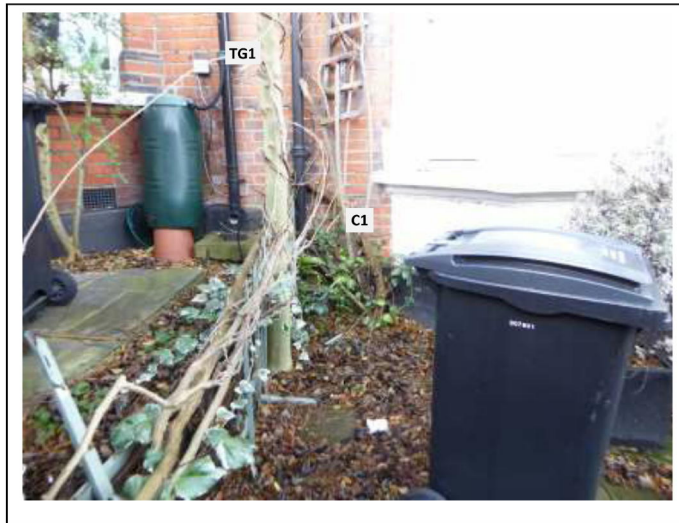
Roots were observed to a depth of 2400mm bgl in TP/BH1 and recovered samples have been positively identified (using anatomical analysis) as *Fraxinus* spp., the origin of which will be TG1 (ash) confirming its influence on the soils below the foundations.

Based on the technical reports currently available, engineering opinion and our own site assessment we conclude the damage is consistent with shrinkage of the clay subsoil related to moisture abstraction by vegetation. Having considered the information currently available, it is our opinion that TG1 and C1 are materially contributing to the current subsidence damage.

View of TG1 and C1

If an arboricultural solution is to be implemented to mitigate the influence of the implicated trees/vegetation we recommend that TG1 and C1 are removed. Other vegetation recorded presents a potential future risk to building stability and management is therefore recommended.

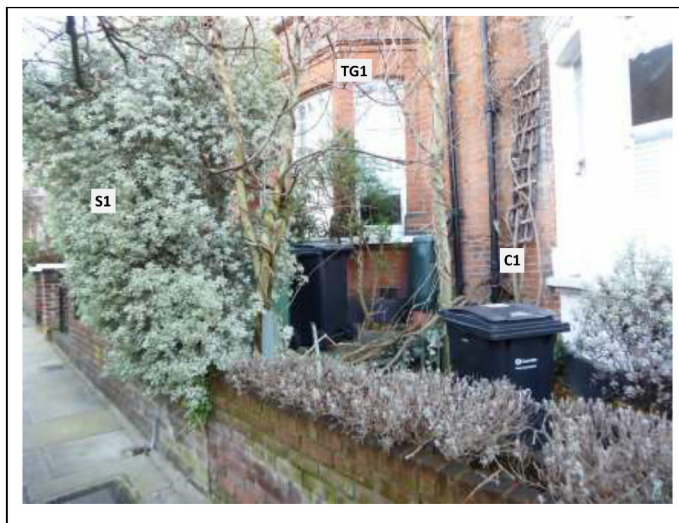
View of S1, TG1 and C1

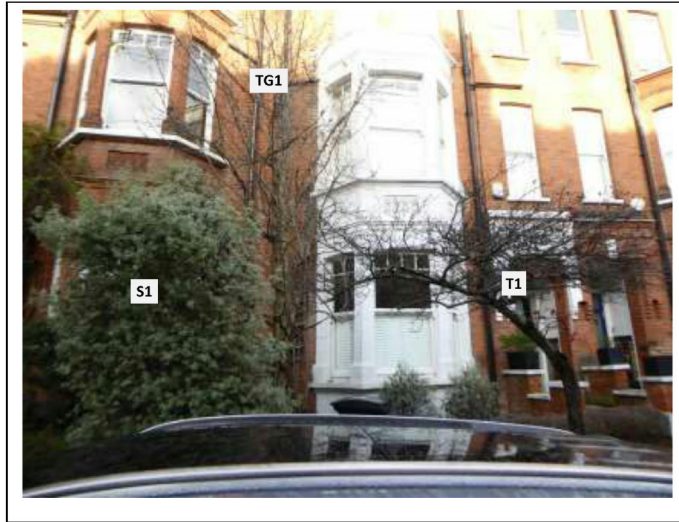
View of S1, TG1 and T1

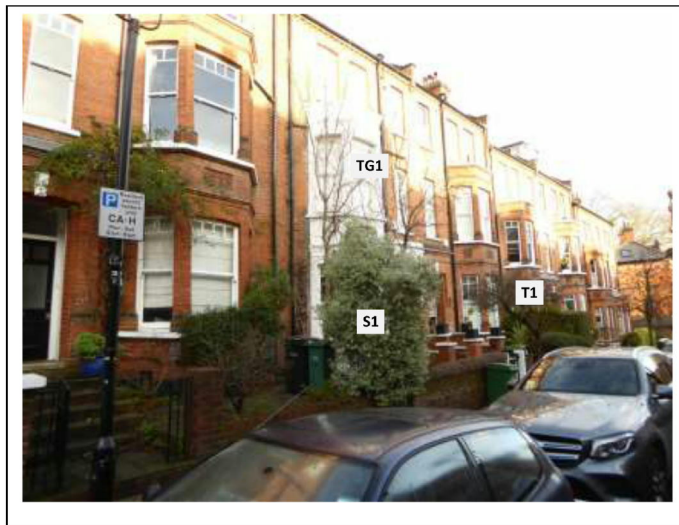
View of TG1, S1 and T1
