TECHNICAL REPORT ON A SUBSIDENCE CLAIM

[REDACTED]
Flat 2, 34 Frognall
London
NW3 6AG

SUBSIDENCE CLAIM

22nd November 2019

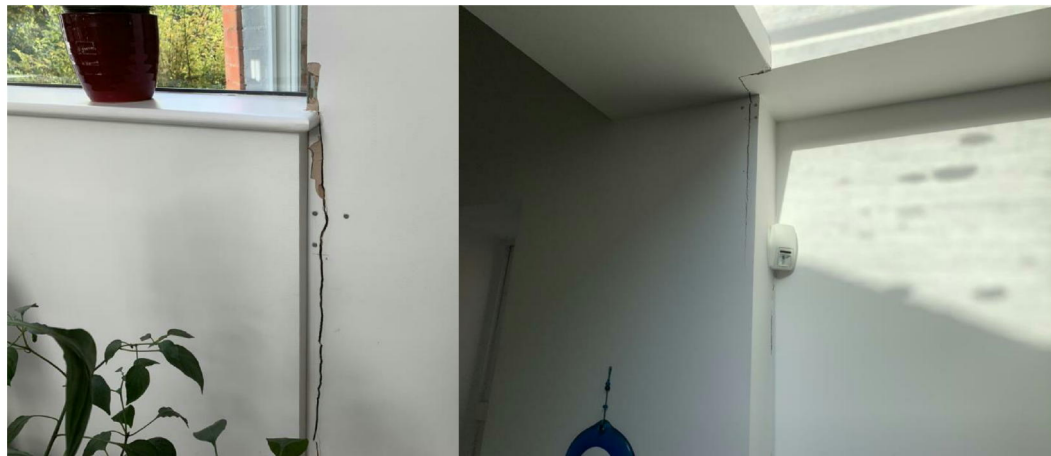
Rear Lounge Extension (Conservatory)

Right junction

Left junction

Tapering vertical crack at left junction with rear wall of main house, extending into roof light area.

Tapering vertical crack at right junction. Additional fine hairline vertical crack.

Tapering vertical crack on right wall at mid-point.

Slight displacement/pulling of window units in roof light at junction with rear wall of main house.

Rear door frame slightly out of square rendering door catching.

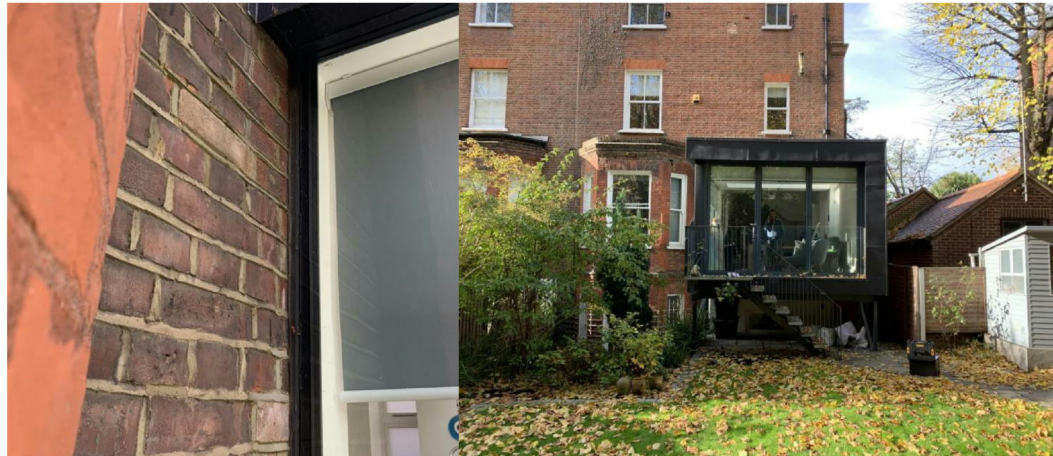
Right junction

View from rear

Tapering vertical crack at junction of original projection with rear wall of house, extending partly as a stress crack on the rear of the original house.

Diagonal and vertical crack on left flank wall above door to kitchen on lower ground floor flat.

Slight displacement between conservatory structure and rear wall of house.

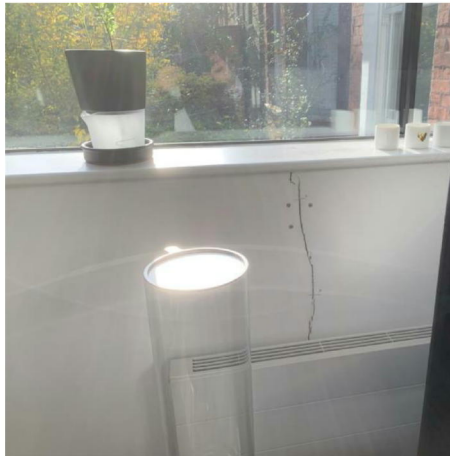
Right mid-point

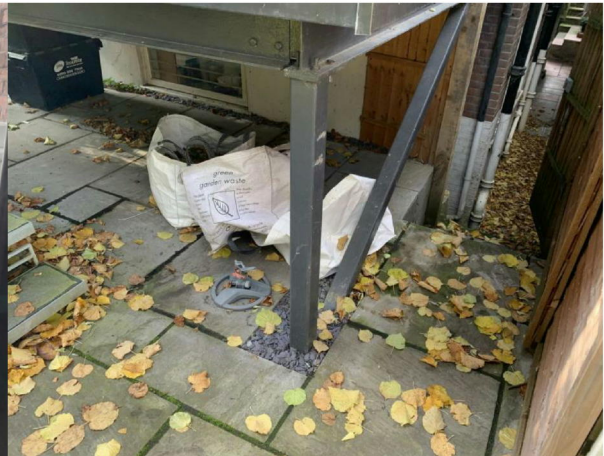
Steel supports, reportedly on pad footings
2.5m-3m deep

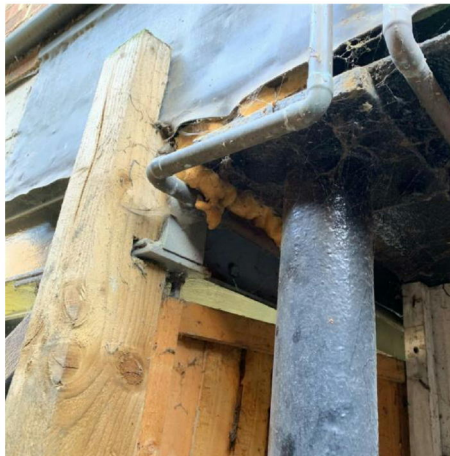
Supporting columns to original projection

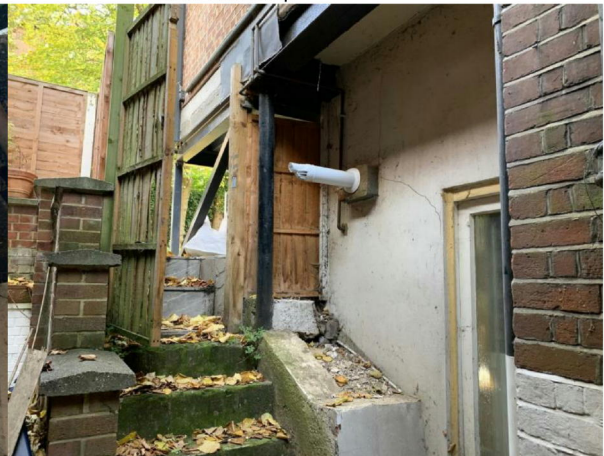
Supporting column to original projection
and diagonal crack on lower ground flat
wall

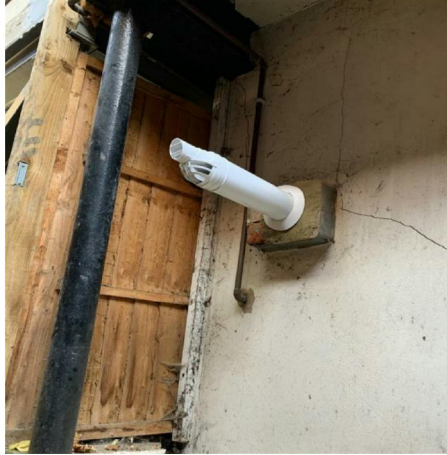
Lower ground falt - cracking above door at rear junction

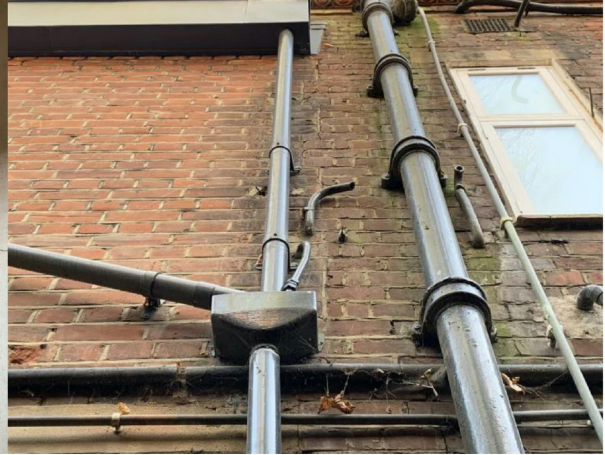
Cracking at junction on left flank wall

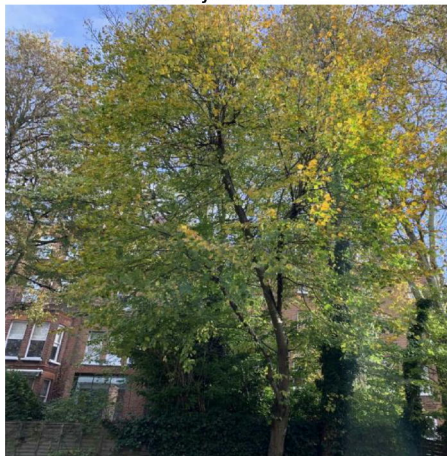
Protected Lime trees at rear

Although the cause of the movement needs to be dealt with, we note the vegetation is subject to a Preservation Order. Unfortunately, current legislation requires certain investigations to be carried out to support an application for the tree works.

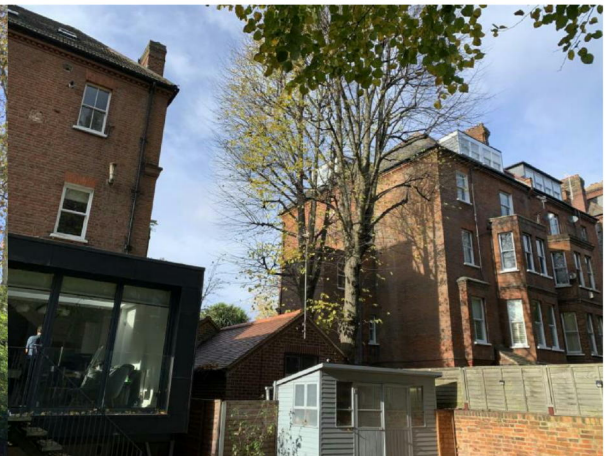
Lime trees to side, behind neighbouring property built on original drive for house
