Arboricultural Appraisal Report

Subsidence Damage Investigation at:

Flat 2, 34 Frognal
London
NW3 6AG

REPORT DATE: 11/03/2020

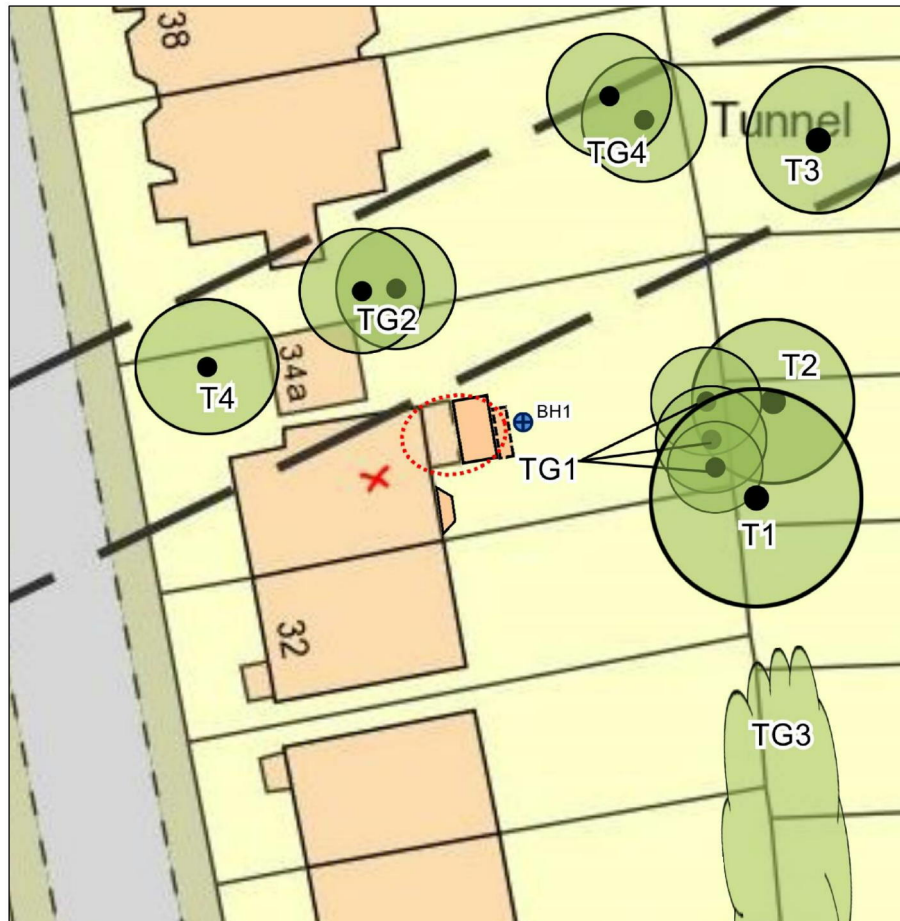
Site Plan

Approximate areas of damage

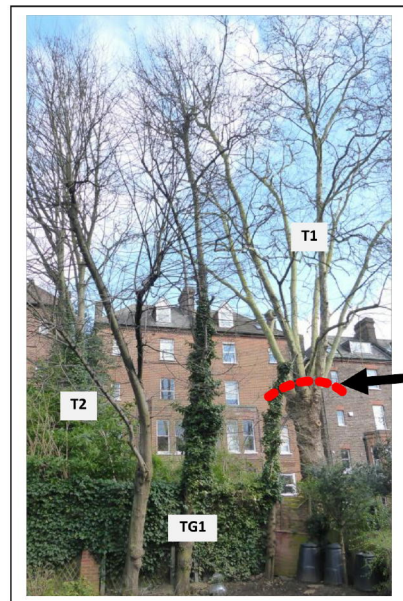
Roots were observed to a depth of 3.0m bgl in BH1, and recovered samples have been positively identified (using anatomical analysis) as *Platanus* spp. and *Tilia* spp.; the origins of which will be T1 London Plane and most likely the TG1 Lime group, however the TG2 Lime group is also within influencing distance and may account for retrieved samples.

Based on the technical reports currently available, engineering opinion and our own site assessment we conclude the damage is consistent with shrinkage of the clay subsoil related to moisture abstraction by vegetation. Having considered the information currently available, it is our opinion that T1 London Plane, T2 Sycamore and TG1 Lime group are the combined cause of the current subsidence damage. TG2 Lime group has recently been pollarded, and so any current involvement is at present equivocal.

View of T1 London Plane, TG1 Lime group and T2 Sycamore

If an arboricultural solution is to be implemented to mitigate the influence of the implicated trees/vegetation we recommend that T1 London Plane is pollarded, T2 Sycamore and TG1 Lime group are removed. Other vegetation recorded presents a potential future risk to building stability and management is therefore recommended.

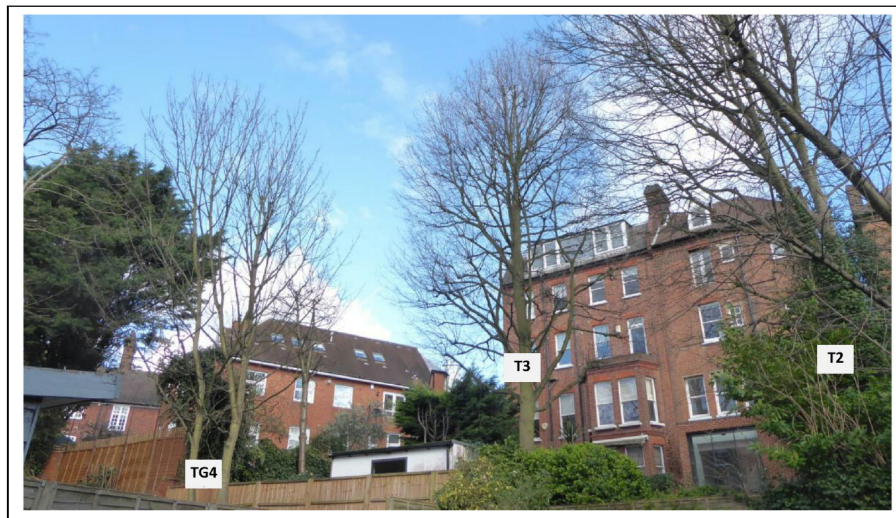
View of T3 Lime and TG4 Sycamore group with T2 Sycamore visible to right of frame

Tree No.	Species	Ht (m)	Dia (mm)	Crown Spread (m)	Dist. to building (m)	Age Classification	Ownership
T3	Lime	22.5	750 *	13.0 *	23.0	Older than Property	Third Party: 43 Netherhall Gdns NW3 5RL
Management history		Subject to past management/pruning - previously crown reduced.					
Recommendation		Maintain broadly at no more than current dimensions by periodic pruning.					
T4	False Acacia	9.5	550 *	10.5	6.1	Similar Age to Property	Third Party: 34a Frognall NW3 6AG
Management history		No past management noted.					
Recommendation		Maintain broadly at no more than current dimensions by periodic pruning.					
TG2	Lime group [x 2 stems]	18.0 *	600 *	9.0	5.9*	Older than Property	Third Party: 36 Frognall NW3 6AG
Management history		Subject to past management/pruning – recently pollarded at current dimensions and historically pollarded at approx. 6.5m.					
Recommendation		Maintain broadly at no more than current dimensions by periodic [triennial] re-pollarding.

TG3	Lime group	18.0	550 Ms *	11.0	18.6	Older than Property	Third Party: ownership not visible from PH garden (Possibly 33/35 Netherhall Gdns)
Management history		Subject to past management/pruning - appears regularly pruned.					
Recommendation		Maintain broadly at no more than current dimensions by periodic pruning.					
TG4	Sycamore group [x2 stems]	15.5	350 *	9.0	19.6	Younger than Property	Third Party: 36 Frognall NW3 6AG
Management history		Subject to past management/pruning - previously crown reduced.					
Recommendation		Maintain broadly at no more than current dimensions by periodic pruning.

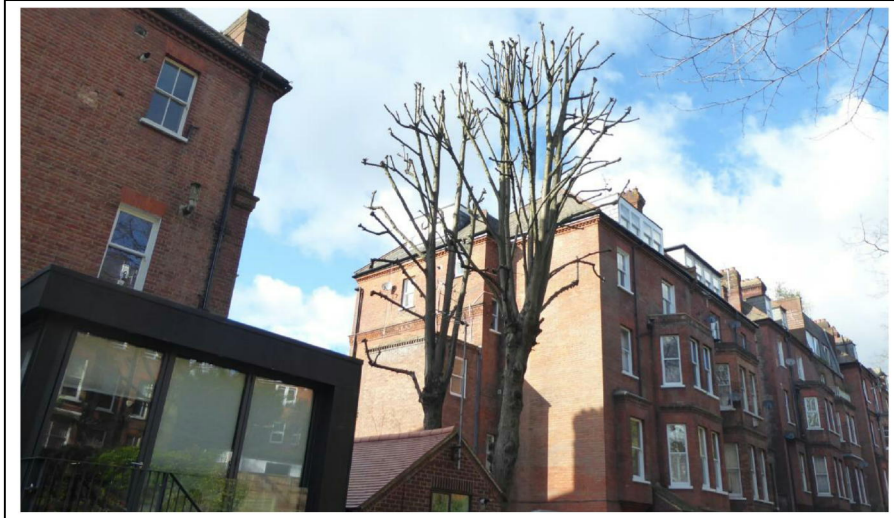
View of TG2 Lime group

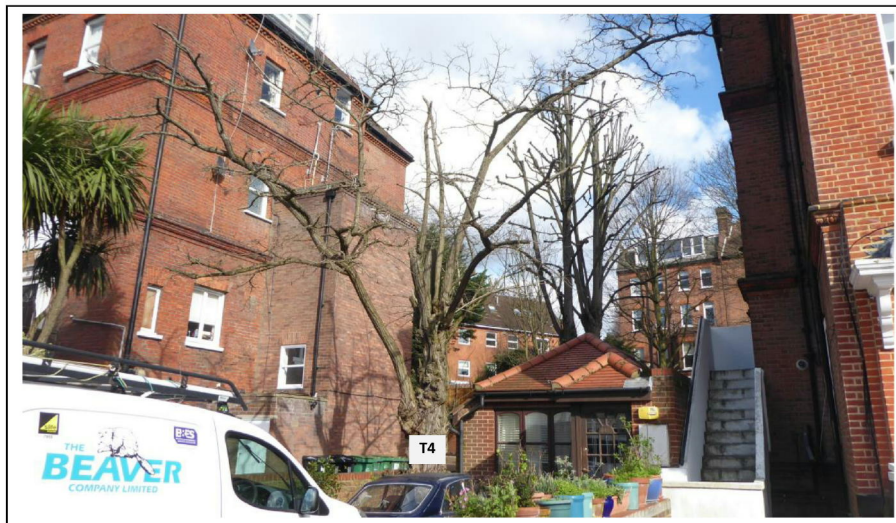
View of T4 False Acacia
