ARBORICULTURAL ASSESSMENT REPORT

For:	Client:	Sedgwick International UK
	Insurer:	Deacon Insurance Brokers
Site:	Policyholder:	Mr Kenyon
	Risk Address:	23a Nassington Road, London, NW3 2TX
Refs:

Arborist Name:	Edward Clear	Date:	27/03/2020
QC:	Margaret MacQueen	Date:	09/04/2020
Reviewed:	Margaret MacQueen	Date:	14/04/2020

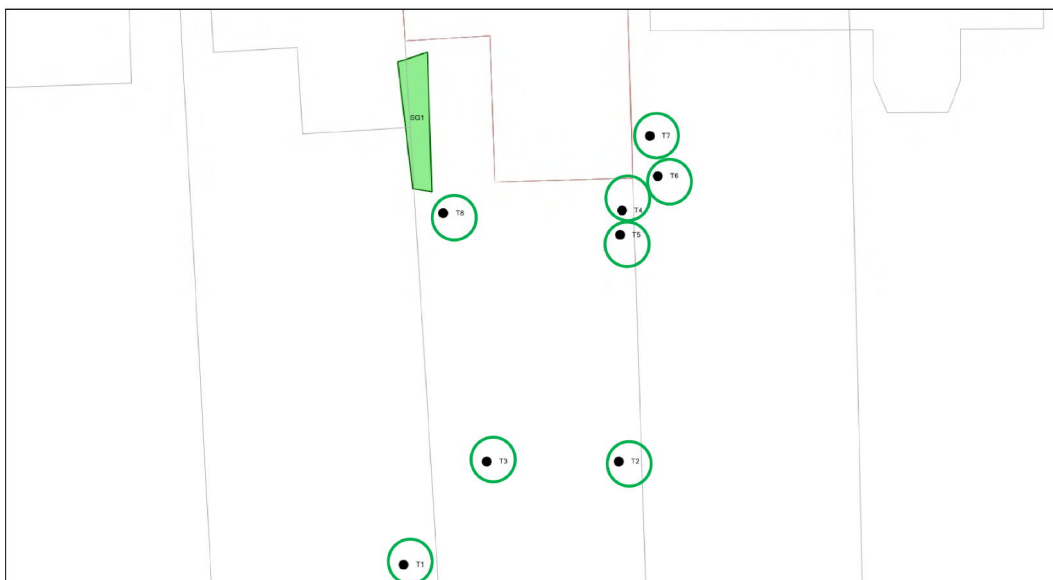
7.0 APPENDIX 2: SITE PLAN

Tree No:	Species	Works Required
SG1	Spindle Rose Clematis & Maple	Fell and treat stumps
T1	Willow	Fell and treat stump
T6	Willow	Fell and treat stump
