Arboricultural Appraisal Report

Subsidence Damage Investigation at:

9 Willoughby Road
London
NW3 1RT

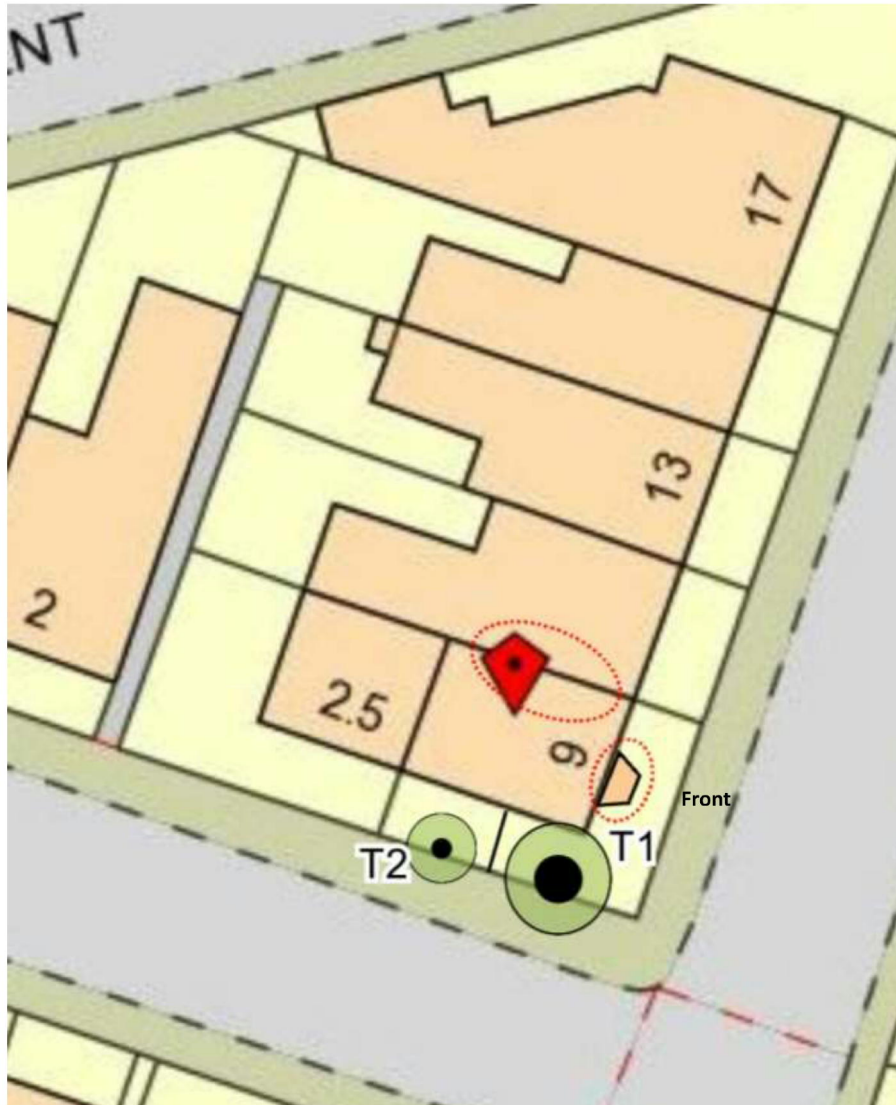
Site Plan

Approximate areas of damage

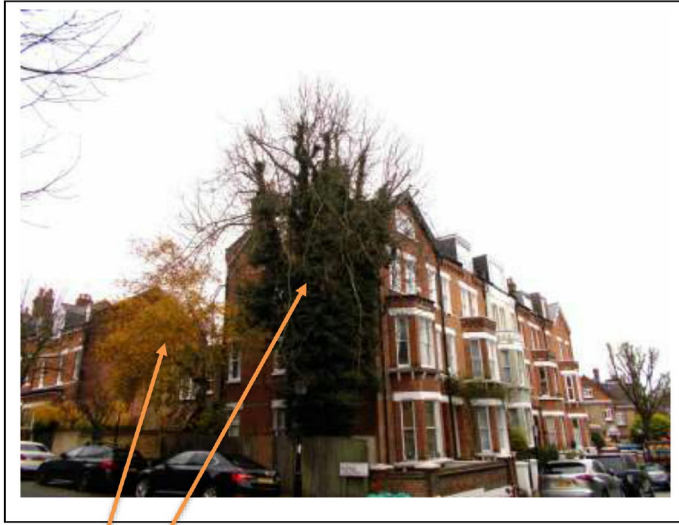
The vegetation considered to be most significant in relation to the current damage is T1.

Based on the information currently available, engineering opinion and our own site assessment we conclude the damage appears consistent with shrinkage of the clay fraction due to the soil drying effects of vegetation.

Tree No.	Species	Ht (m)	Dia (mm)	Crown Spread (m)	Dist. to building (m)	Age Classification	Ownership
T1	Ash	16*	650*	12*	2.5	Younger than Property	Policyholder
Management history		No recent management noted.					
Recommendation		Remove (fell) to near ground level and treat stump to inhibit regrowth.

Tree No.	Species	Ht (m)	Dia (mm)	Crown Spread (m)	Dist. to building (m)	Age Classification	Ownership
T2	Birch	7.5	300	9	4.5	Younger than Property	Policyholder
Management history		No recent management noted.					
Recommendation		Reduce height by 2m and crown radius by 1m leaving balanced crown. Prune on a triennial cycle to maintain at broadly reduced dimensions.

View of T2 and T1

If an arboricultural solution is to be implemented to mitigate the influence of the tree considered to be responsible for the damage we recommend that T1 is removed. Other vegetation recorded presents a potential future risk to building stability and management is therefore recommended.

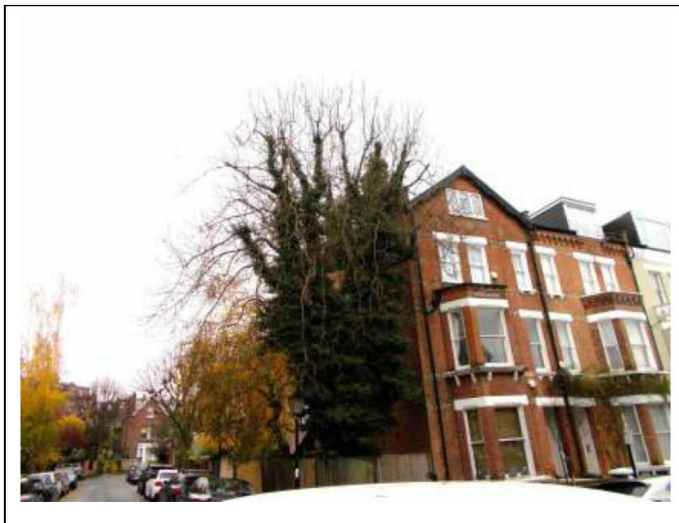
Alternative view of T1 and T2
