**CCTV REPORT FOR: 112 HIGHGATE ROAD  
LONDON  
NW5 1PB**

**Site Visit:** 30-Oct-19  
**Report Date:** 01-Dec-19

## SITE AND DRAINAGE LAYOUT

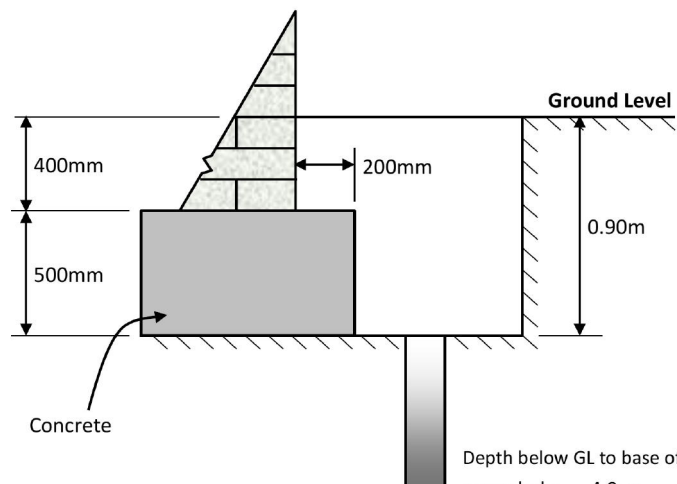
Location: <b>Front Right Corner of Bay</b>	T/H No. <b>1</b>
Ground Surface: <b>Dry</b>	Weather: <b>Dry</b>
	Date: <b>30-Oct-19</b>

Depth (m)	Soil Descriptions (NB: Field crew description only)	Test Type	Depth (m)	
			From	To
G.L.				
0.90	Firm brown CLAY	V(n) 52	0.900	
4.00	End of Borehole	V(n) 55	1.500	
		V(n) 60	2.000	
		V(n) 65	2.500	
		V(n) 60	3.000	
		V(n) 55	3.500	
		V(n) 55	4.000	
<b>Photograph</b>

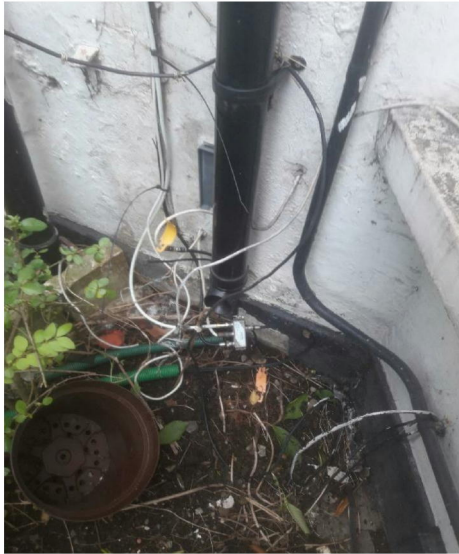
<b>Brief:</b>	The Drainage Repair Company Ltd were commissioned to undertake a CCTV survey / inspection of the drainage at the property.
<b>Specific Area of Interest:</b>	Accessible drainage at the property.
<b>System Access:</b>	No suitable survey access available.
<b>Visual Survey:</b>	RWP to left of bay discharges directly onto ground.
<b>Water Main Test:</b>	Pass - No movement observed on meter.

RWP to left of property

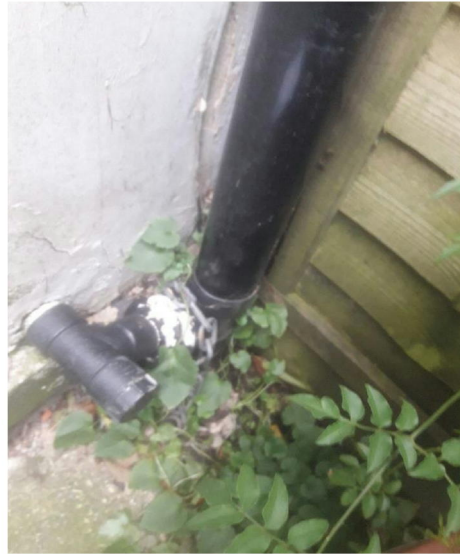
R&FWP to left of property

Should further investigation of the drainage be required then we would propose to carry out a small access excavation at the base of R&FWP to the right of the property so that we may cut into the pipework below ground. Once entry to the pipework has been gained we can then complete a CCTV survey downstream.
