Bartlett Consulting

TREE STRUCTURAL INTEGRITY REPORT

CLIENT: Daleham Gardens Housing Association

SITE ADDRESS: Flat 26a
Daleham Gardens
London
NW3 5DA

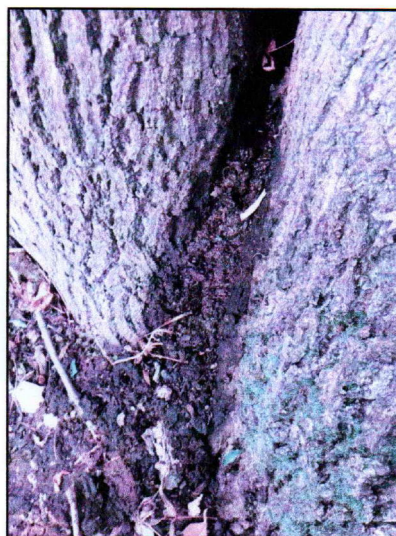
The presence of a desiccated fungal fruiting body suspected to be Shaggy Polypore (*Inonotus hispidus*) was found in a desiccated state at the base of the Common Ash.

Figure 2: Image of western base of Common Ash with desiccated Fungal Fruiting Bodies

The suspected desiccated remains of *Inonotus hispidus* identified within the base of the old stem wound to the western quadrant is attributed to the decay highlighted within Test 02 at 1.3 metres although currently is not of significant concern.

Tree Reference	Specification of Works
Common Ash	<ul style="list-style-type: none"> Carry out a high pollard back to previous points reducing height to 12.0m a lateral growth accordingly Crown raise to 6.0m ? Remove epicormic growth from main stem and scaffold limbs Carry out root collar excavation to reduce build-up of soil Apply Phosphite drench at base

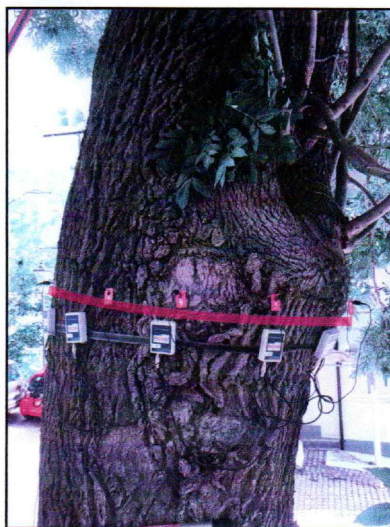
The first test was carried out at a height of 3,250 millimetres above ground level. Sensor 1 was positioned on the northern side of the main stem; and the subsequent 11 sensors were spaced at regular intervals at the same height to create a level test plane. Please see Figure 3 below.

Figure 3: Image Showing PiCUS Test Plane on the western Aspect of the Common Ash at 3.25m

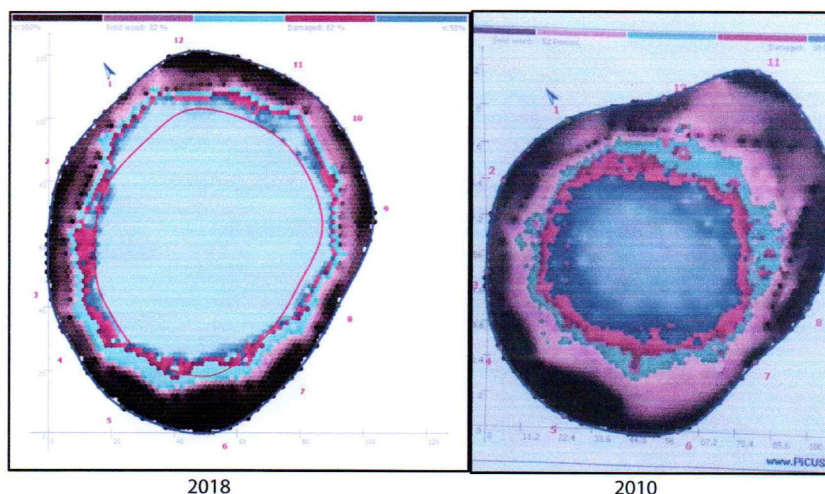
Figure 2: Image of PiCUS Sonic Tomograph-test at 3250 Millimetres Height on the Common Ash

The Tomogram re-test (Test 1) carried out 2018, depicts that at 3,250 millimetres above ground level approximately 62% of the wood has been decayed as indicated by the blue / pink colours, with 32% as solid wood as shown in brown colours. The remaining 6% is considered incipient decay and partially damaged wood as indicated by the green coloured areas of the image.

The blue and pink coloured zones are areas of the stem where the soundwaves have encountered woody material; however, this is in such a state of advanced decay that there is little structural property remaining.

The surrounding belt of green depicted on the image between the damaged wood (blue and pink) and the solid wood (brown) indicate areas of the stem where we believe there is incipient and early-stage decay. The small width of the green zone suggests relatively good defence capabilities and compartmentalisation of the decay.

The circumferential red line within the Tomograph is a notional representation of Mattheck's "t/R ratio". The theory proposed by Mattheck & Breloer (1994) argues that when the remaining solid wood within the main stem of a tree, with a full crown, falls below a ratio of 0.3 then the tree is liable to increased risk of failure. From the above image it can be seen that the residual solid wood at this level falls just shy of the circumferential red line and highlighting a t/R ratio of 0.32.

When comparing the results against the 2010 image it is clear to see that decay is progressing at a faster rate than annual tree growth resulting in a 20% solid wood loss within the last eight years. It must be noted there is a slight variation in profile between 2010 test and the 2018 re-test. This variation in profile within the 2010 test has resulted in an over estimation of remaining solid wood percentage.

When comparing the results of the Picus Tomography at 3.25m from 2010 against the current 2018 T01 re-test it is clear that the main stem has been severely compromised by the fungal activity *Polyporus squamosus* (identified within the 2010 report) and its persistent action has degraded the wood by approximately 20% in less than 8 years.

In conclusion, I would advise that the tree structure has been considerably de-graded by the internal decay identified at 3.25m to such an extent that significant remedial works must now be recommended in order to reduce weight on the compromised structure.

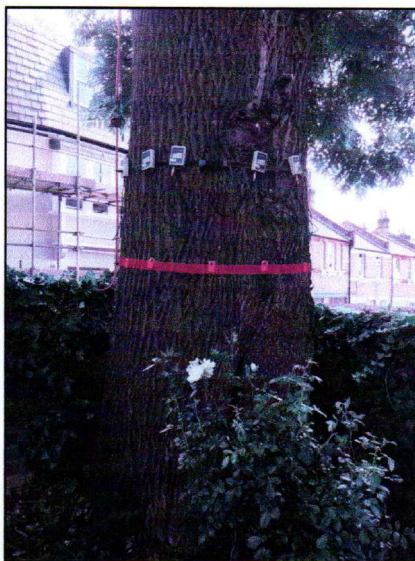
The second test was carried out at a height of ^{1.30 m} 1,300 millimetres above ground level. Due to the proximity of the retaining brick wall to the east 1.3 metres was the lowest point on the main stem in which sufficient access could be achieved in order to carry out the required testing. Sensor 1 was positioned on the northern side of the main stem; and the subsequent 11 sensors were spaced at regular intervals at the same height to create a level test plane. Please see Figure 6 below.

Figure 6: Image Showing PiCUS Test Plane on the north-western Aspect of the Common Ash at 1.3m

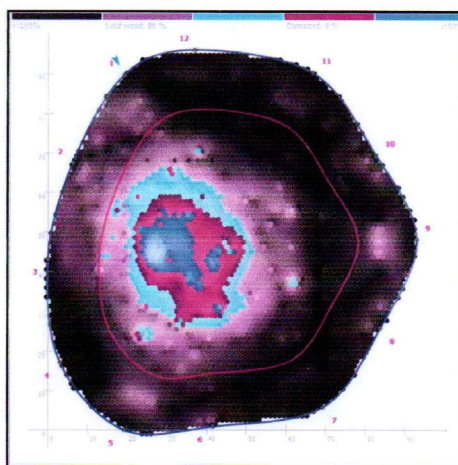
Figure 7: Image of PiCUS Sonic Tomograph-test at 3250 Millimetres Height on the Common Ash

The Tomogram test (Test 2) carried out 2018, depicts that at 1,300 millimetres above ground level approximately 9% of the wood has been decayed as indicated by the blue / pink colours, with 86% as solid wood as shown in brown colours. The remaining 5% is considered incipient decay and partially damaged wood as indicated by the green coloured areas of the image.

The blue and pink coloured zones are areas of the stem where the soundwaves have encountered woody material; however, this is in such a state of advanced decay that there is little structural property remaining.

The surrounding belt of green depicted on the image between the damaged wood (blue and pink) and the solid wood (brown) indicate areas of the stem where we believe there is incipient and early-stage decay. The width of the green zone suggests moderate defence capabilities and compartmentalisation of the decay.

From the above image it can be seen that the residual solid wood at this level is well within the circumferential red line and highlighting a t/R ratio of 0.86.

The decay at this level is slightly asymmetrical to the west indicative of the open wound and decay within the western quadrant running from ground level to a height of 1.0 metre.

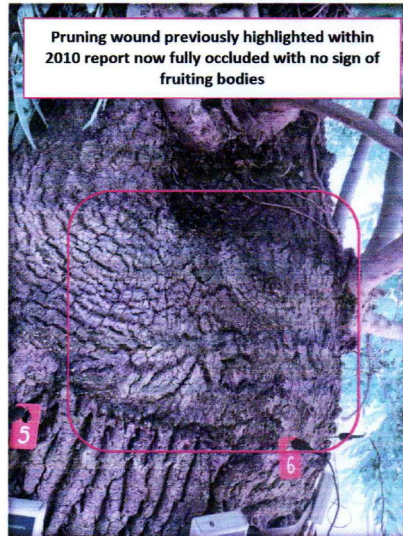
Image 8: Pruning wound at 3.5m. to southern quadrant of main stem

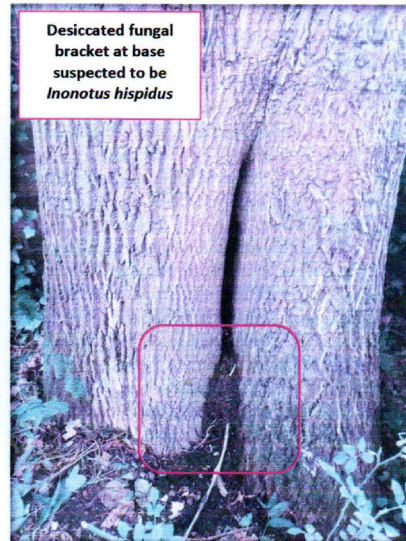
Image 9: Old stem wound within western quadrant from ground level up height of 1.0m

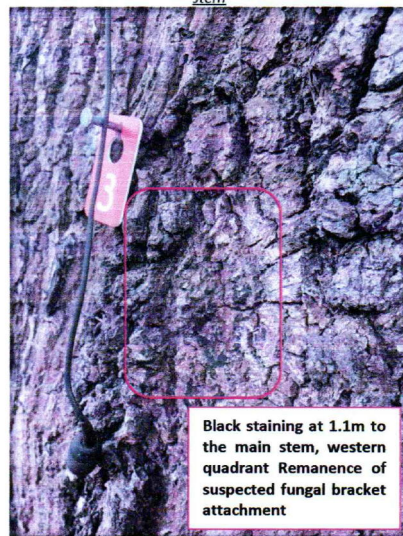
Image 10: 1.1m on western quadrant of main stem above old stem wound

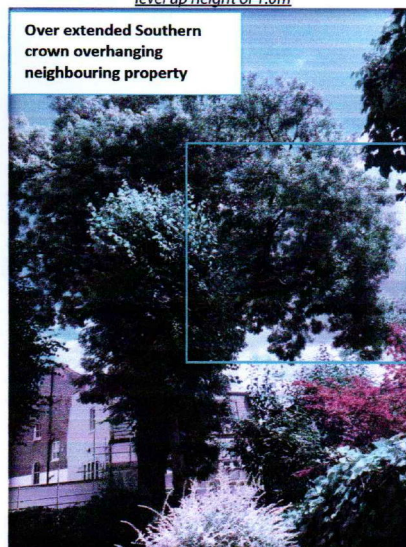
Image 11: Showing Common Ash as viewed from a western aspect

The Common Ash has undergone a number of historic pollarding works resulting in multiple included unions and regrowth on weak points of attachment that have now lapsed creating an un natural and structurally compromised form.
