REFURBISHMENT SURVEY FOR ASBESTOS-CONTAINING MATERIALS

CLIENT: Quartz

SITE: The Diorama, 17, 18 & 19 Park Square East, London, NW1 4LH

TYPE OF SURVEY: Refurbishment

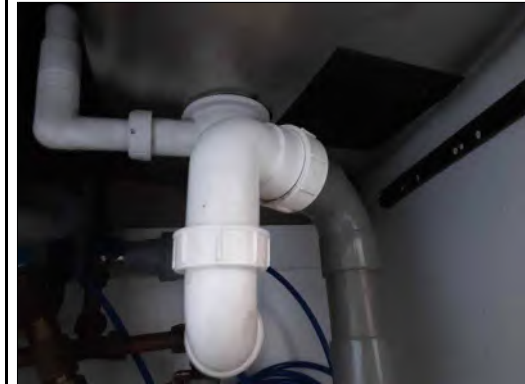
Assessment details				Comments	Photograph
Building	The Diorama Building 17	Floor/ room	2nd Floor / 2.01		
Assessment no.	0001	Accessibility			
Material Risk					
Identification	Identified	Condition			
Extent		Asbestos Type	No Asbestos Detected		
Location/ position	Sink pad sink				
Surface treatment					
Product type	n/a				
Material risk		Material risk score			
Action	No further action required

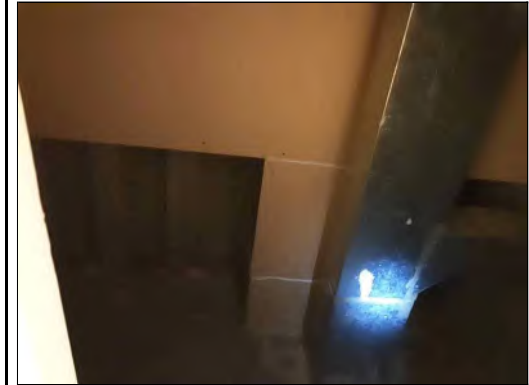
Assessment details				Comments	Photograph
Building	The Diorama Building 18	Floor/ room	2nd Floor / 2.02		
Assessment no.	0003	Accessibility			
Material Risk					
Identification	Identified	Condition			
Extent		Asbestos Type	No Asbestos Detected		
Location/ position	Mastic to metal ducting in ceiling void				
Surface treatment					
Product type	n/a				
Material risk		Material risk score			
Action	No further action required

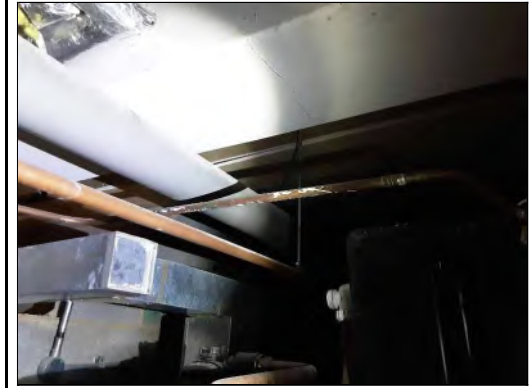
Assessment details				Comments	Photograph
Building	The Diorama Building 18	Floor/ room	Ground Floor / G.07		
Assessment no.	0013	Accessibility			
Material Risk					
Identification	Strongly Presumed (010)	Condition			
Extent		Asbestos Type	No Asbestos Detected		
Location/ position	Mastic To metal ducting in ceiling void				
Surface treatment					
Product type	n/a				
Material risk		Material risk score			
Action	No further action required

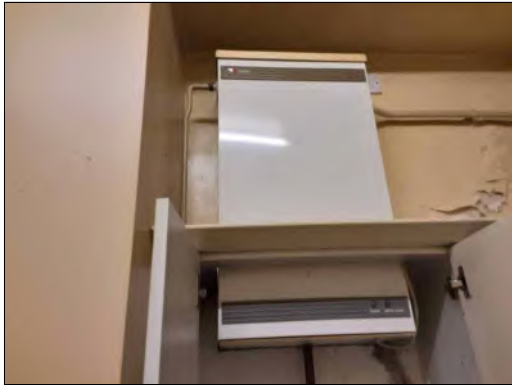
Assessment details				Comments	Photograph
Building	The Diorama Building 17	Floor/ room	Basement 1 / B.08		
Assessment no.	0018	Accessibility			
Material Risk					
Identification	Inaccessible (Presumed)	Condition	n/a		
Extent		Asbestos Type	n/a		
Location/ position	No access to water heater				
Surface treatment	n/a				
Product type	n/a				
Material risk		Material risk score			
Action	Inspect Prior to Disturbance

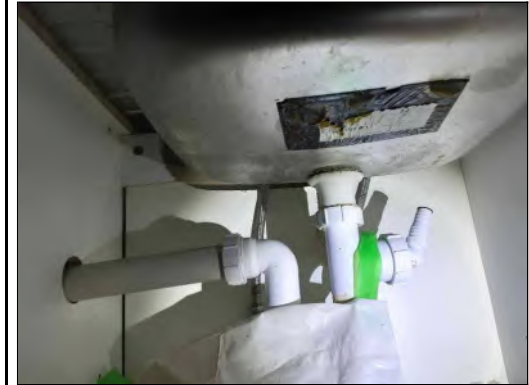
Assessment details				Comments	Photograph
Building	The Diorama Building 19	Floor/ room	Basement 1 / B.07		
Assessment no.	0020	Accessibility			
Material Risk					
Identification	Identified	Condition			
Extent		Asbestos Type	No Asbestos Detected		
Location/ position	Sink pad sink				
Surface treatment					
Product type	n/a				
Material risk		Material risk score			
Action	No further action required
