Appendix A
Site Plan

job title
 Freemasons Hall
 Great Queen Street
 London
 WC2

Appendix D
Typical Repair Details

Technical Masonry Repair Specification

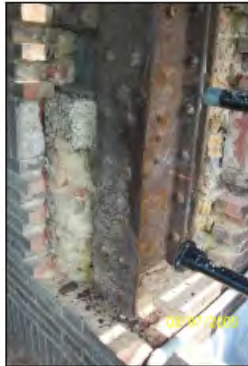
REMOVAL OF BRICKWORK FOR ACCESS TO CLEAN AND TREAT CORRODING STEEL COLUMN

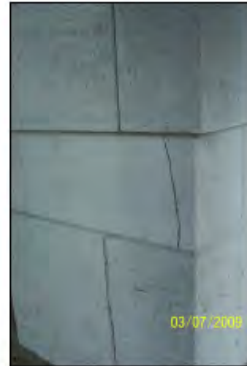
CRACKED STONE CAUSED BY CORROSION OF BURIED STEEL COLUMN BEHIND

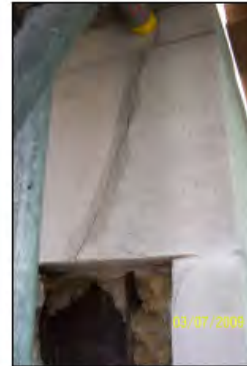
CRACKED STONE CAUSED BY CORROSION OF BURIED STEEL COLUMN BEHIND

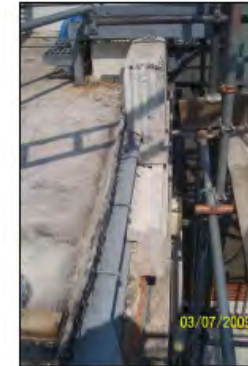
STEEL PARAPET BEAM AFTER CLEANING + PAINTING

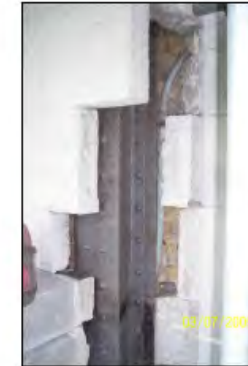
REMOVAL OF STONE FOR ACCESS TO CLEAN AND TREAT CORRODING STEEL COLUMN

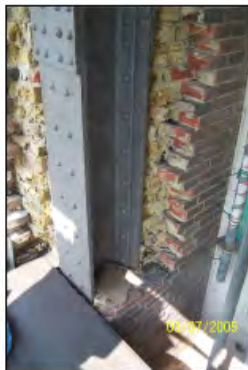
STEEL COLUMN CLEANED AFTER SHOT BLASTING PRIOR TO PAINTING

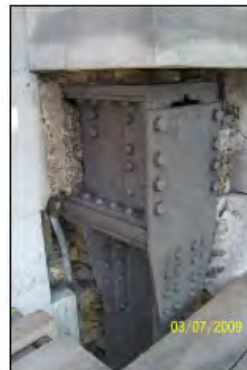
STEEL COLUMN CLEANED AFTER SHOT BLASTING PRIOR TO PAINTING

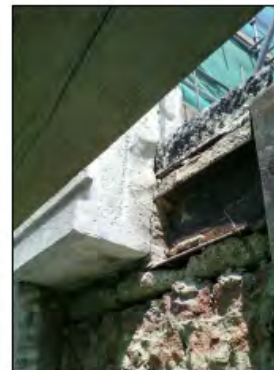
REMOVAL OF STONE PARAPET FOR ACCESS TO CLEAN AND TREAT CORRODING STEEL BEAM
