**Royal Bank of Scotland Group  
NatWest Retail Branch  
212-214 High Holborn  
London  
WC1V 7BF**

**Refurbishment of Roof Covering &  
Associated Internal Works**

**Design, Access, Heritage & Repairs Statement**

Reference: 20-080-AS-DA-HRS

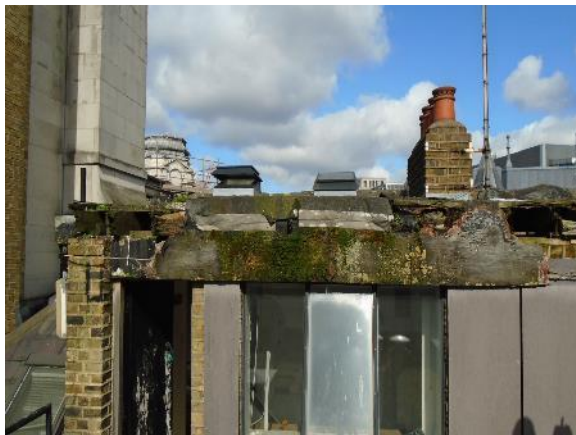
3. Roof to rear dormer

- Re-construction of dormers to main roof in preparation to receive new roof coverings and leadwork detailing. Allowance for the replacement of all defective timberwork and roof deck. Installation of new joinery items and rainwater goods.

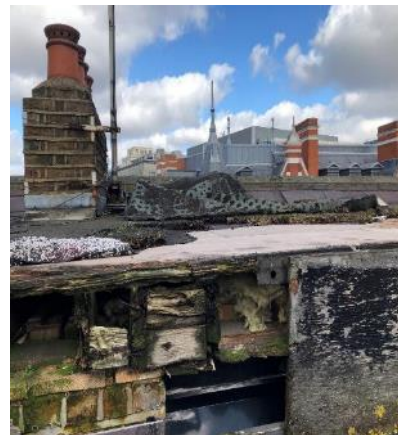
4. Roof to rear dormer

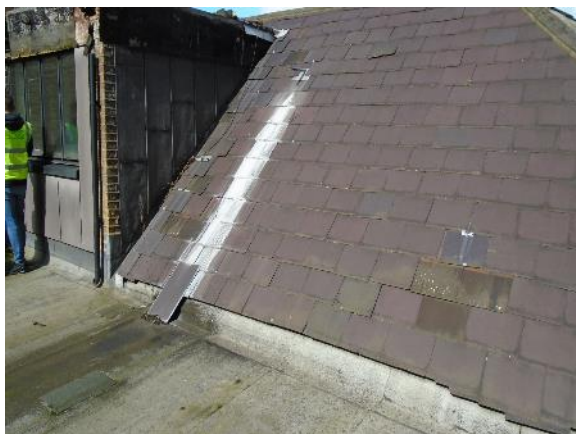
5. Rear pitch to main roof

- Isolated repairs to all pitched roof portions, including relaying of the natural slate covering and clay ridge tiles.

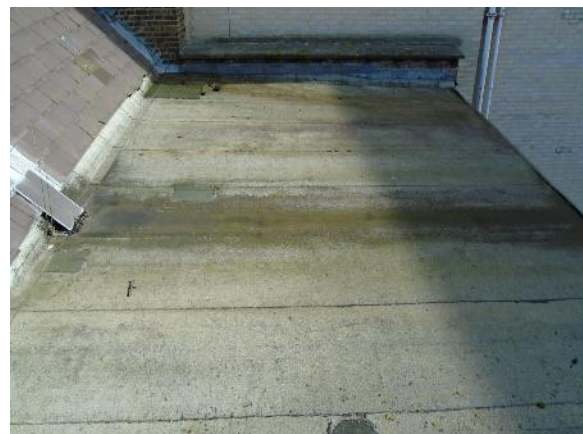
6. Flat roof at third storey level

- Application of mineral felt covering to roof at third storey level.
- Application of cold liquid applied coating to roofs at first, mezzanine and third floor level.
- All waterproofing works to be undertaken in strict accordance with manufacturer instructions and recommendations.
- Installation of retrospective GRP dome roof lights

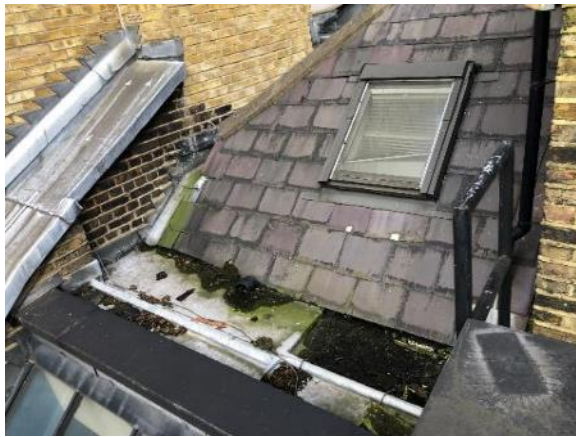
7. Lead box gutter

- Renew waterproofing to parapet gutter. Replacement Code 6 leadwork to be installed.

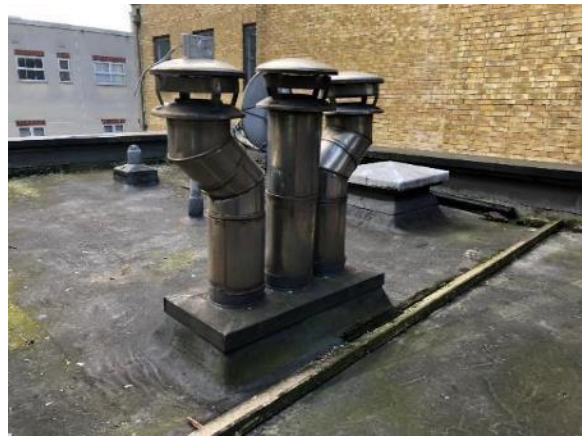
8. Asphalt roof at third storey level

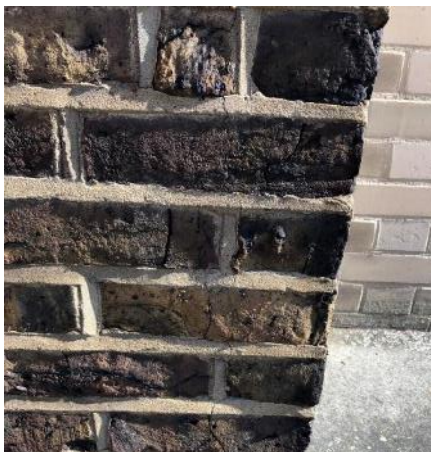
9. Brickwork to chimneystack

- Repairs to chimney stacks to main roof portions, including; repointing, brickwork repairs, render repairs and repairs to flaunching and pots. All works to be carried out with a lime-based mortar – colour, texture and mix to match existing as agreed with Conservation Officer.
- All damaged bricks are to be replaced with reclaimed bricks to match existing stock as agreed with the Conservation Officer. New brickwork to be toothed in using a hydraulic lime-based mortar. Mortar to be 1-part lime to 3 parts aggregate. Ensure an aggregate is used to best match existing mortar in colour and texture.
- Repointing, flaunching and fillet repairs to all facing elevations complete including chimneystacks, reveals, upstands, plinths and the like.

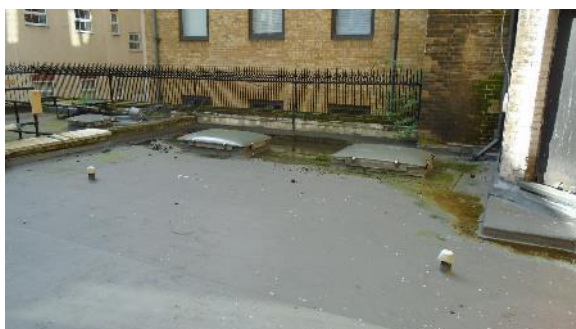
11. Failed roof covering to first floor

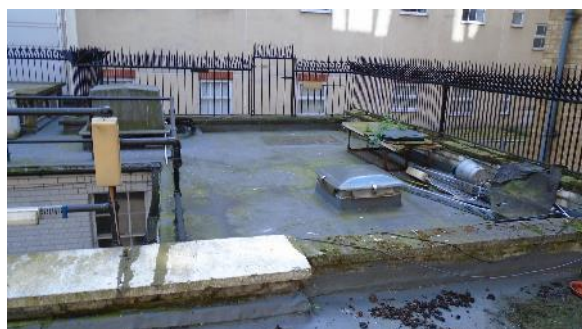
12. Failed roof covering to first floor

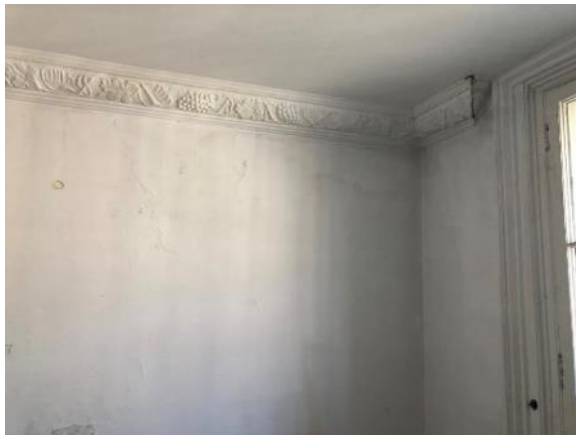
13. Visible water ingress to internal accommodation at third floor

- Internal plaster repairs to walls and ceilings to all affected areas to the upper floors of the building. Allowance for reinstatement with lath & plaster unless agreed with the appointed Conservation Officer.
- Laths to be woven to match existing allowing for the application of horse hair as required.
- Lime plaster to be formed with NHL 2 mixed 1-part sand to 1-part hydraulic lime. Sand to be fine silica 0.8mm down to 0.075mm clean and free from silt or clays.
- Gypsum plaster repairs to be undertaken to areas identified on plans.

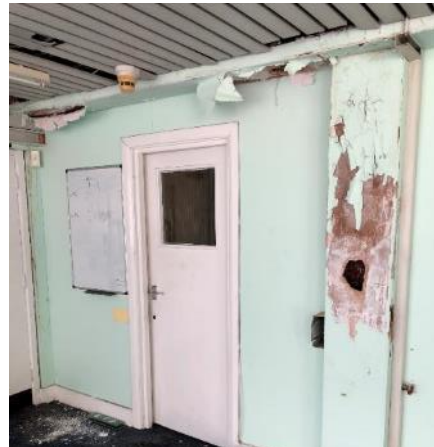
14. Visible water ingress to internal accommodation at third floor

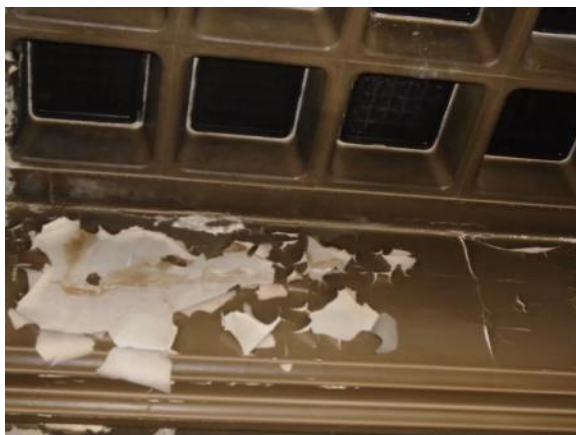
15. Visible water ingress to internal accommodation at ground floor
