TECHNICAL REPORT ON A SUBSIDENCE CLAIM

180 Camden Road
London
NW1 9HG

SUBSIDENCE CLAIM

27th November 2019

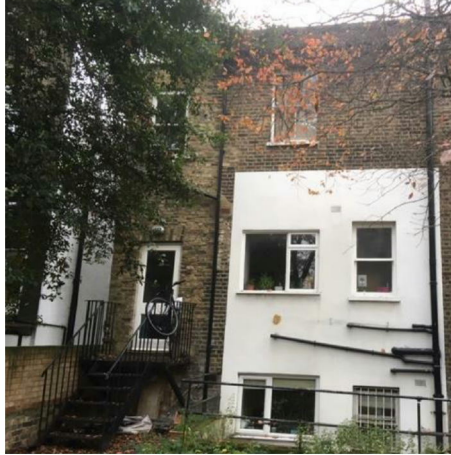
Rear elevation

- Diagonal / stepped cracking was noted to above and below door and window openings.

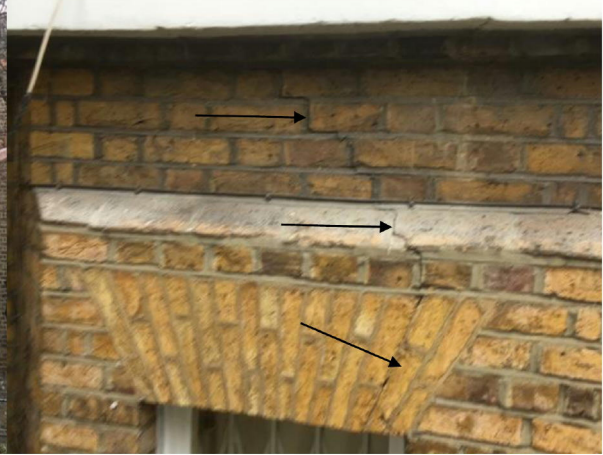
Cracking to bay

- Stepped cracking / displacement of flat brick lintels were noted to the left hand return wall of the bay.

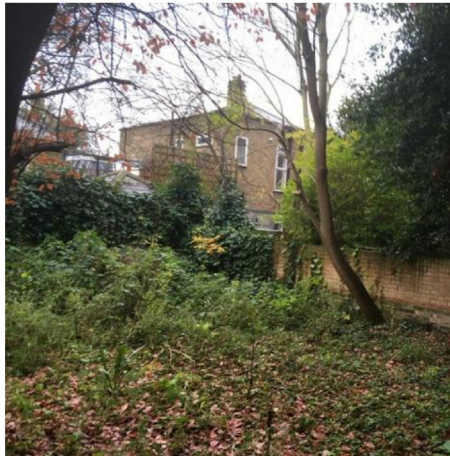
Trees at rear

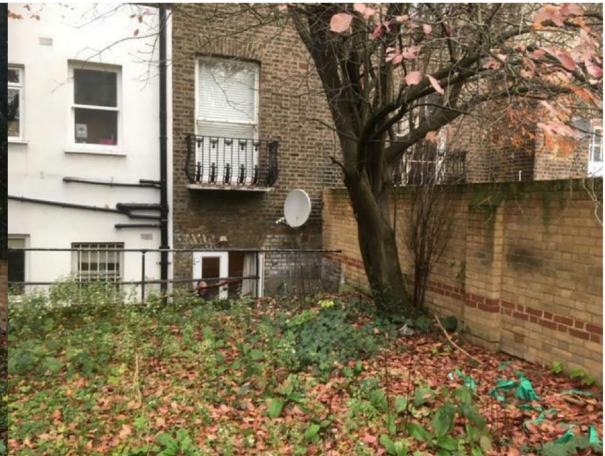
Trees at rear

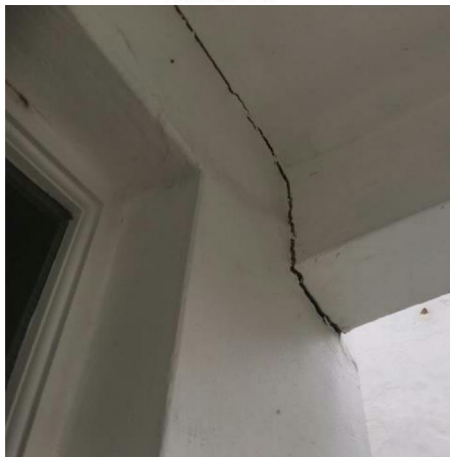
- Cracking, up to 10-15mm in width, was noted at the junction between the porch and main house/extension.
- Stepped cracking, up to 6mm in width was noted the right hand wall of the porch.

Cracking to porch

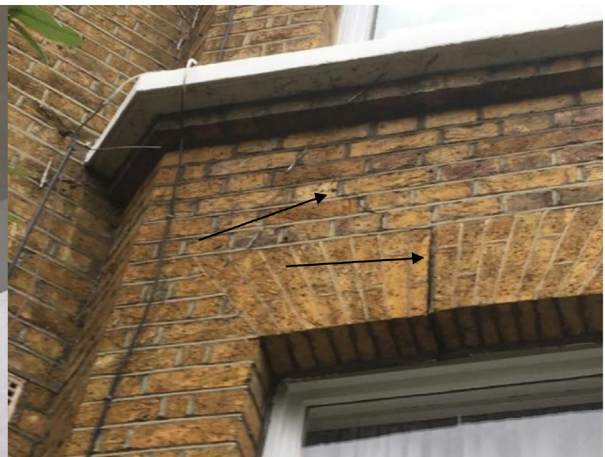
Cracking to bay

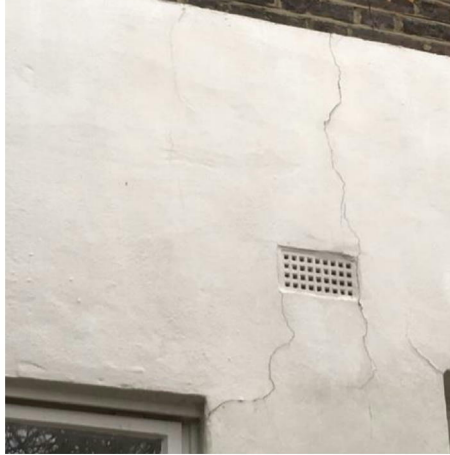
Cracking to rear elevation

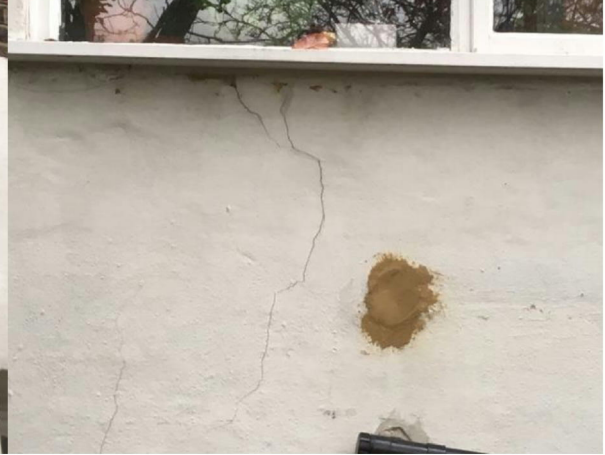
Cracking to rear elevation

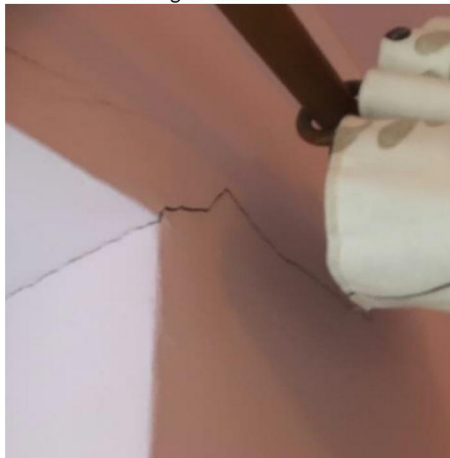
Rear Bedroom - Garden floor flat - rear wall

- To the right hand wall slight cracking was noted above the corridor door (seen both sides).
- To the rear wall, 3mm wide cracking was noted to the top right of the window.

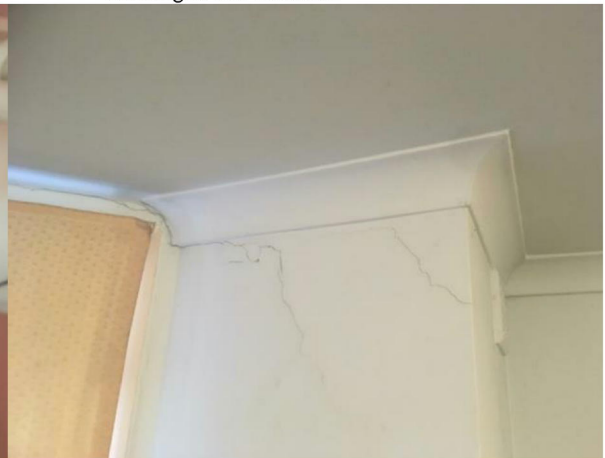
Garden flat - Lounge

- Slight cracking was noted to the left hand side of the bay at its junction with the main house.
- To the right hand wall cracking was noted either side of the hall door head.
