## Arboricultural Appraisal Report

### Subsidence Damage Investigation at:

180 Camden Road  
London  
NW1 9HG

CLIENT:	Crawford & Company
CLIENT REF:	[REDACTED]
MWA REF:	[REDACTED]
MWA CONSULTANT:	Steve Swinburne
REPORT DATE:	12/03/2020

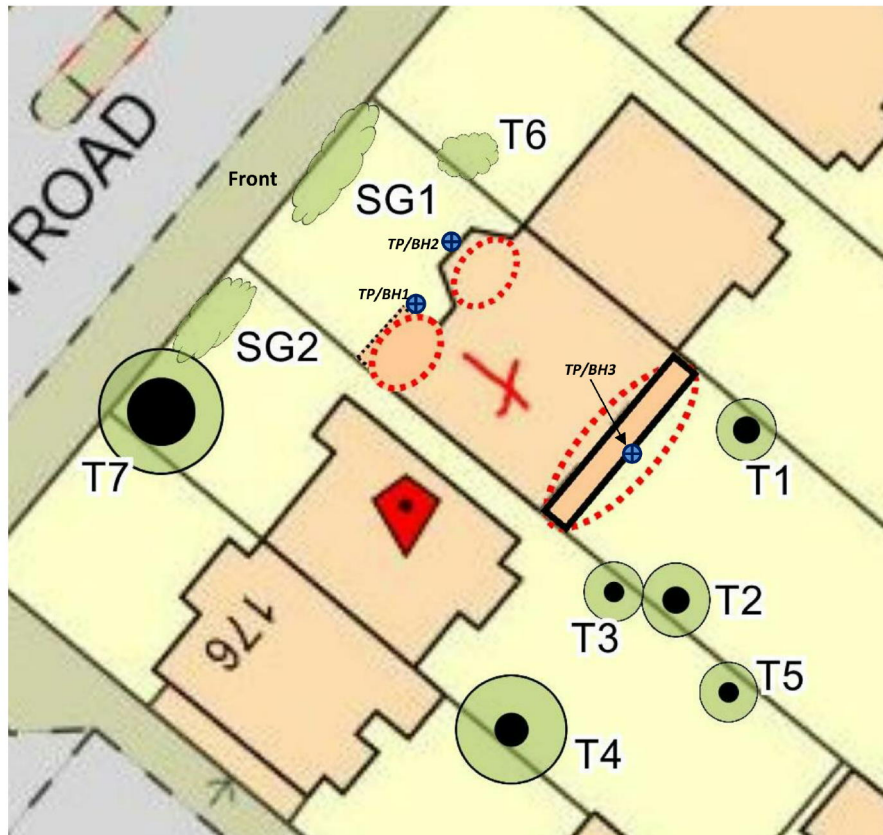
Site Plan

Approximate areas of damage

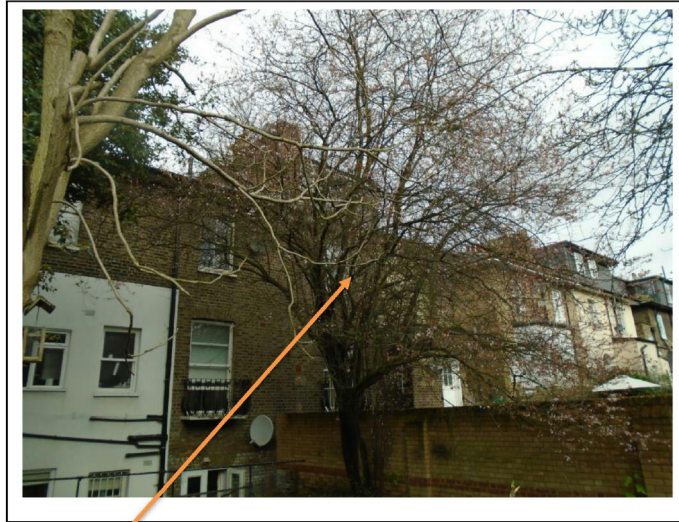
View of T1

Tree No.	Species	Ht (m)	Dia (mm)	Crown Spread (m)	Dist. to building (m)	Age Classification	Ownership
T1	Prunus	9.5	300 *	9	3.5	Younger than Property	Policy Holder
Management history		No recent management noted. Tree located approximately 2m above ground level of basement flat.					
Recommendation		Remove (fell) to near ground level and treat stump to inhibit regrowth.					
T2	Tree of Heaven	12	240	8	7	Younger than Property	Policy Holder
Management history		No recent management noted. Tree located approximately 2m above ground level of basement flat.					
Recommendation		Remove (fell) to near ground level. Owner to physically remove any regrowth (no chemical treatment due to translocation risk).					
T3	Holly	9.5	Ms	7	6	Younger than Property	Third Party 178 Camden Road NW1 9HG
Management history		No recent management noted. Tree located approximately 2m above ground level of basement flat.					
Recommendation		Remove (fell) to near ground level and treat stump to inhibit regrowth.

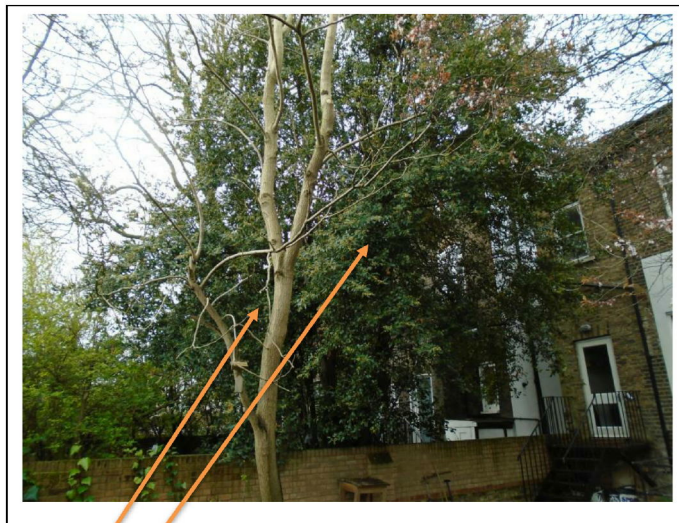
View of T2 & T3

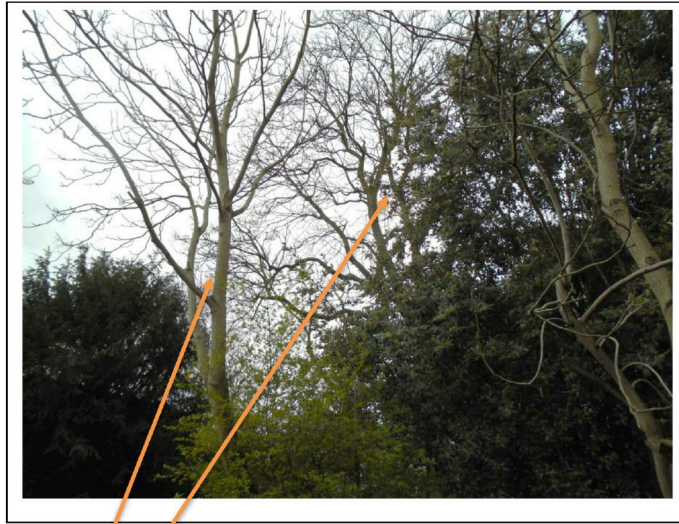
View of T5 and T4

T4	Tree of Heaven	14 *	550 *	14 *	12 *	Younger than Property	Third Party 178 Camden Road NW1 9HG
Management history		No recent management noted. Tree located approximately 2m above ground level of basement flat. Unable to access the location to confirm species of tree.					
Recommendation		Reduce height by 2m and crown radius by 1m leaving balanced crown. Prune on a triennial cycle to maintain at broadly reduced dimensions.					
T6	Holly	6	Ms	5 *	5	Younger than Property	Third Party 182 Camden Road NW1 9HG
Management history		No recent management noted.					
Recommendation		Reduce height by 2m and crown radius by 1m leaving balanced crown. Prune on a biennial cycle to maintain at broadly reduced dimensions.					
T7	Tree of Heaven	17 *	650 *	13 *	12 *	Younger than Property	Third Party 178 Camden Road NW1 9HG
Management history		Subject to past management/pruning.					
Recommendation		Remove (fell) to near ground level and grind out stump to inhibit regrowth.

Tree No.	Species	Ht (m)	Dia (mm)	Crown Spread (m)	Dist. to building (m)	Age Classification	Ownership
T5	Tree of Heaven	9 *	250 *	7 *	11 *	Younger than Property	Third Party 178 Camden Road NW1 9HG
Management history		No recent management noted.					
Recommendation		Maintain broadly at no more than current dimensions by periodic pruning.					
SG1	Mixed species shrubs including Pyracantha & Laurel	4 *	Ms	3	6	Younger than Property	Policy Holder
Management history		No recent management noted.					
Recommendation		Maintain broadly at no more than current dimensions by periodic pruning.					
SG2	Laurel	3 *	Ms	3 *	9 *	Younger than Property	Third Party 178 Camden Road NW1 9HG
Management history		Subject to past management/pruning.					
Recommendation		Maintain broadly at no more than current dimensions by periodic pruning.

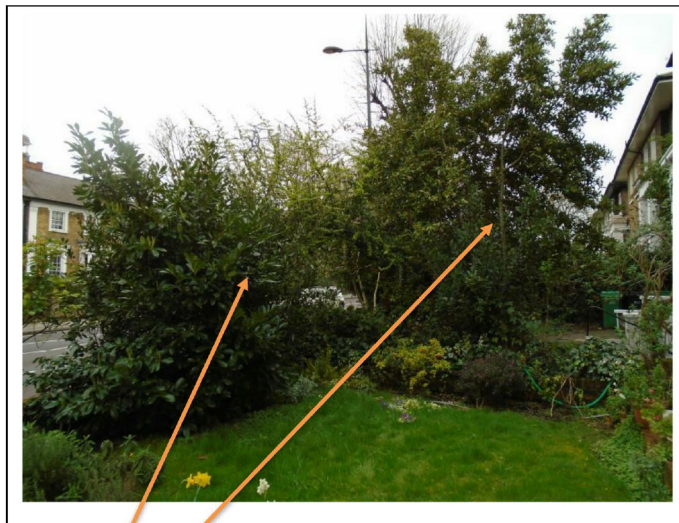
View of SG1 and T6

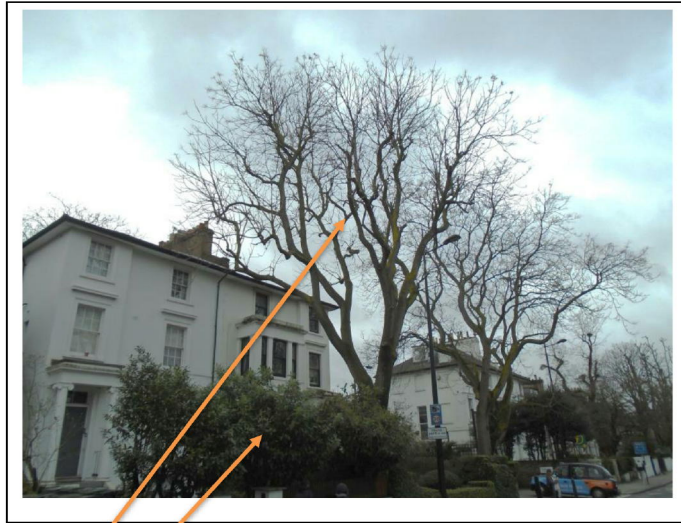
View of T7 and SG2
