Site Investigation Report

Job Information	
Client	Crawford & Co
Client ref	
Visit date	02/01/2020
Report date	06/01/2020

Auger were commissioned by Crawford & Co to undertake a site investigation and CCTV inspection of the underground drainage within the area of concern at the property.

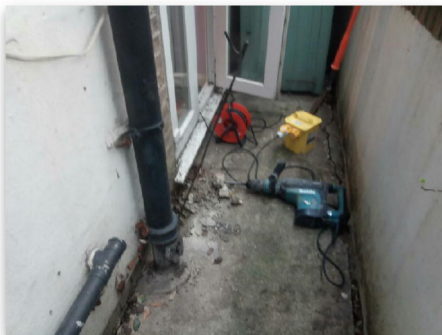
Fig 3.1: Trial Hole 3 Location

We were unable to collect root samples from TH3 because no roots were located within the trial hole.

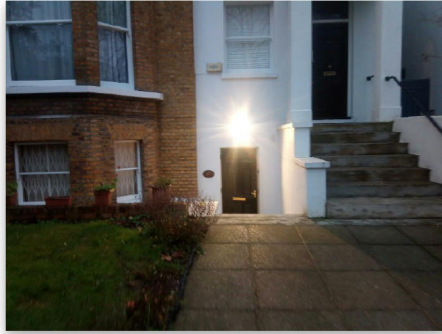
It should also be noted that there was a manhole located beneath the front set of stairs. This was over 2m deep and was a very tight manhole, due to this we could not survey any drainage lines entering it. If the LA wishes for this to be surveyed then 2 men will be required to attend site with confined space entry equipment which will come at a considerable cost. We believe that the drainage at the customers property is all accounted for and runs to the rear manhole.

Fig 7.1: Steps which MH is located beneath

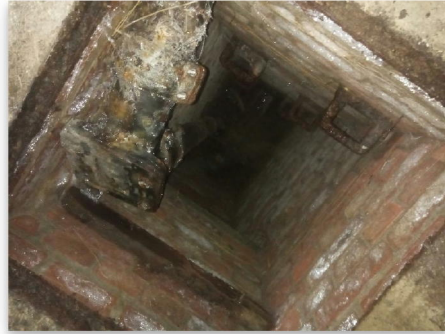
Fig 7.2: Deep MH

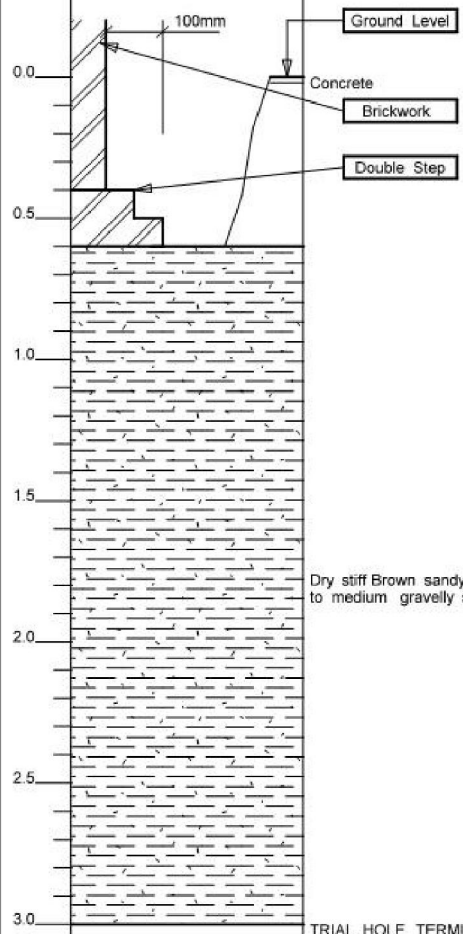
Trial Hole Log No.2

Ground Level Concrete Brickwork Double Step Dry stiff Brown sandy fine to medium gravelly silty CLAY TRIAL HOLE TERMINATED				
0.5			41kpa		Soil @ 0.6m	
1.0			56kpa		Soil @ 1.1m	Root @ 1.1m
1.5			60kpa		Soil @ 1.6m	
2.0			61kpa		Soil @ 2.1m	
2.5			64kpa		Soil @ 2.6m	
3.0			71kpa

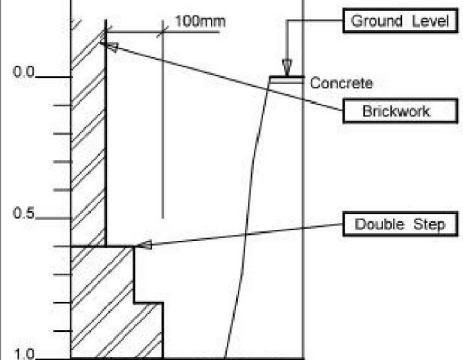
Trial Hole Log No.3

Ground Level				
		Concrete				
		Brickwork				
0.5		Double Step				
1.0			31kpa		Soil @ 1m	
1.5			49kpa		Soil @ 1.5m	
2.0		Dry firm Brown sandy fine medium gravelly silty CLAY	61kpa		Soil @ 2m	
2.5			69kpa		Soil @ 2.5m	
3.0		TRIAL HOLE TERMINATED	70kpa
