Resistograph micro-drill decay mapping test report

Site address: 28 St. Edmunds Terrace, London NW8 7QH

2.1. Tree number: T1

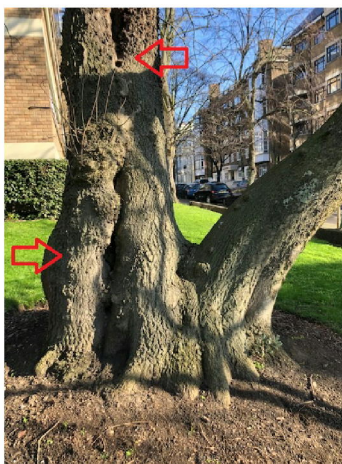
Photograph #1: Lower red arrow shows approximate height of drill points 1-4. Upper arrow shows height of drill point 5

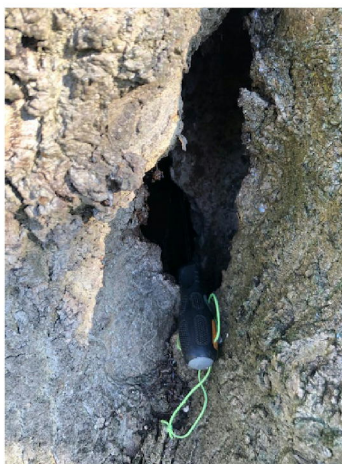
Photograph #2: Shows lower stem cavity opening which extends into significant hollowing of the lower trunk. My 40cm long probe failed to reach sound wood when inserted to maximum depth from the cavity opening

2.3.1. All drilling points indicate a significant column of heart rot within the stem centre. Taking the stem diameter of 900mm for drill points (DP) 1-4, the ratio between sound and decayed wood across the stem at these points are: Drill point (DP) 1: t/R ratio of 0.22, DP2: 0.51, DP3 0.51, DP4: 0.20, DP5: 0.42 (*Mattheck & Breloer: The body language of trees 1994*). The ratio results of the remaining residual wall exceeds the recommended safety factor ratio of 0.3 for two of the drillings and is within the safety factor for the remaining three drilling points, when using the Mattheck model for tree failure analysis.

3.1. The results demonstrate that whilst extensive, historic hollowing and decay is present within the heartwood/ centre of the trunk – the remaining residual wall thickness is on the borderline of what is regarded as acceptable in relation to a tree with a full crown canopy.

3.2. Given the above considerations, I recommend that the tree should not be retained at its current size - with a full crown canopy. However, the tree is located in a prominent location and provides a good level of visual amenity. Therefore, I believe it could potentially be retained, with some remedial pruning, to bring the tree to within a greater level of an acceptable safety factor, if the crown is reduced in size. A crown reduction will significantly reduce the 'wind sail' of the tree and henceforth improve its stability and capacity to resist strong winds or other extreme weather events. The tree is of reasonable physiological health and should have the vitality required to recover from a crown reduction, albeit a rather heavy one to be recommended.

3.3. I recommend a height reduction of up to 3m and a radial reduction of the lateral branches of up to 2m in length. Pruning cuts should be made at suitable secondary growth points and kept to a small a diameter as is possible.

3.4. I recommend that the tree should be re-inspected within 2 years of the date of this inspection.
