Ark Stained Glass & Leaded Lights Limited

Condition Report on Christ Apostolic Church (Formerly St John the Baptist) Kentish Town South Nave Windows

5th May 2020

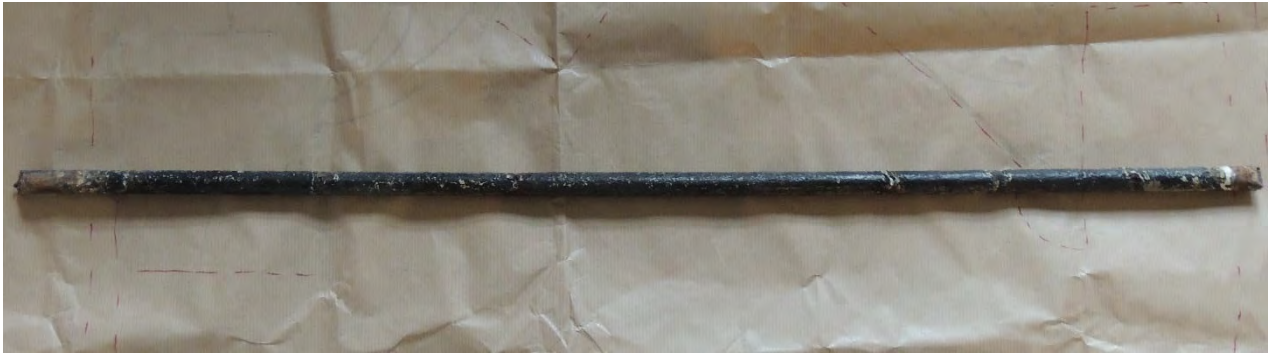
The ferrous saddle-bars are rusted but not laminated. The bars are perhaps wrought iron, as suggested by the grain effect on some of the cut edges.

Example of saddle-bar

The existing 5/8 inch round saddle-bars can either be replaced with non-ferrous bars, powder-coated stainless steel or bronze, or the originals re-tipped with stainless steel ends and then decorated with two-part paint system.

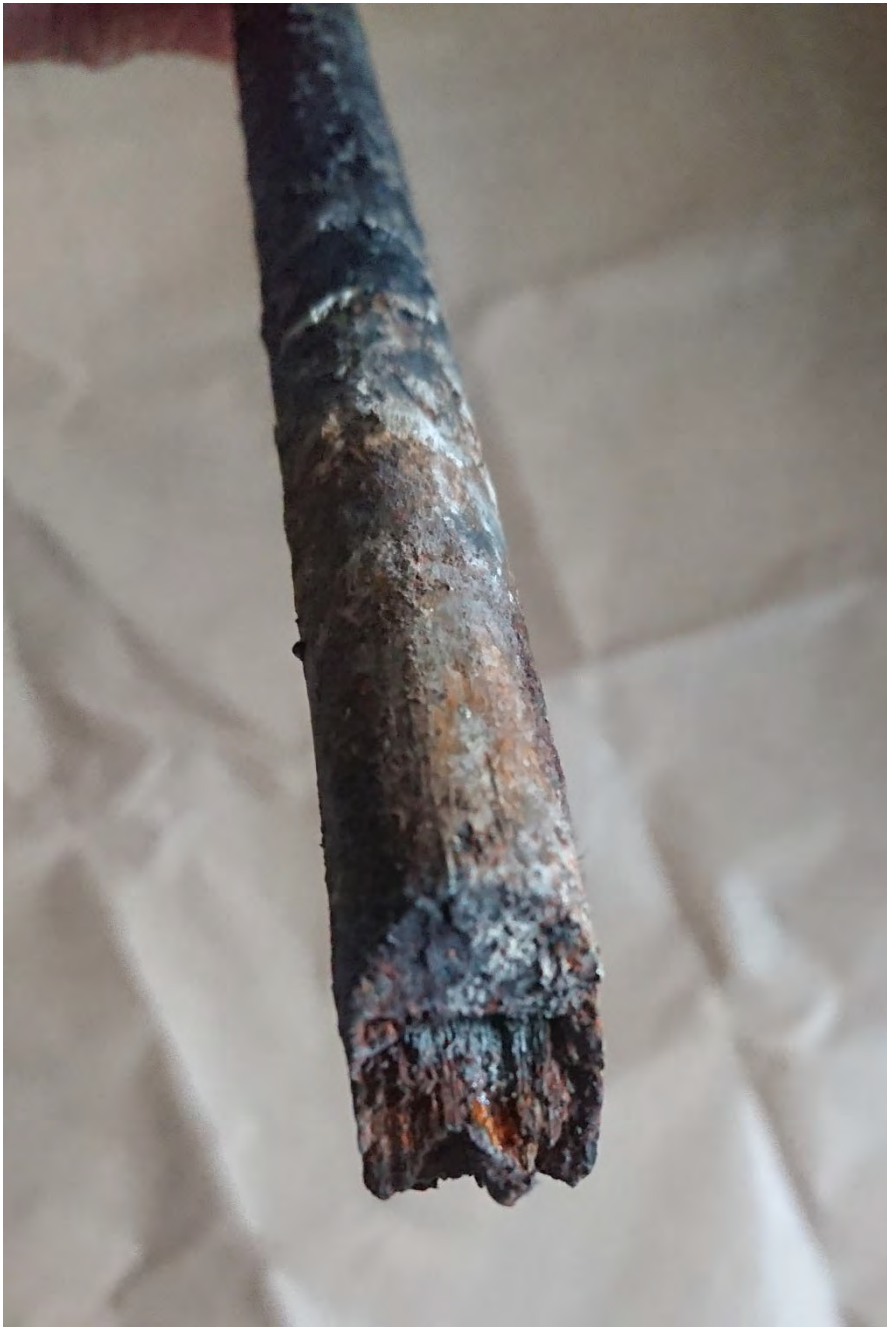
Grain-like appearance of cut end suggests the bars are wrought iron

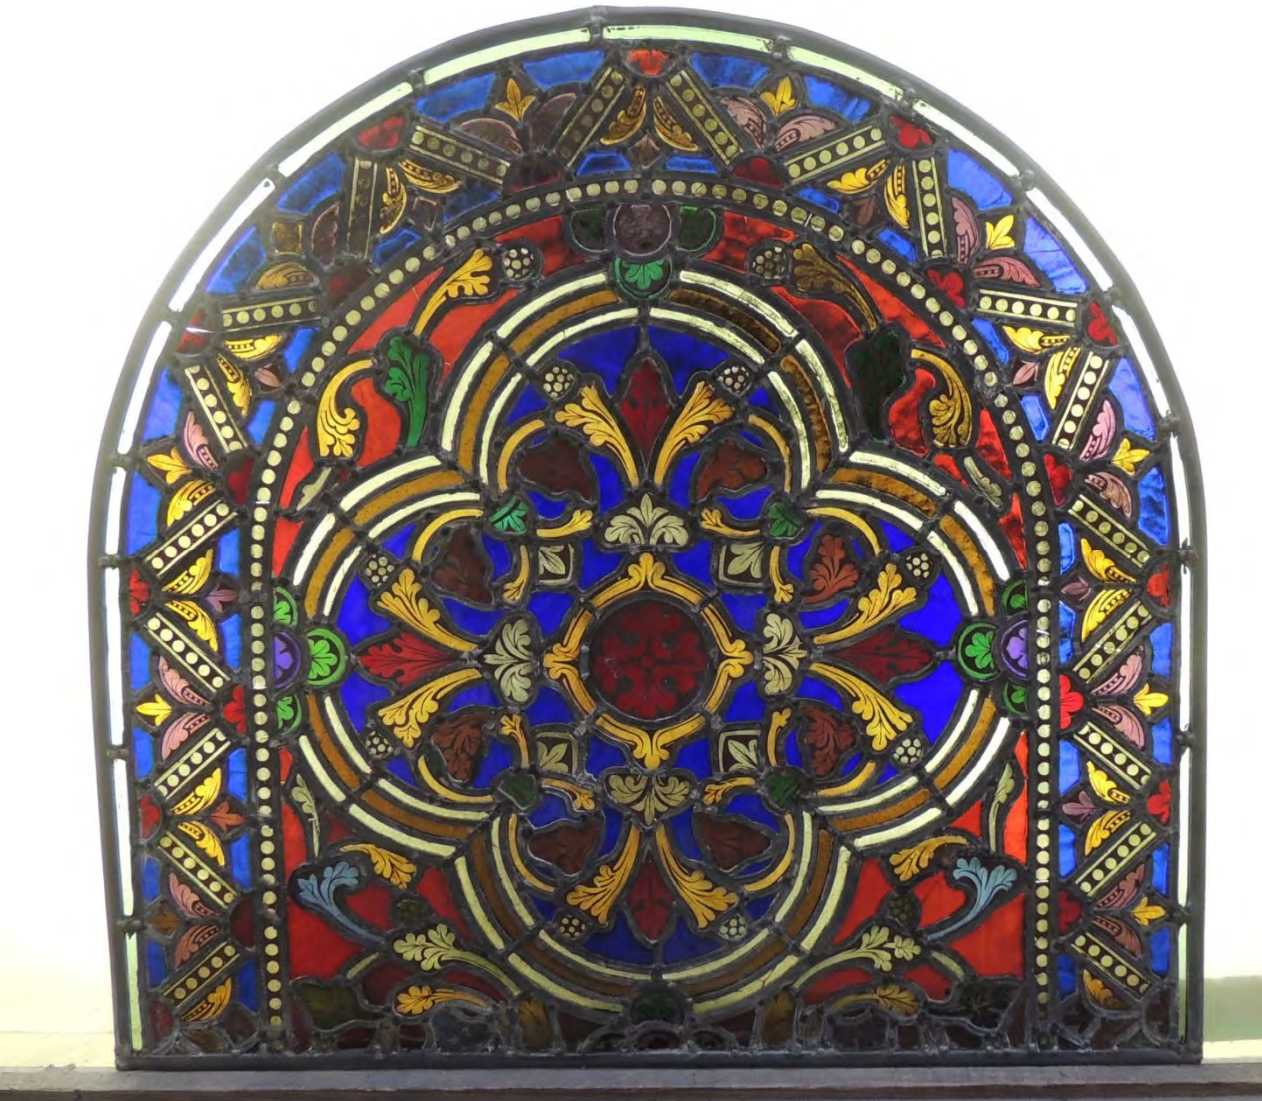
SN2 Head Light-Box

- The head panel is complete in fair condition, there are a number of breaks.
- Break shown with red line
- There is some bowing to the leadwork, around on the edge of the roundel.
- Bowed areas outlined in blue.

- Degree of releading required: the panel is generally sound condition and as the panel is not load bearing, we would not suggest that the panel is releaded. The panel should be given new perimeter leads.
- On areas where there is some bowing, unsolder the joints, gently flatten the panels and resolder joints.
- Cracked quarries of glass will be repaired. Methodology see appendix *Treatment of Cracks and Breaks*. We would recommend the order of preference would to copper-foil single breaks and only edge-bond were the piece has multiple breaks. We would take this approach as the edge-bonded items require back-plated, thereby increasing the weight of the panel.
- Clean glass

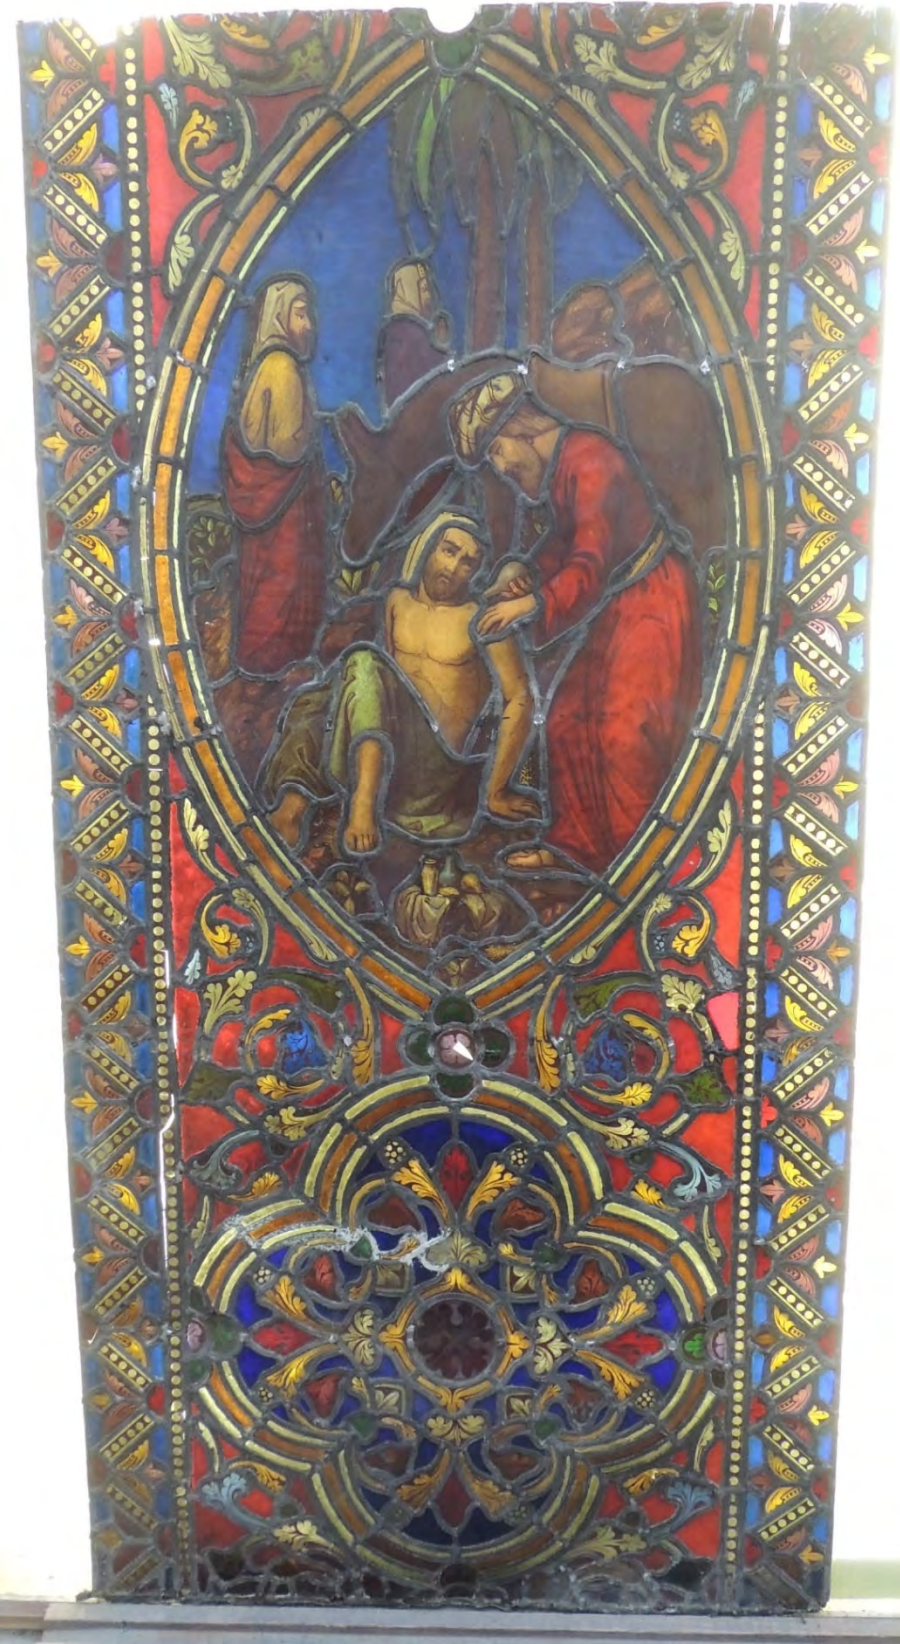
SN2 Middle Panel Light-Box

- The middle panel is complete.
- There are a number of breaks and missing pieces of glass. Missing border glass.
- Breaks shown with red line; missing areas with red hatching.
- The main structural leadwork of the panels is very weak, while the areas within the roundels and blocks of decorative leadwork are in better condition.
- Bowed areas outlined in blue.
- The decorative border has split away from the central section.
- Lines of detachment shown in green.

- Some degree of releading is required: from partial dismantling and releading to a full relead.
- The extent of releading to be discussed below. Though the sketch shows the minimum amount.
- Cracked quarries of glass will be repaired. Methodology see appendix *Treatment of Cracks and Breaks*. We would recommend the order of preference to be; copper-foiling single breaks and only edge-bonding where the piece has multiple breaks. We would take this approach, as the edge-bonded items require back-plating, thereby increasing the weight of the panel.
- Clean glass.

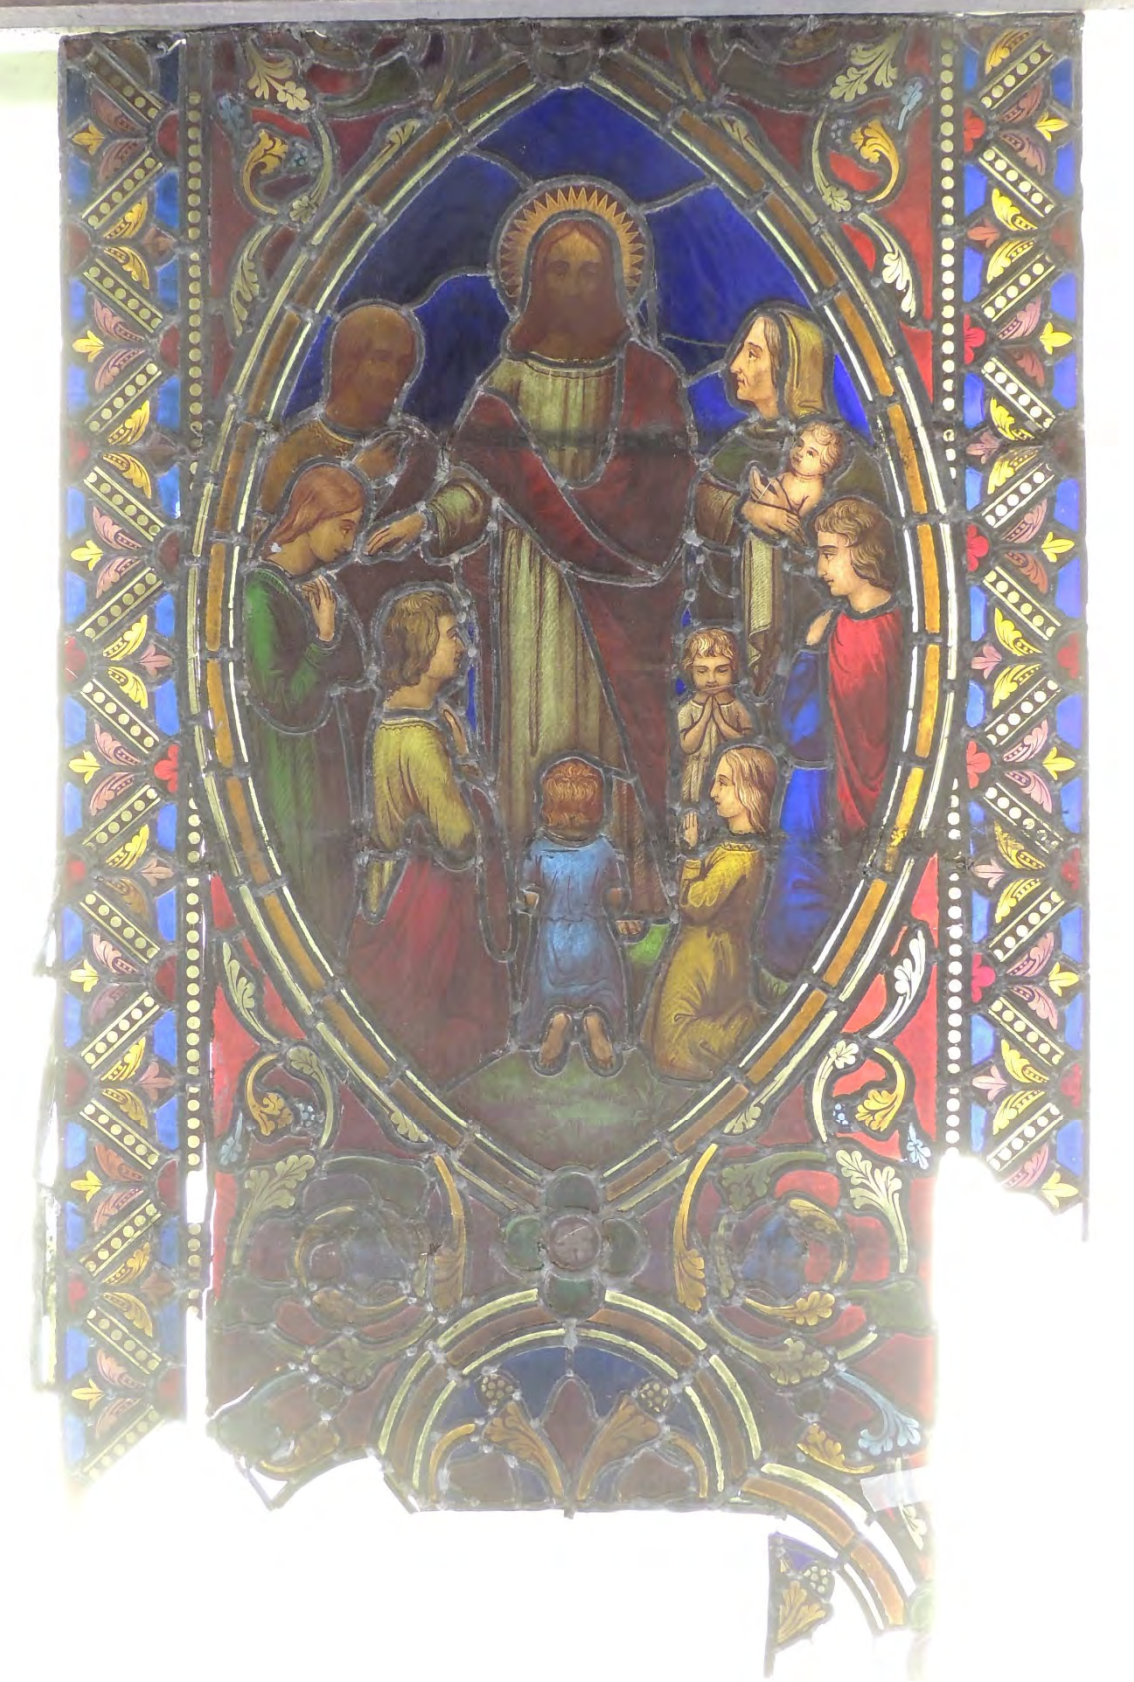
SN2 Base Panel Light-Box

- Large missing area of glass and lead. Missing border pieces.
- The main structural leadwork of the panels is very weak, areas outline in blue, while the areas within the roundels and blocks of decorative leadwork are in better condition.
- The decorative border has split away from the central section. Shown with green line.
- Broken pieces of glass. Breaks shown with red line

- Some degree of releading is required: from partial dismantling and releading to a full relead.
- The extent of releading to be discussed below. Though the sketch shows the minimum amount.

- Replace missing areas. The design, glass and lead came size will be match the surrounding areas. The existing lead lines indicate that in the section of missing lead there would have been a shield; this would correspond with the other Wailes' windows in the north and south aisle. Unless there is evidence of the design of the shield, a matted tinted piece of glass will be used.

- Other new glass will match existing glass and be painted to match.
- New painted glass will be dated.
- Any releded pieces to be leaded using comes to match the size and profile of the original lead.

- Cracked quarries of glass will be repaired. Methodology see appendix *Treatment of Cracks and Breaks*. We would recommend the order of preference to be; copper-foiling single breaks and only edge-bonding where the piece has multiple breaks. We would take this approach as the edge-bonded items require back-plating, thereby increasing the weight of the panel.

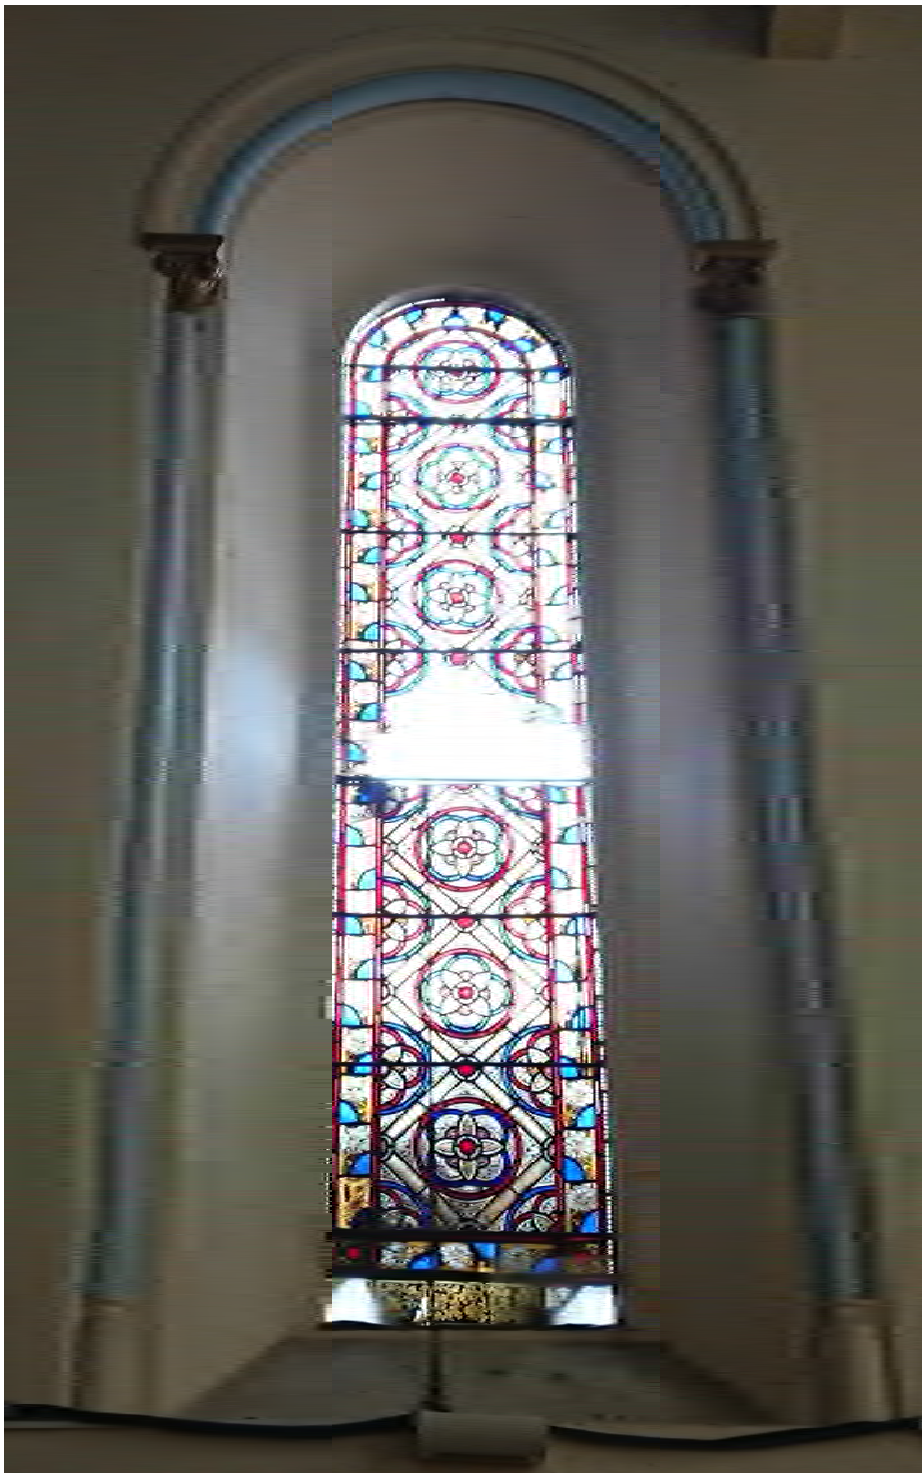
SN3

There are missing areas of glass.

There is evident bowing of the panels.

The windows have a build-up of dirt and smears of wall paint.

There are a number of cracked pieces throughout the window.

The newer pointing is a cement mix and the removal of the old pointing was carried-out quite crudely. Large areas of the original stonework were removed; in areas the rebate is 20mm wide. The cement pointing has been tooled over the day-light border of the window. The effect of a large area of cement pointing looks to have been to deteriorate the surrounding stonework.

The ferrous saddle-bars are rusted but not laminated. The bars are perhaps wrought iron, as suggested by the grain effect on some of the cut edges.

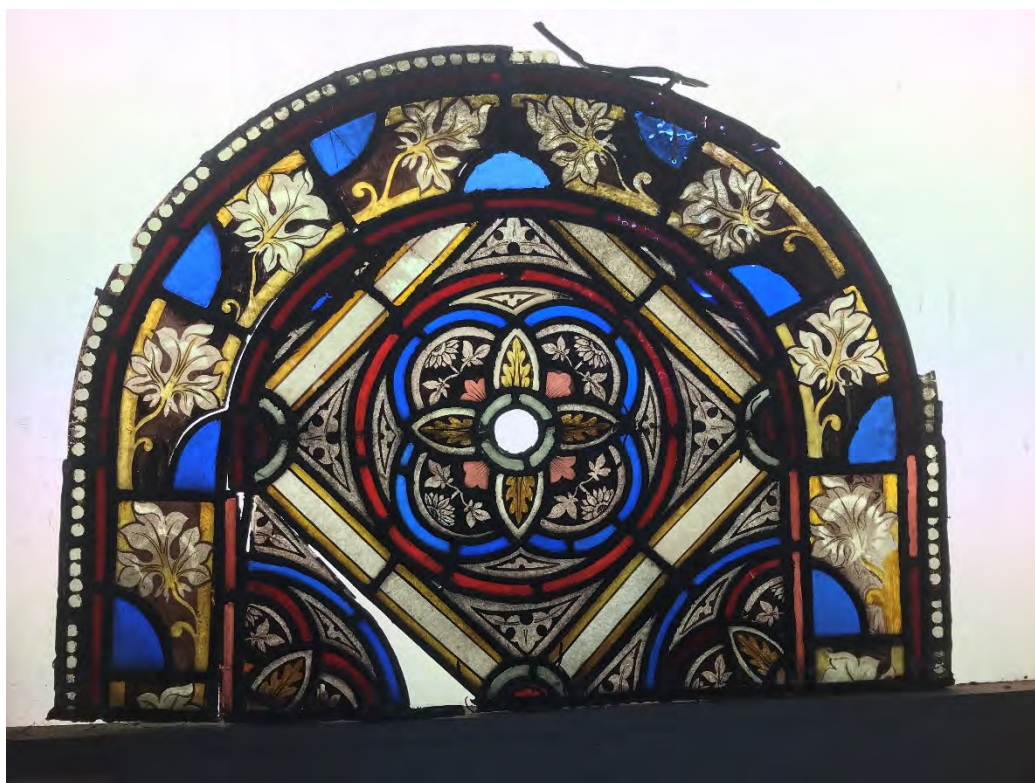
SN3 Head Light-box

- Central area fair condition.
- The borders are in weak condition
- Missing areas of pieces of glass, including border pieces. Shown with red hatching.
- Broken pieces of glass. Breaks shown with red line
- There has been a mistake in the setting-out or the painting of the head panel. The border sections alternating pattern is lost. The paintwork is internal, so the mistake was not at the leading-up stage. The mistake looks to have happened in either the setting-out or the painting stage.

- Dismantle borders and relead in the existing set-out; leaving the historical mistake.
- The extent of releading to be discussed below. Though the sketch shows the minimum amount.
- Replace missing quarries and old bad repairs with new glass with glass and painting to match. New painted glass will be dated.
- Any releaded areas to be leaded using comes to match the size and profile of the original lead.
- Any new glass will match existing glass and be painted to match.
- New painted glass will be dated.
- Cracked quarries of glass will be repaired as appendix *Treatment of Cracks and Breaks*. We would recommend the order of preference to be; copper-foiling single breaks and only edge-bonding where the piece has multiple breaks.

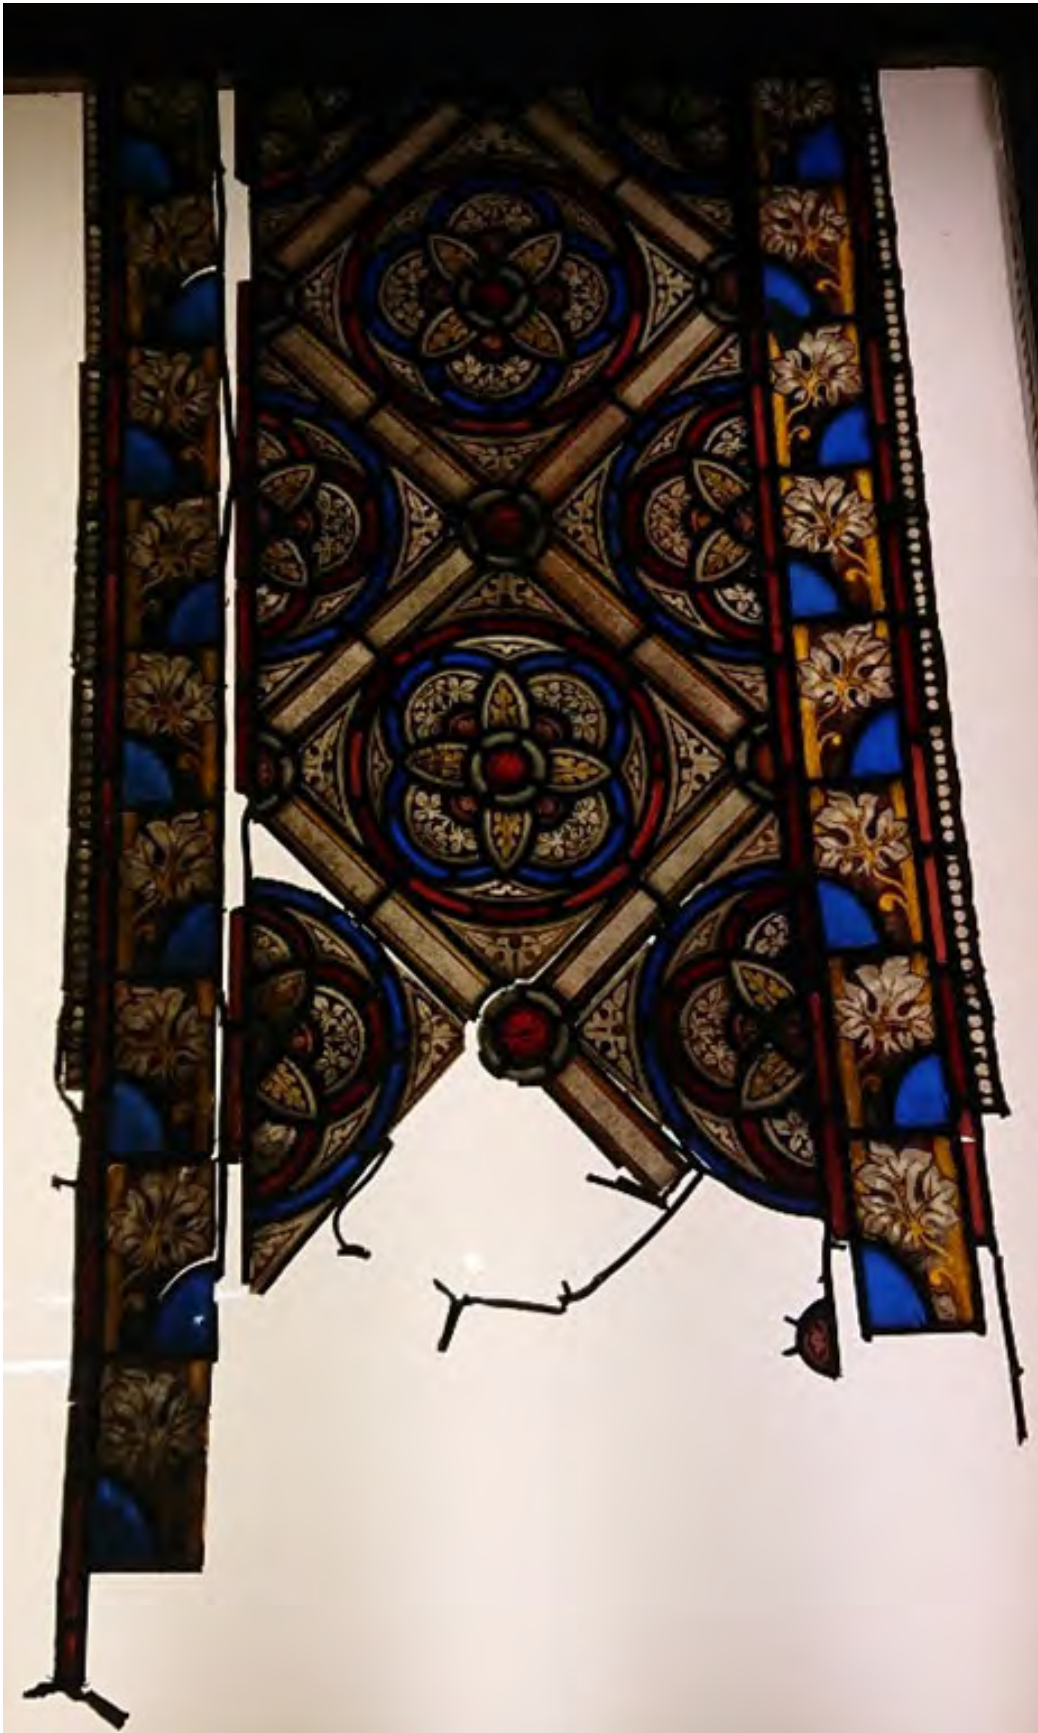
SN3 Middle Light-box

- There is a large areas of missing glass and lead.
- The borders are in weak condition.
- There are a number of breaks and missing pieces of glass. Breaks shown with red line; missing areas with red hatching.
- The decorative border has split away from the central section.
- Lines of detachment shown in green.

- Dismantle borders and relead.
- The extent of releading to be discussed below. Though the sketch shows the minimum amount.
- Remake missing area. The design, glass and lead came size will match the surrounding areas. The windows overall design is constant, so the replacement of the missing area with a continuation of the overall design is not contentious. New glass will match existing glass and be painted to match. New painted glass will be dated.

- Any relead pieces to be leaded using comes to match the size and profile of the original lead.
- Cracked quarries of glass will be repaired. Methodology see appendix *Treatment of Cracks and Breaks*. We would recommend the order of preference to be; copper-foiling single breaks and only edge-bonding where the piece has multiple breaks. We would take this approach as the edge-bonded items require back-planting, thereby increasing the weight of the panel.

- Clean glass

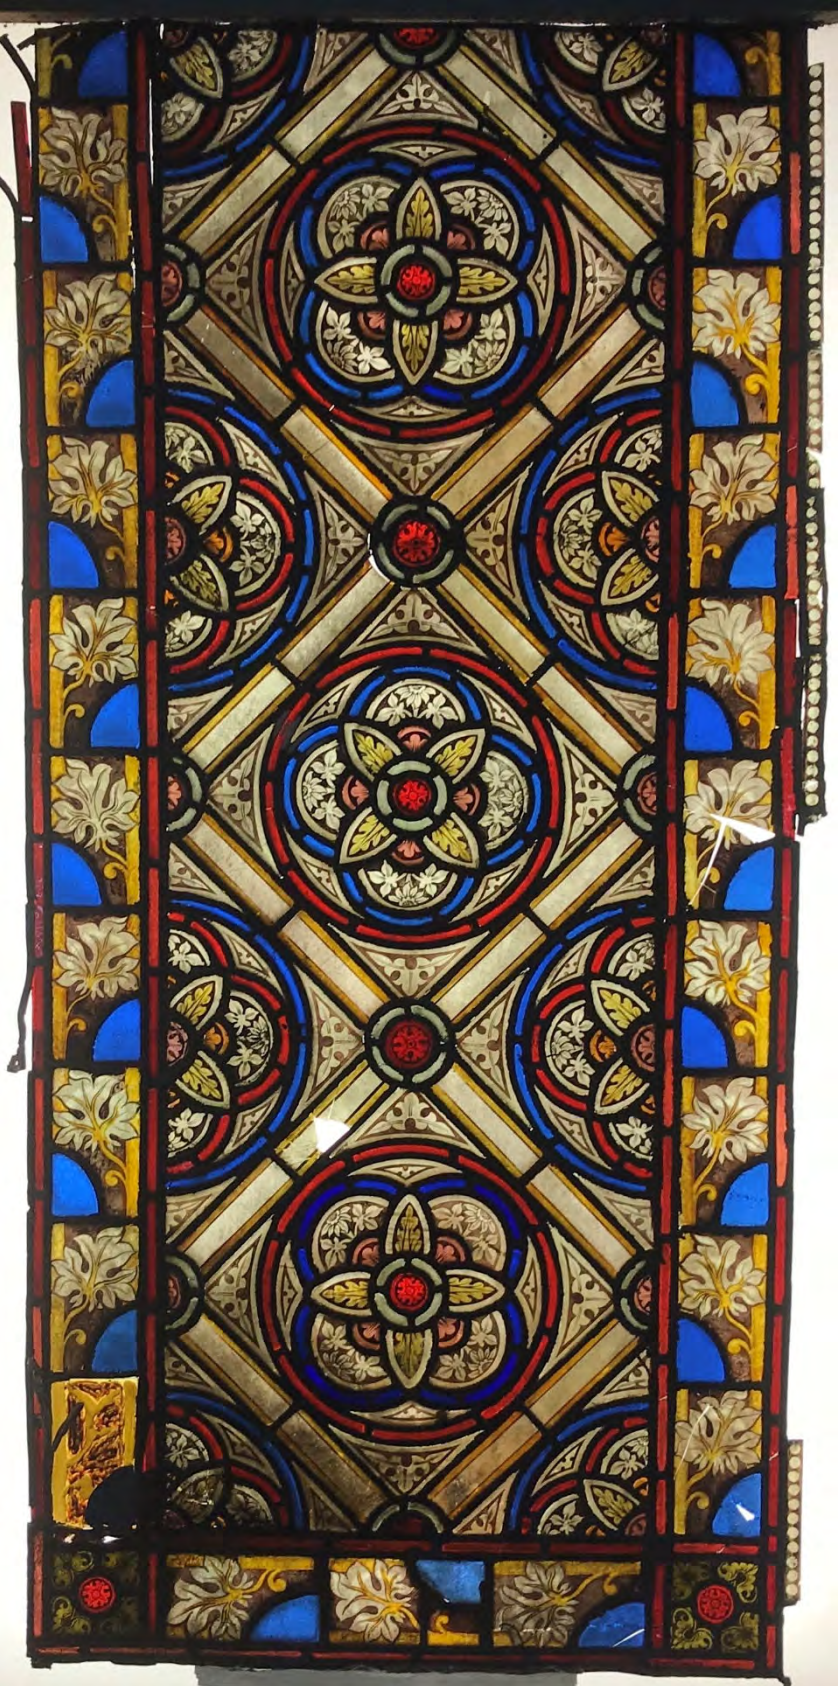
SN3 Base Light-box

- Medallions in fair condition.
- The borders and main structure comes are in weak condition.
- Section of base border missing.
- There are a number of breaks and missing pieces of glass.
- There are some badly matching repairs; crudely cold-painted.
- Breaks shown with red line; missing areas with red hatching.
- The leadwork of the borders of the panels is very weak, while the areas within the roundels and blocks of decorative leadwork are in better condition.
- Bowed areas outlined in blue.
- The decorative border has split away from the central section.
- Lines of detachment shown in green.
- Smears of paint.

- Dismantle borders and main structure and relead.
- The extent of releading to be discussed below. Though the sketch shows the minimum amount.
- Replace missing quarries and bad old repairs with new glass with glass and painting to match. New painted glass will be dated.
- Any releaded areas to be leaded using comes to match the size and profile of the original lead.
- Cracked quarries of glass will be repaired. Methodology see appendix *Treatment of Cracks and Breaks*. We would recommend the order of preference to be; copper-foiling single breaks and only edge-bonding where the piece has multiple breaks. We would take this approach as the edge-bonded items require back-plating, thereby increasing the weight of the panel.
- Mismatching repairs replaced with new glass to match.
- Clean glass

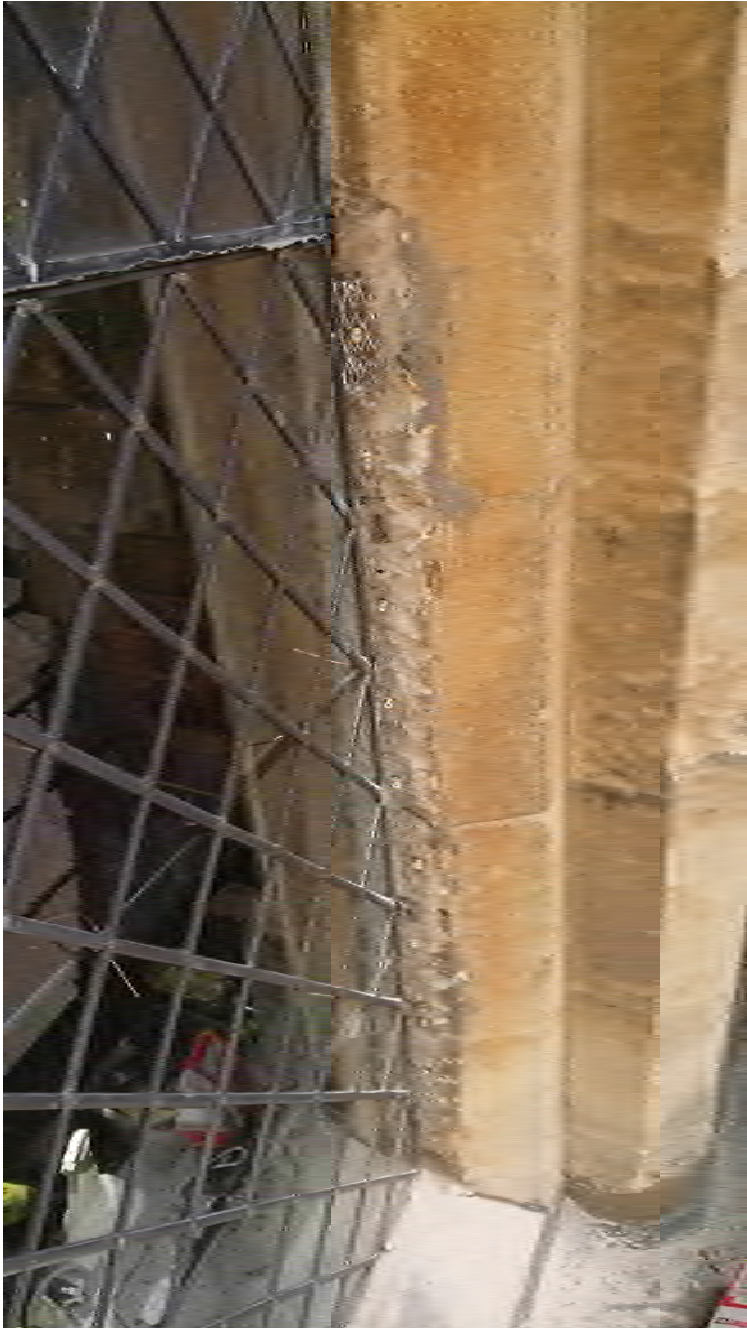
Area of pointing previously been made-up of cement mix, packed out with s-s mesh and coarse pointing mix, before being over pointed with a stone dust mix.

- The windows will be shuffled into the rebates, the saddle-bars (perhaps T-bars in places) fitted and the panels blocked into position.
- A first mix of sharp sand, stone dust and 3.5nhl pointing mix. Second, top mix of stone dust and nhl3.5
- Any larger areas of missing stonework will be packed out with stainless steel mesh fitted into the stone work with stainless steel fittings, and pointed over.
