[REDACTED]
18th February 2019

48-52 St Albans Road London NW5 1RH
Defect Diagnosis – Cracking

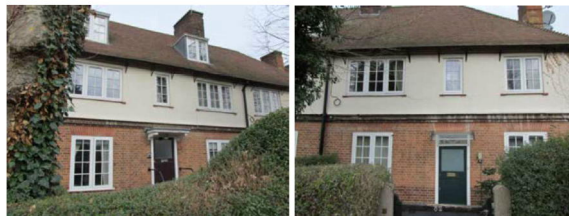
Externally, cracking is present to the front elevation to nos. 50 and 52, although little in the way of cracking is present to no. 48.

It can be clearly seen when viewing the front elevation that the section of front wall to nos. 50 and 52 has dropped vertically downwards, with the bottom of the curve corresponding with the party wall between the two properties. The heads to the ground floor windows either side of the party wall are noticeably declined towards one another, and the pattern of cracking to the front elevation also indicates that the front external wall has dropped at a point corresponding to the party wall between nos. 50 and 52.

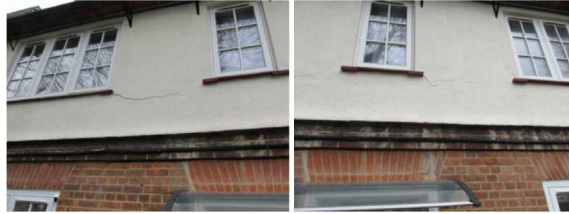
Cracking is present to a number of window and door openings and are most prevalent to the exterior front wall of no 52.

Whilst much of the cracking to the brickwork appears to follow the mortar courses and perpend joints to the brickwork, it can be seen that a proportion of the damage has resulted in bricks being split.

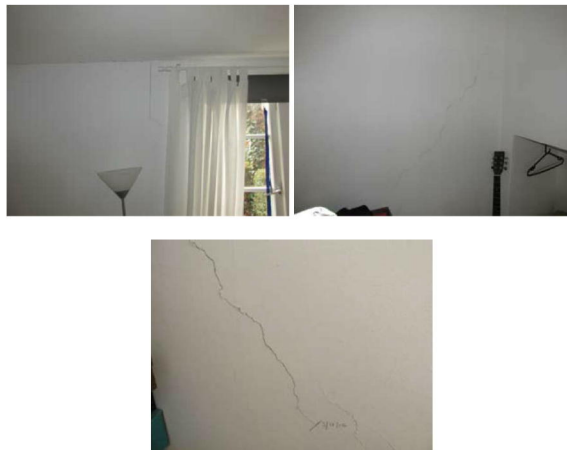
Internally, a degree of cracking is present to no. 48; this is most prevalent in the bedroom to the front right-hand side; the cracking appears on the front wall close to the window opening and extends around the perimeter of the room to the wall / ceiling junctions. Cracking then extends down the rear right-hand side corner and down the rear wall at a diagonal. The cracking to the rear wall extends through the wall and appears within the hallway behind.

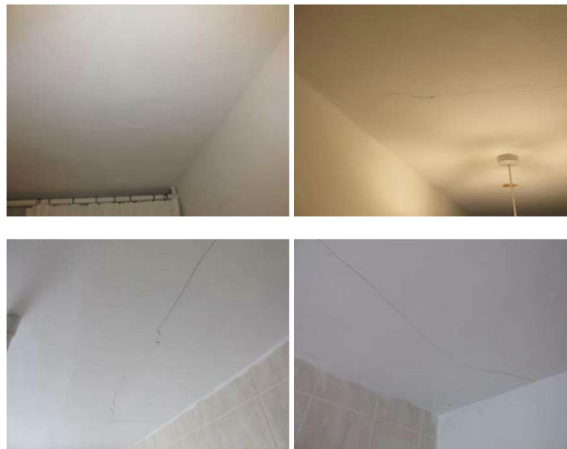
Further cracking is present within the hallway corridor, extending longitudinally along the ceiling and into the bathroom.

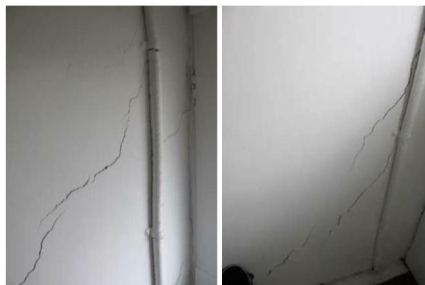
Cracking was present to the right-hand side wall of the entrance hall, immediately to the right of the entrance door, extending diagonally downwards from the front elevation.

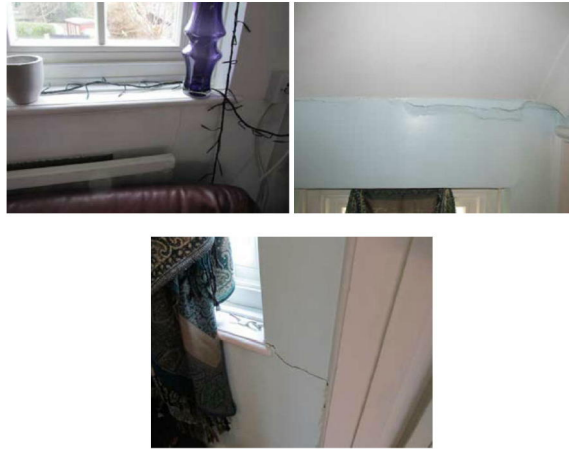
To the first floor, cracking is present to the sitting room front wall below the window and is also present to the stairway to the second floor, with cracking to the wall / ceiling junction and adjacent the window cill of the front wall.

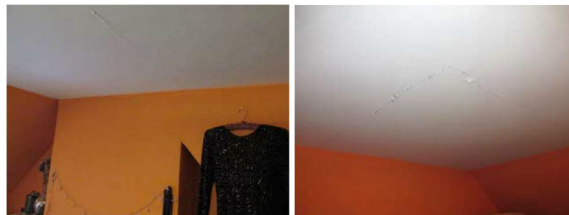
To the second floor, cracking is present to the left-hand side bedroom, manifesting at the wall / ceiling junctions and following the joints to the plasterboard of the ceiling.

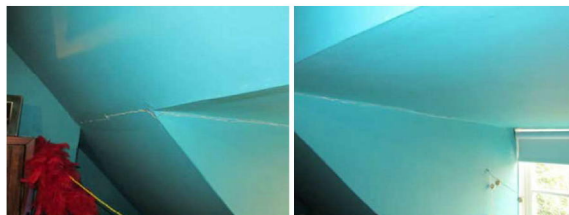
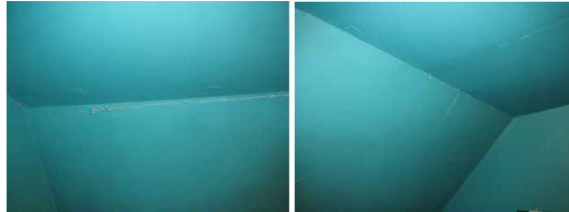
To the right-hand side bedroom, significant cracking is present to the junctions of the sloping and horizontal sections of ceiling as well as around the dormer window, with generalised cracking to the wall / ceiling junctions throughout.

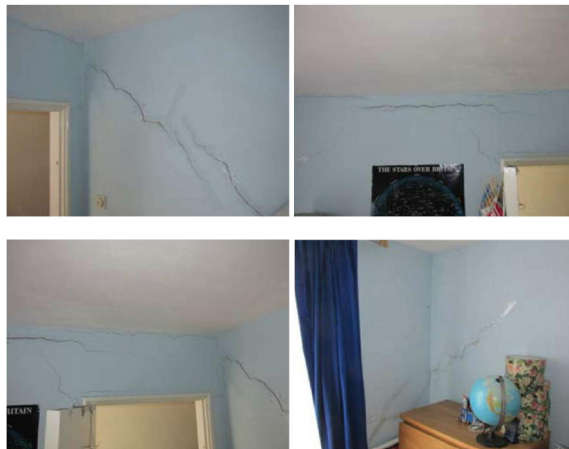
Substantial cracking was present to all rooms to the front of the property and within the hallway. To the front right-hand side room, substantial cracking is present to the rear, left hand side and front walls, with the cracks passing through the full thickness of each wall.

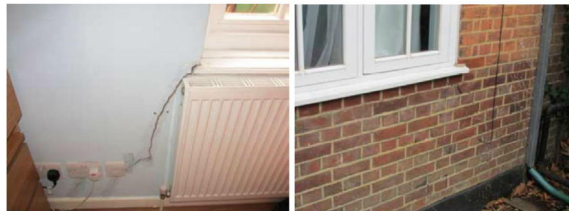
The cracking to the front wall below the right-hand side corner of the window opening is some 8mm wide at its widest and is clearly visible on the exterior face of the wall.

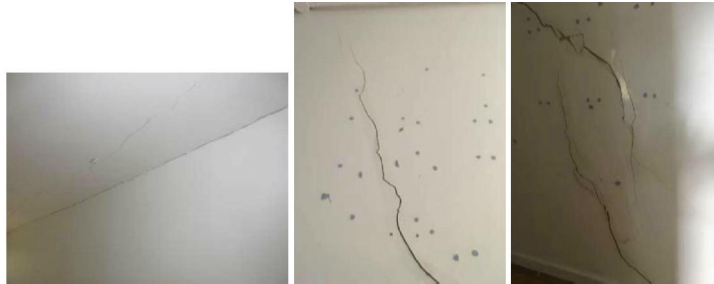
Further cracking is present within the flat within both the longitudinal and lateral sections of the hallway corridor, with cracking to both the front and rear walls of the lateral section.

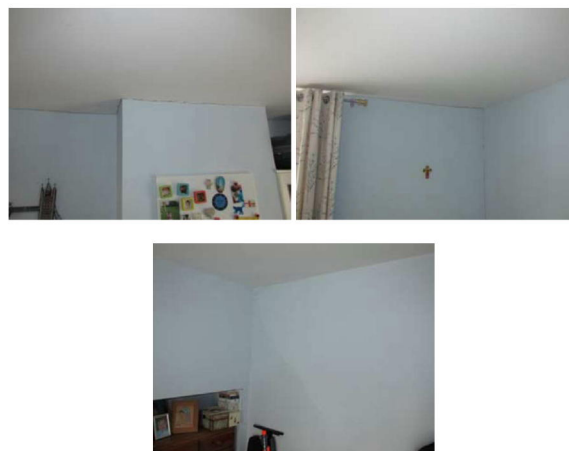
Cracking is also present within the front left-hand side room, largely manifesting at the wall / ceiling junctions, although cracking is also present to the rear wall at the rear left-hand side corner.
