Appendix C – Asbestos Survey

REFURBISHMENT SURVEY FOR ASBESTOS-CONTAINING MATERIALS

CLIENT: 1923 Mortimer Investments Ltd

SITE: 40-50 Tottenham Street, London, W1T 4RN

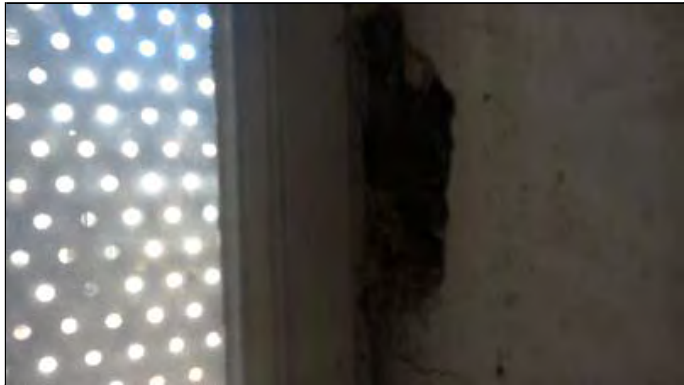
Assessment no.	001	Accessibility			
Material Risk					
Identification	Identified	Condition			
Extent		Asbestos Type	No Asbestos Detected		
Location/ position	Ropes lining between windows and walls.				
Surface treatment					
Product type	n/a				
Material risk		Material risk score			
Action	No further action required

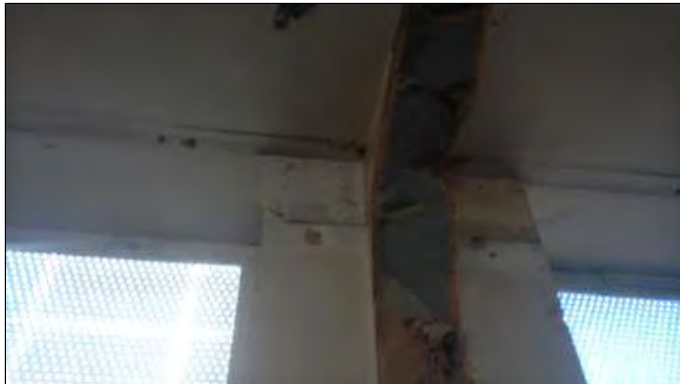
Assessment no.	002	Accessibility			
Material Risk					
Identification	Identified	Condition			
Extent		Asbestos Type	No Asbestos Detected		
Location/ position	Insulating board wall (high level)				
Surface treatment					
Product type	n/a				
Material risk		Material risk score			
Action	No further action required

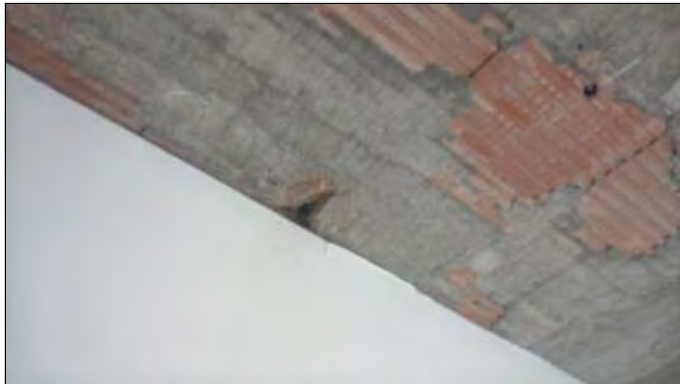
Assessment details				Comments	Photograph
Building	Block	Floor/ room	1st Floor / 1.1	Small piece found.

Assessment no.	003	Accessibility			
Material Risk					
Identification	Identified	Condition			
Extent		Asbestos Type	No Asbestos Detected		
Location/ position	Bitumen ceiling membrane				
Surface treatment					
Product type	n/a				
Material risk		Material risk score			
Action	No further action required

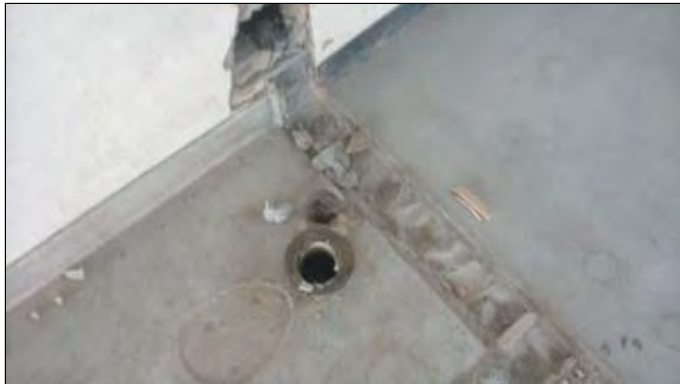
Assessment no.	004	Accessibility			
Material Risk					
Identification	Identified	Condition			
Extent		Asbestos Type	No Asbestos Detected		
Location/ position	Mastic pipe penetration to floor				
Surface treatment					
Product type	n/a				
Material risk		Material risk score			
Action	No further action required

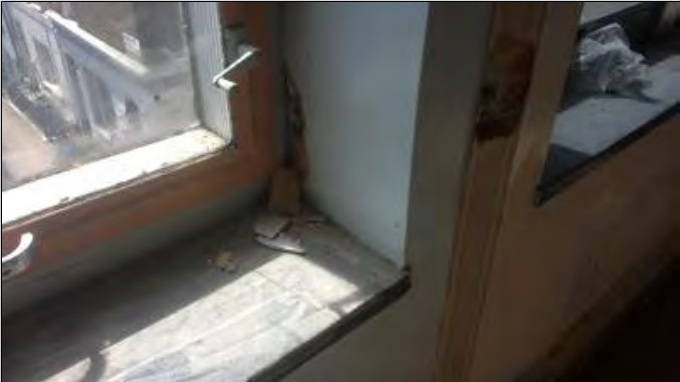
Assessment no.	005	Accessibility			
Material Risk					
Identification	Identified	Condition			
Extent		Asbestos Type	No Asbestos Detected		
Location/ position	Ropes windows to front elevation				
Surface treatment					
Product type	n/a				
Material risk		Material risk score			
Action	No further action required

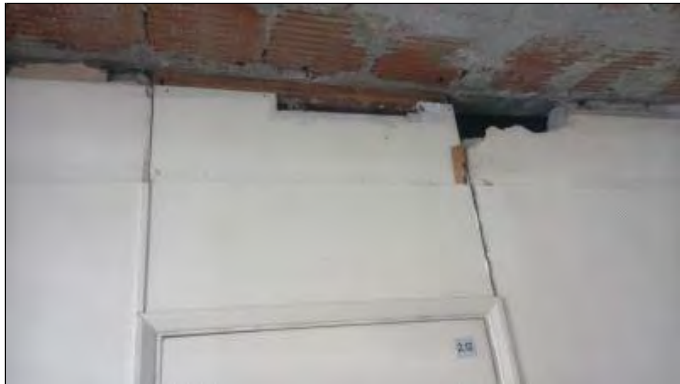
Assessment no.	006	Accessibility			
Material Risk					
Identification	Identified	Condition			
Extent		Asbestos Type	No Asbestos Detected		
Location/ position	Insulating board door header to riser				
Surface treatment					
Product type	n/a				
Material risk		Material risk score			
Action	No further action required

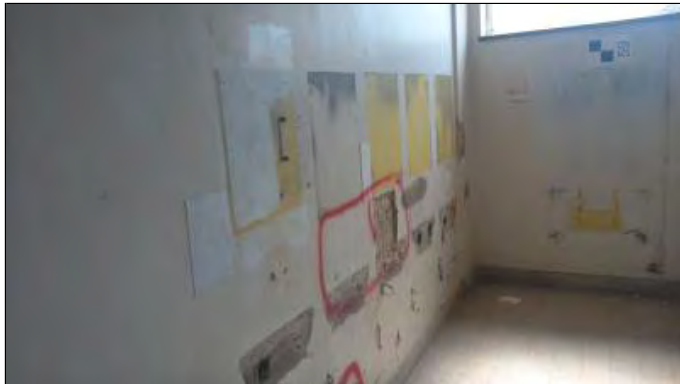
Assessment no.	008	Accessibility			
Material Risk					
Identification	Identified	Condition			
Extent		Asbestos Type	No Asbestos Detected		
Location/ position	Textured coating walls				
Surface treatment					
Product type	n/a				
Material risk		Material risk score			
Action	No further action required

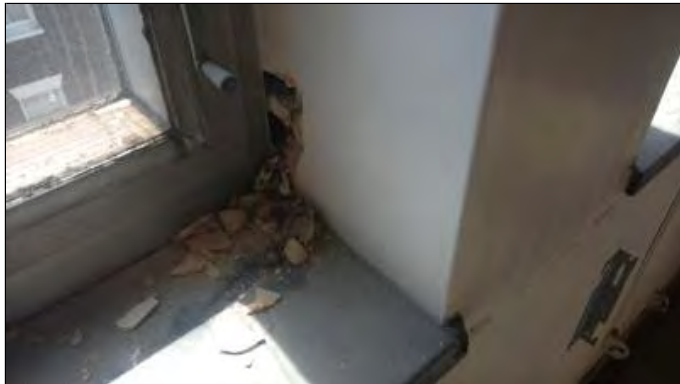
Assessment no.	009	Accessibility			
Material Risk					
Identification	Identified	Condition			
Extent		Asbestos Type	No Asbestos Detected		
Location/ position	Ropes lining between windows and walls.				
Surface treatment					
Product type	n/a				
Material risk		Material risk score			
Action	No further action required

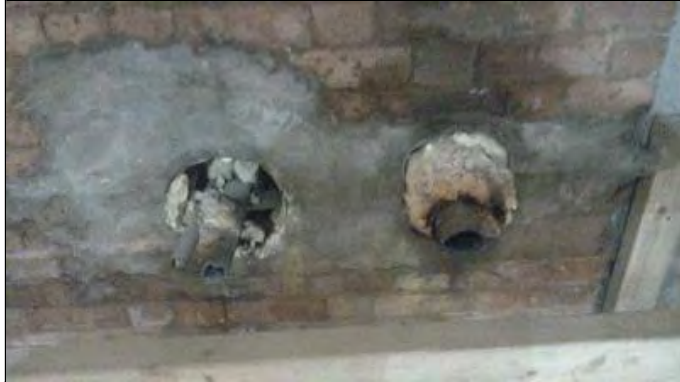
Assessment details				Comments	Photograph
Building	Block	Floor/ room	Basement 1 / B1	No access into wall penetration - pipe penetrations blocked with red asbestos bags and foam sealed

Assessment no.	012	Accessibility			
Material Risk					
Identification	Inaccessible (Presumed)	Condition	n/a		
Extent		Asbestos Type	n/a		
Location/ position	No access into wall penetration				
Surface treatment	n/a				
Product type	n/a				
Material risk		Material risk score			
Action	Inspect Prior to Disturbance

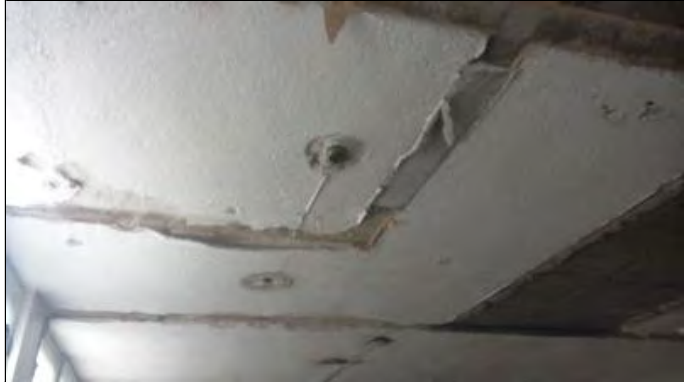
Assessment details				Comments	Photograph
Building	Block	Floor/ room	Basement 1 / B1	No access to condensation barrier - high level access required, approx 8-10m height

Assessment no.	013	Accessibility			
Material Risk					
Identification	Inaccessible (Presumed)	Condition	n/a		
Extent		Asbestos Type	n/a		
Location/ position	No access to condensation barrier				
Surface treatment	n/a				
Product type	n/a				
Material risk		Material risk score			
Action	Inspect Prior to Disturbance

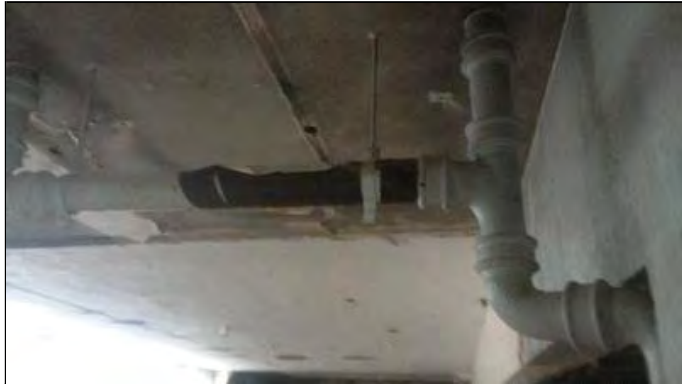
Assessment details				Comments	Photograph
Building	Block	Floor/ room	Basement 1 / B1	No access to bitumen hessian wrap to pipe - high level access required

Assessment no.	014	Accessibility			
Material Risk					
Identification	Inaccessible (Presumed)	Condition	n/a		
Extent		Asbestos Type	n/a		
Location/ position	No access to bitumen hessian wrap to pipe				
Surface treatment	n/a				
Product type	n/a				
Material risk		Material risk score			
Action	Inspect Prior to Disturbance

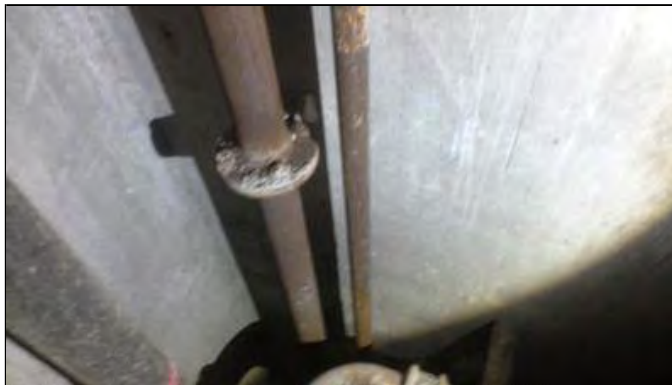
Assessment no.	015	Accessibility	Occasionally likely to be disturbed		
Material Risk					
Identification	Presumed	Condition	Good Condition		
Extent	2no.	Asbestos Type	Chrysotile		
Location/ position	Gasket Pipe to riser				
Surface treatment	Surface Sealed				
Product type	Gaskets				
Material risk	Very low	Material risk score	4		
Action	Remove

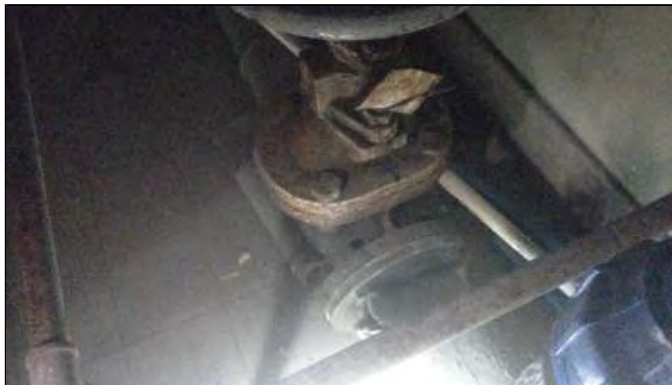
Building	Block	Floor/ room	Basement 1 / B2		
Assessment no.	016	Accessibility	Occasionally likely to be disturbed		
Material Risk					
Identification	Identified	Condition	Good Condition		
Extent	7no.	Asbestos Type	Chrysotile		
Location/ position	Gasket pipe				
Surface treatment	Surface Sealed				
Product type	Gaskets				
Material risk	Very low	Material risk score	4		
Action	Remove

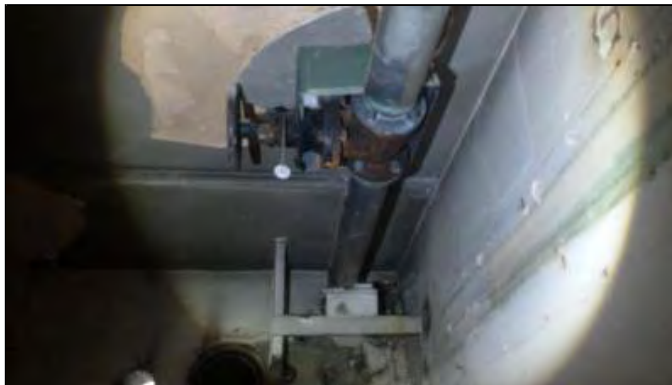
Building	Block	Floor/ room	Basement 1 / B1		
Assessment no.	017	Accessibility	Occasionally likely to be disturbed		
Material Risk					
Identification	Presumed	Condition	Good Condition		
Extent	<4no.	Asbestos Type	Chrysotile		
Location/ position	Gasket High level pipe				
Surface treatment	Surface Sealed				
Product type	Gaskets				
Material risk	Very low	Material risk score	4		
Action	Remove

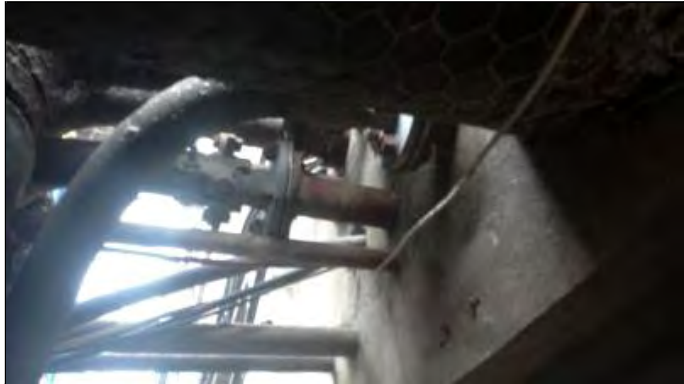
Assessment no.	019	Accessibility			
Material Risk					
Identification	Identified	Condition			
Extent		Asbestos Type	No Asbestos Detected		
Location/ position	Gaskets pipe flanges				
Surface treatment					
Product type	n/a				
Material risk		Material risk score			
Action	No further action required

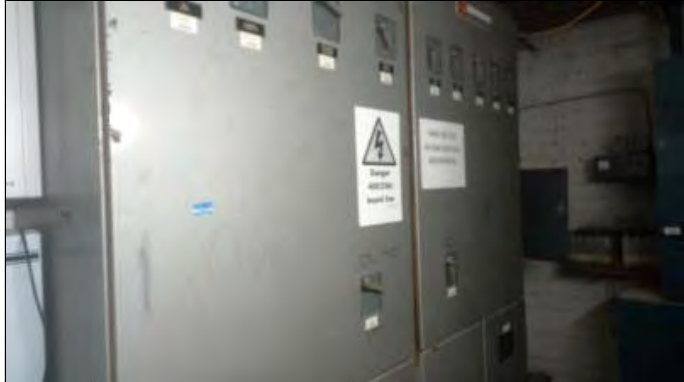
Assessment details				Comments	Photograph
Building	Block	Floor/ room	Basement 1 / B4	No access to electrics - live services

Assessment no.	020	Accessibility			
Material Risk					
Identification	Inaccessible (Presumed)	Condition	n/a		
Extent		Asbestos Type	n/a		
Location/ position	No access to electrics				
Surface treatment	n/a				
Product type	n/a				
Material risk		Material risk score			
Action	Inspect Prior to Disturbance

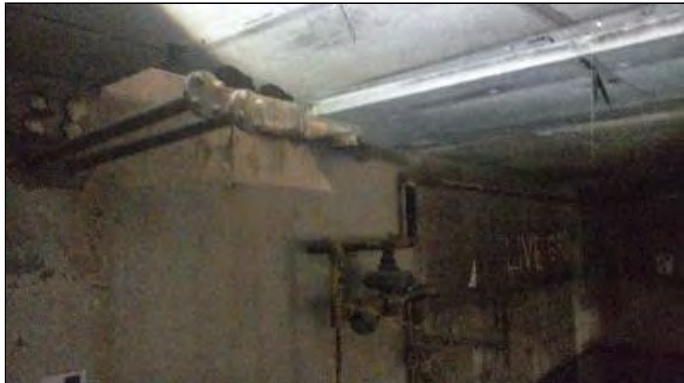
Assessment no.	021	Accessibility	Usually inaccessible or unlikely to be disturbed		
Material Risk					
Identification	Presumed	Condition	Good Condition		
Extent	<12no.	Asbestos Type	Chrysotile		
Location/ position	Gaskets Pipe flanges				
Surface treatment	Surface Sealed				
Product type	Gaskets				
Material risk	Very low	Material risk score	4		
Action	Remove

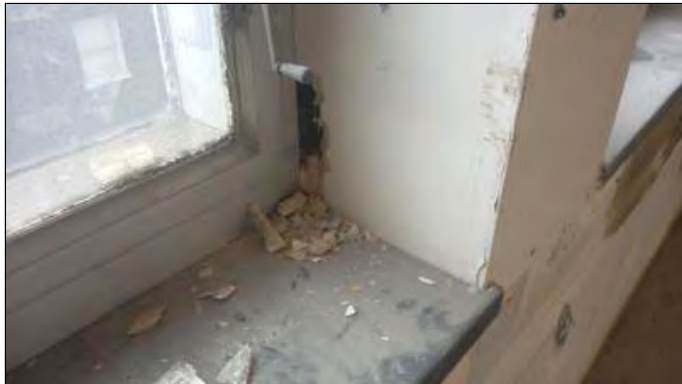
Assessment no.	022	Accessibility			
Material Risk					
Identification	Identified	Condition			
Extent		Asbestos Type	No Asbestos Detected		
Location/ position	Ropes lining between windows and walls.				
Surface treatment					
Product type	n/a				
Material risk		Material risk score			
Action	No further action required

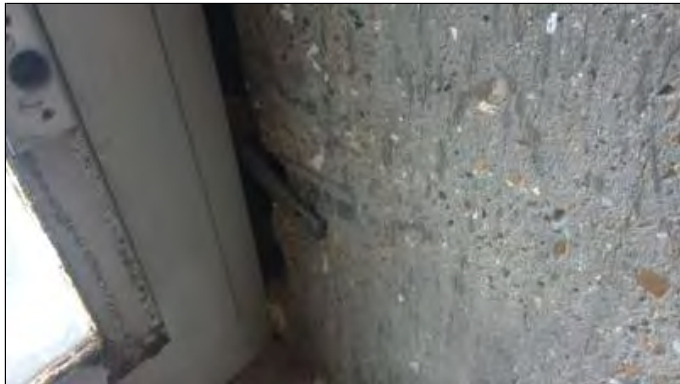
Assessment no.	023	Accessibility			
Material Risk					
Identification	Identified	Condition			
Extent		Asbestos Type	No Asbestos Detected		
Location/ position	Ropes lining between windows and walls.				
Surface treatment					
Product type	n/a				
Material risk		Material risk score			
Action	No further action required

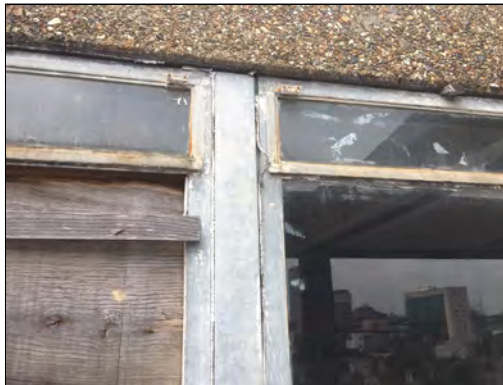
Assessment details				Comments	Photograph
Building	Block	Floor/ room	External / External	Only sampled from roof only as the only external windows accessible

Assessment no.	025	Accessibility	Occasionally likely to be disturbed		
Material Risk					
Identification	Identified	Condition	Good Condition		
Extent	<2000lm	Asbestos Type	Chrysotile		
Location/ position	Mastic windows				
Surface treatment	Completely Sealed				
Product type	Well Bound Material				
Material risk	Very low	Material risk score	2		
Action	Remove

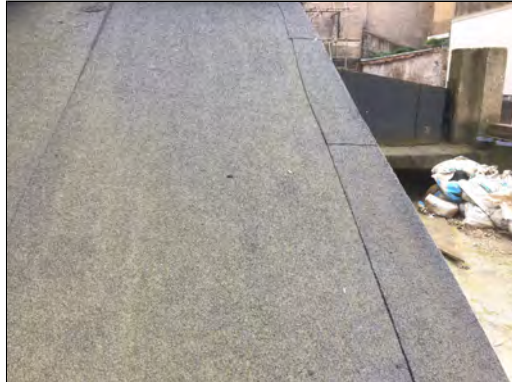
Assessment no.	026	Accessibility			
Material Risk					
Identification	Identified	Condition			
Extent		Asbestos Type	No Asbestos Detected		
Location/ position	Bitumen felt timber roof				
Surface treatment					
Product type	n/a				
Material risk		Material risk score			
Action	No further action required

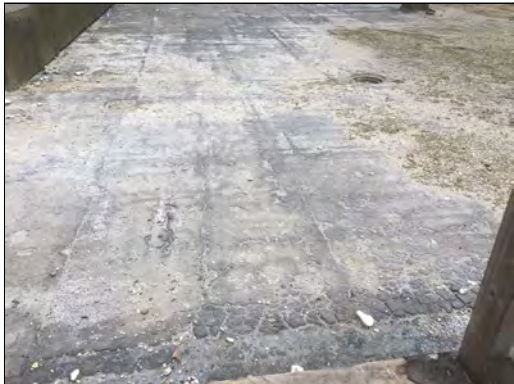
Assessment no.	027	Accessibility			
Material Risk					
Identification	Identified	Condition			
Extent		Asbestos Type	No Asbestos Detected		
Location/ position	Bitumen floor				
Surface treatment					
Product type	n/a				
Material risk		Material risk score			
Action	No further action required

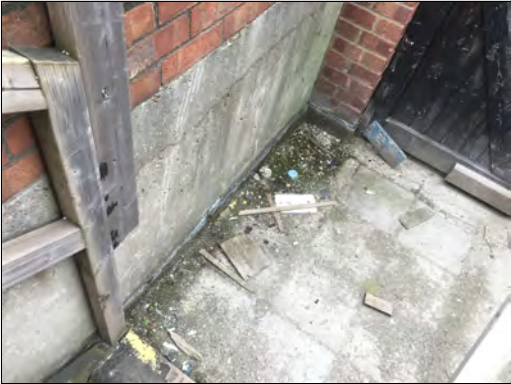
Building	Block	Floor/ room	External / External to rear of building		
Assessment no.	028	Accessibility	Occasionally likely to be disturbed		
Material Risk					
Identification	Identified	Condition	Good Condition		
Extent	<10lm	Asbestos Type	Chrysotile		
Location/ position	Bitumen membrane adjacent timber stairs				
Surface treatment	Completely Sealed				
Product type	Bitumen				
Material risk	Very low	Material risk score	2		
Action	Remove

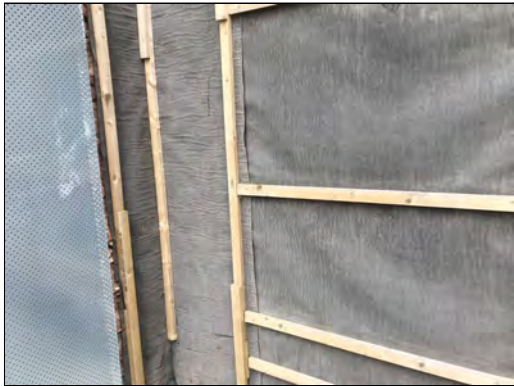
Building	Block	Floor/ room	External / External to rear of building		
Assessment no.	029	Accessibility			
Material Risk					
Identification	Identified	Condition			
Extent		Asbestos Type	No Asbestos Detected		
Location/ position	Bitumen felt lining membrane to adjacent building				
Surface treatment					
Product type	n/a				
Material risk		Material risk score			
Action	No further action required

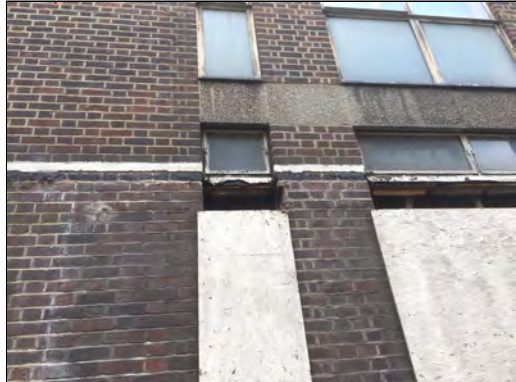
Assessment details				Comments	Photograph
Building	Block	Floor/ room	External / External	No access to panels to windows - high level access required

Assessment no.	030	Accessibility			
Material Risk					
Identification	Inaccessible (Presumed)	Condition	n/a		
Extent		Asbestos Type	n/a		
Location/ position	No access to panels to windows				
Surface treatment	n/a				
Product type	n/a				
Material risk		Material risk score			
Action	Inspect Prior to Disturbance

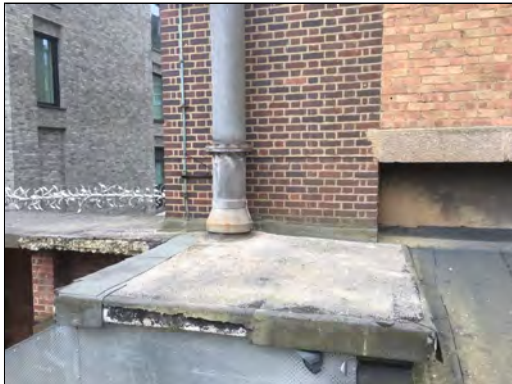
Building	Block	Floor/ room	External / External		
Assessment no.	031	Accessibility	Occasionally likely to be disturbed		
Material Risk					
Identification	Presumed	Condition	Good Condition		
Extent	<5no.	Asbestos Type	Chrysotile		
Location/ position	Gaskets Flue to external of building				
Surface treatment	Surface Sealed				
Product type	Gaskets				
Material risk	Very low	Material risk score	4		
Action	Remove
