Site Investigation Report

Job Information	
Client	
Client ref	
Visit date	17/02/2020
Report date	17/02/2020

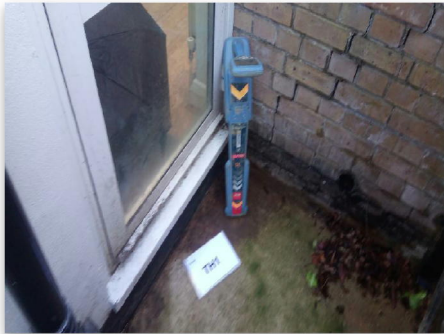
Other Photos	
Fig 7.1: Trial Hole 1 Location	Fig 7.2: Trial Hole 1 Bar Underneath Foundation

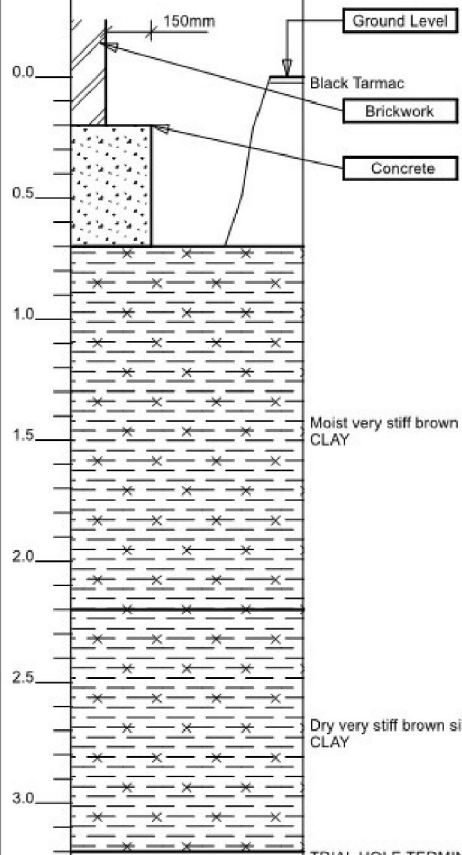
Trial Hole Log No.1

Location: Rear wall by door to conservatory

Ground Level				
		Black Tarmac				
		Brickwork				
		Concrete				
0.5						
1.0			84kpa		Soil @ 0.7m	Root @ 0.7m
1.5		Moist very stiff brown silty CLAY	106kpa		Soil @ 1.2m	
2.0			120kpa		Soil @ 1.7m	
2.5			120kpa		Soil @ 2.2m	
3.0		Dry very stiff brown silty CLAY	120kpa		Soil @ 2.7m	
3.5		TRIAL HOLE TERMINATED	120kpa
