## Simon Pryce Arboriculture

### Report

**Site:** 115 Frognal, Hampstead, London, NW3 6XR

**Subject:** Safety inspection of lime tree

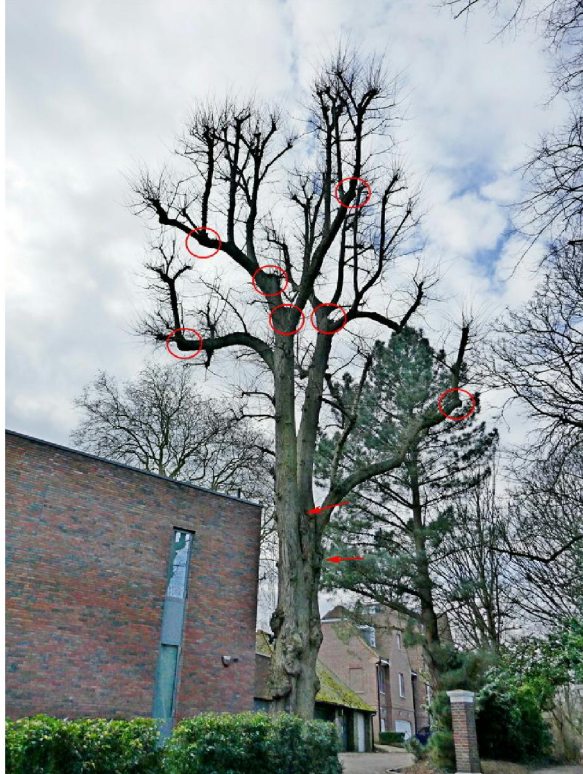
- 2.1 The tree is a mature lime growing in the garden of no.115 Frognal next to Oak Hill Way, which runs past the side. It is approximately 20m high and has a single vertical trunk about 1050mm in diameter just above the root buttresses. Photograph 1 shows the tree crown with the points described below indicated.

1) View of the tree. Circles in the crown indicate the major crown reduction cutting points. Upper arrow shows the large cavity between the main limbs and the lower one shows the location of the small hole in photo 2 below.

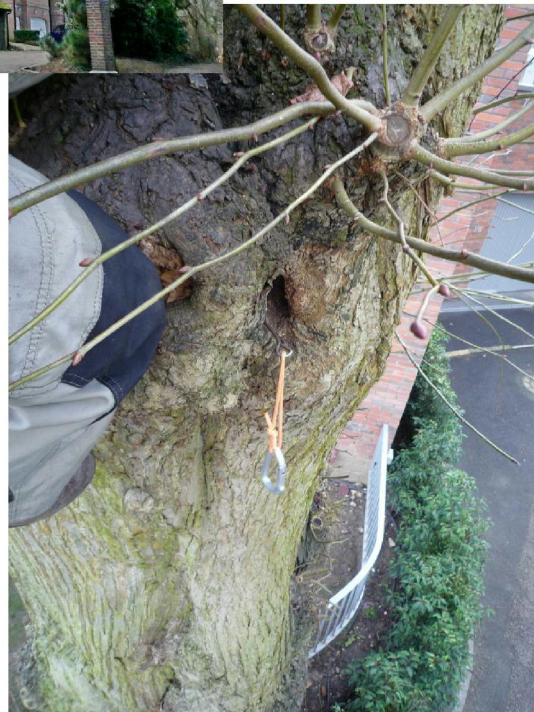
2) Hole in the trunk below the large cavity opening. The probe is 0.9m long and most of the way in, i.e. most of the way through the trunk.

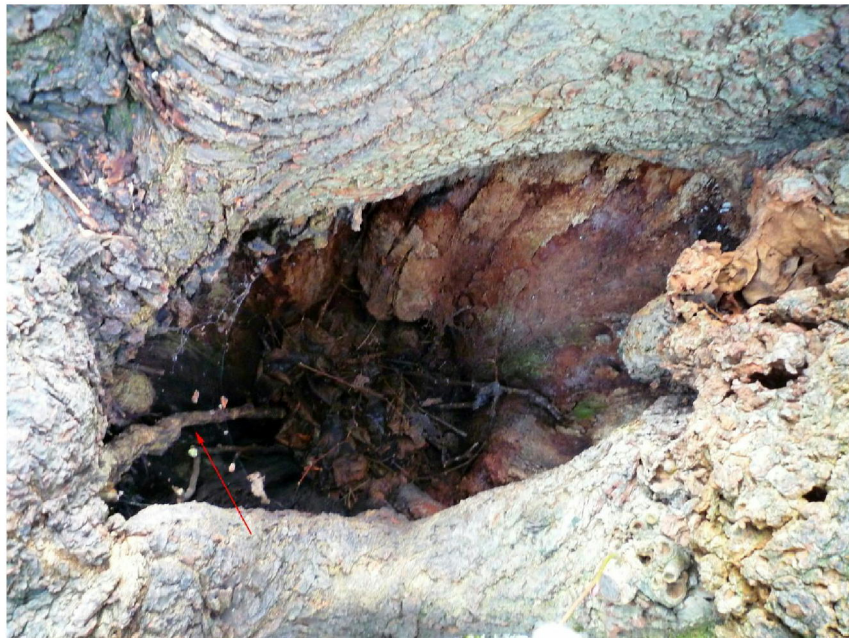
4) Closer view showing decaying side walls and accumulated leaf litter / compost. Arrow shows an adventitious root growing into this material.

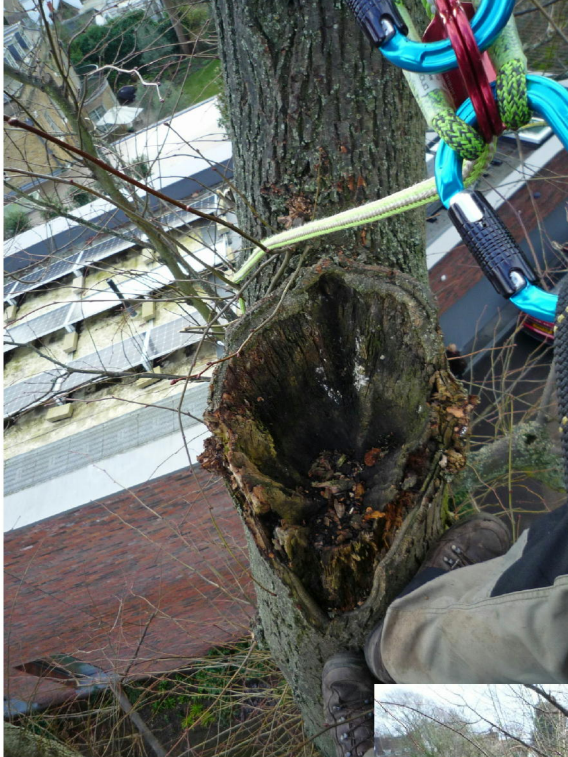
- 3.3 The cuts from the major crown reduction in the past are between about 250 and 300mm across and all of them have well established decay. This is extending down into the upper parts of the main stems and callus growth round the edges is limited or absent in places. These cuts all face upwards and some were full of water, but it had rained during the previous week, so that will not be permanent. Most of them slant, indicating that they were cut to leave a downward slope and have V shaped notches at the lower side, indicating that the final part tore away before the cut finished. That is common in lime, which has tough, fibrous bark.

5) Cut from major reduction, probably done 30 or more years ago. Significant decay and callus growth round the edges is narrow and absent in places. Note notch on the lower side facing the viewer, and on the two in the picture below.

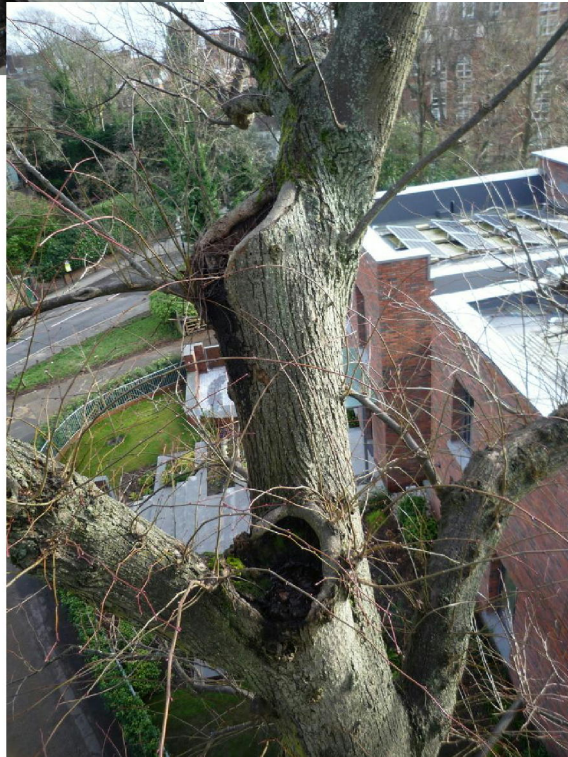
6) Two similar cuts at about the same height on the other main stem.
