228 Belsize Road NW6 4BT

Refurbishment Survey Asbestos Report – Copy 1

Address of Site: 228 Belsize Road
London
Camden
NW6 4BT

Job No: B-20-014

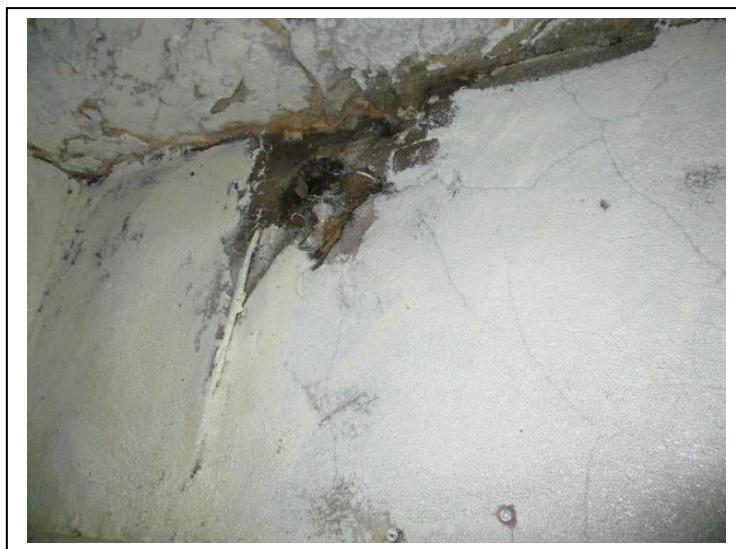
Lead Surveyor	K. Jones	Sample Number	S001
Survey Type	R&D	Location	B03
Survey Date	27/04/2020	Position	Pipework
Next Inspection	n/a	Material	Wrapping
Level of ID	I	Analytical Result	NADIS
		Extent	11m

Description: Wrapping to pipe

RECOMMENDATIONS | No action Required

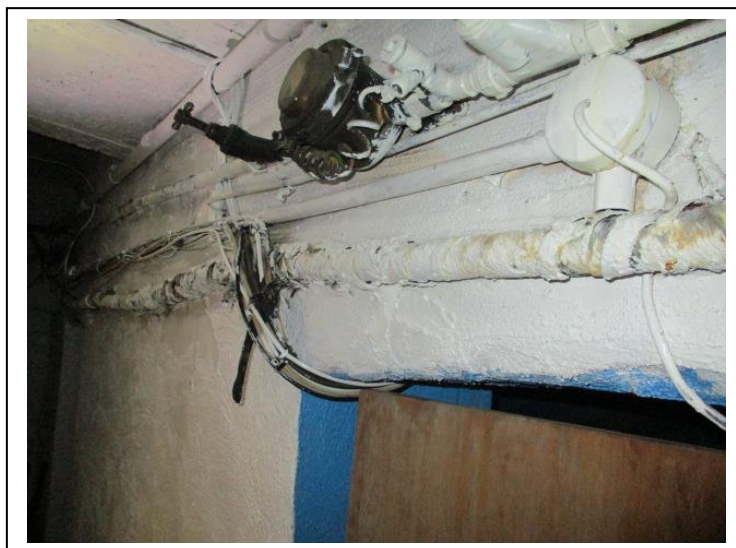
Lead Surveyor	K. Jones	Sample Number	S002
Survey Type	R&D	Location	B03
Survey Date	27/04/2020	Position	Cables
Next Inspection	n/a	Material	Wrapping
Level of ID	I	Analytical Result	NADIS
		Extent	<20LM

Description: Wrapping to Cable

RECOMMENDATIONS | No action Required

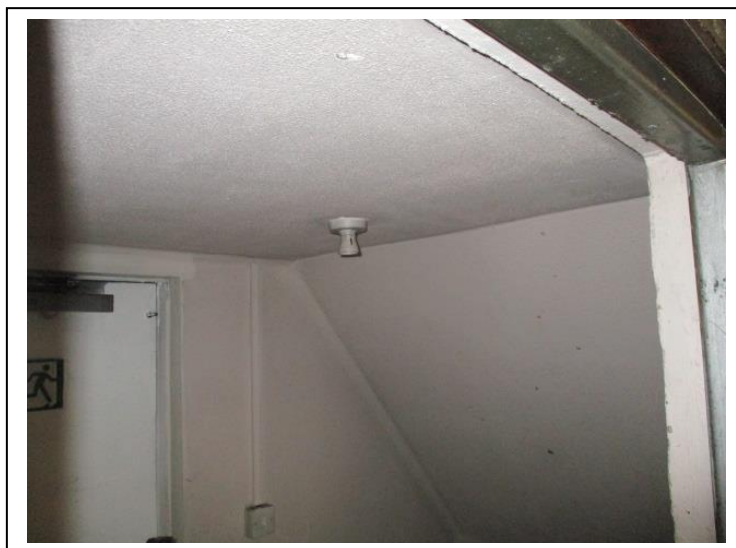
Lead Surveyor	K. Jones	Sample Number	S003
Survey Type	R&D	Location	G01
Survey Date	27/04/2020	Position	Stairs
Next Inspection	n/a	Material	Textured Coating
Level of ID	I	Analytical Result	NADIS
		Extent	6m2

Description: Textured Coating to stairwell

RECOMMENDATIONS | No action Required

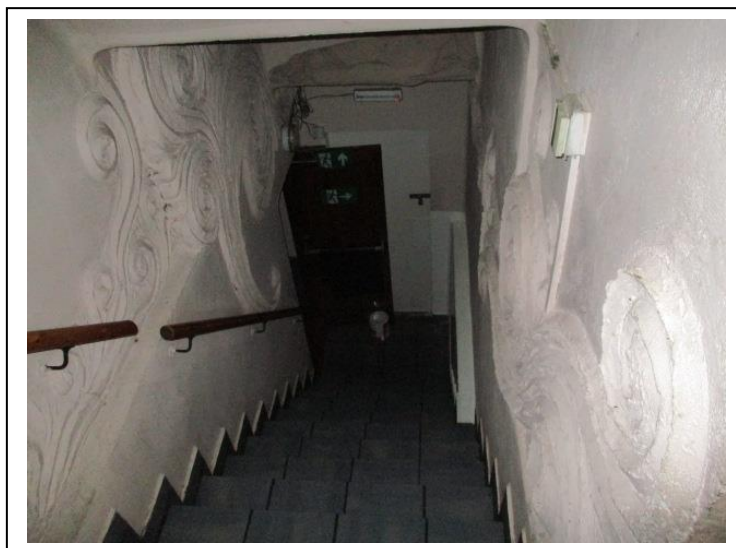
Lead Surveyor	K. Jones	Sample Number	S004
Survey Type	R&D	Location	G01
Survey Date	27/04/2020	Position	Stairwell
Next Inspection	n/a	Material	Artex
Level of ID	I	Analytical Result	NADIS
		Extent	15m2

Description: Textured coating to stairwell

RECOMMENDATIONS | No action Required

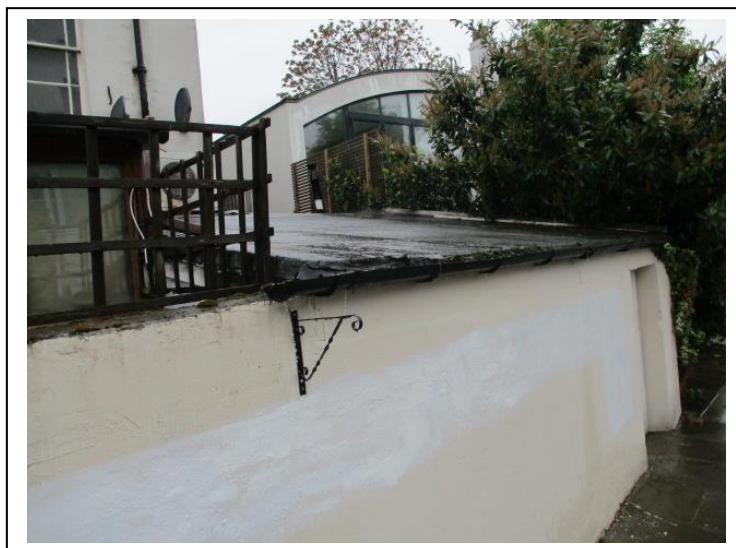
Lead Surveyor	K. Jones	Sample Number	S005
Survey Type	R&D	Location	EX01
Survey Date	27/04/2020	Position	Roof
Next Inspection	n/a	Material	Felt
Level of ID	I	Analytical Result	NADIS
		Extent	20m2

Description: Felt to conservatory roof

RECOMMENDATIONS | No action Required
