22 Froggnal Way - Curtilage Wall and Outbuilding

Structural Inspection Report

Job Number: 23261

Date	Version	Notes/Amendments/Issue Purpose
June, 2018	2	For Information

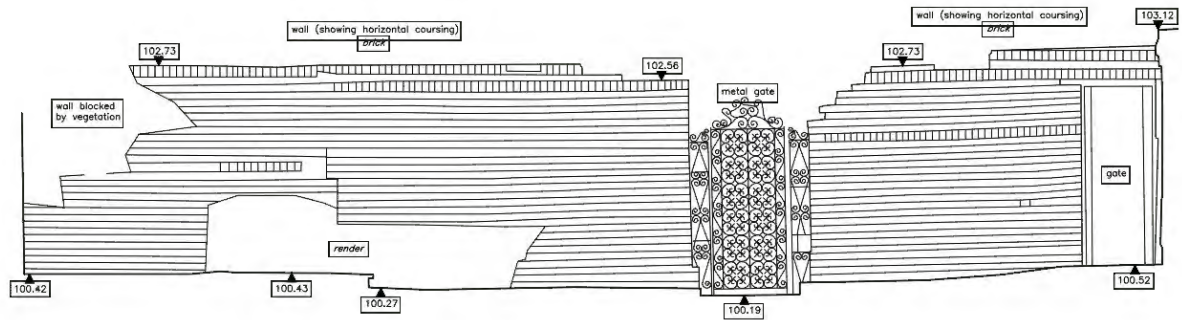
Elevation 5, Matrix Surveys

Elevation 5 depicts the initial straight-line boundary wall with two openings. The left-hand side section, behind the existing shed, has notable previous remedial works to the lower part of the wall. Photograph 2 shows the extent of the concrete render applied to the lower section of the wall. Above the concrete render the brickwork is in poor condition with the corbel portion no longer insitu.

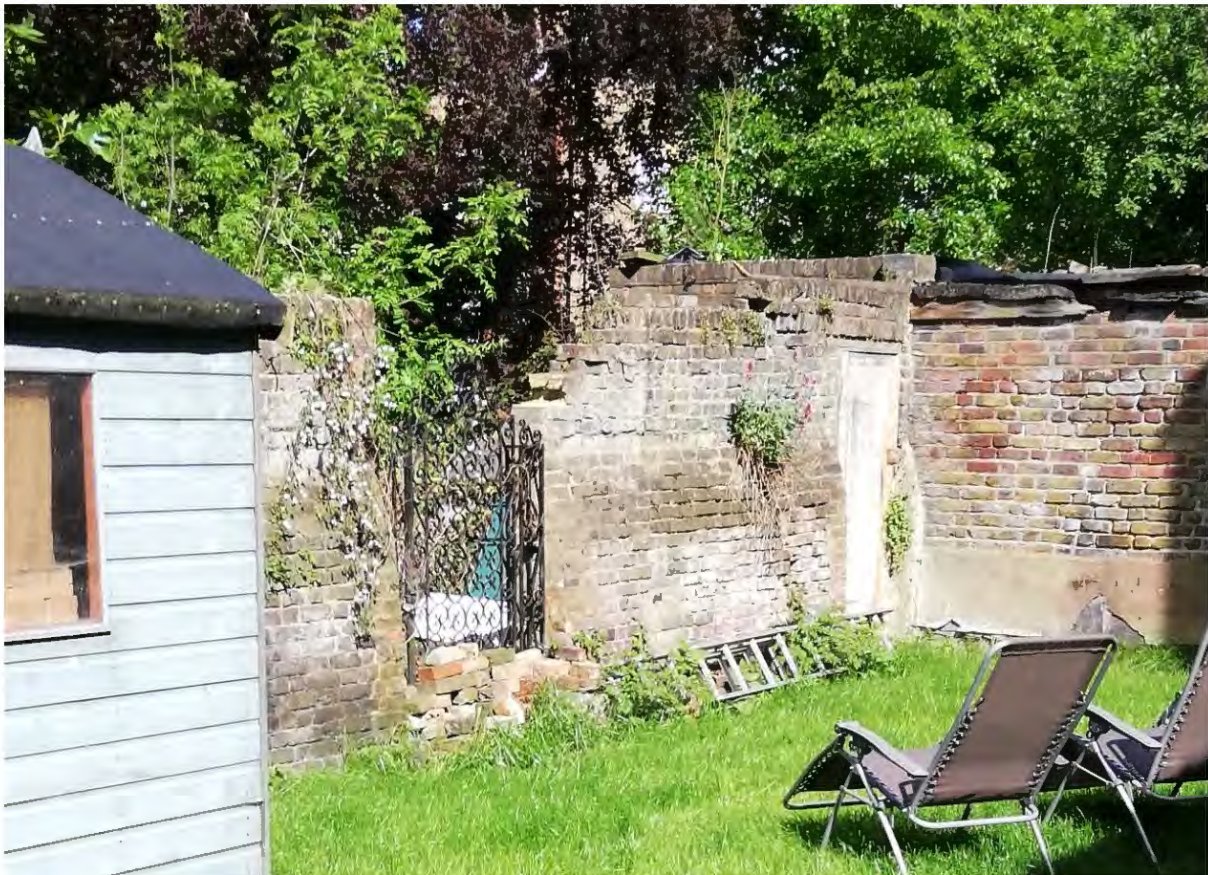
Photo 1, View from 20 Perrins Cottage

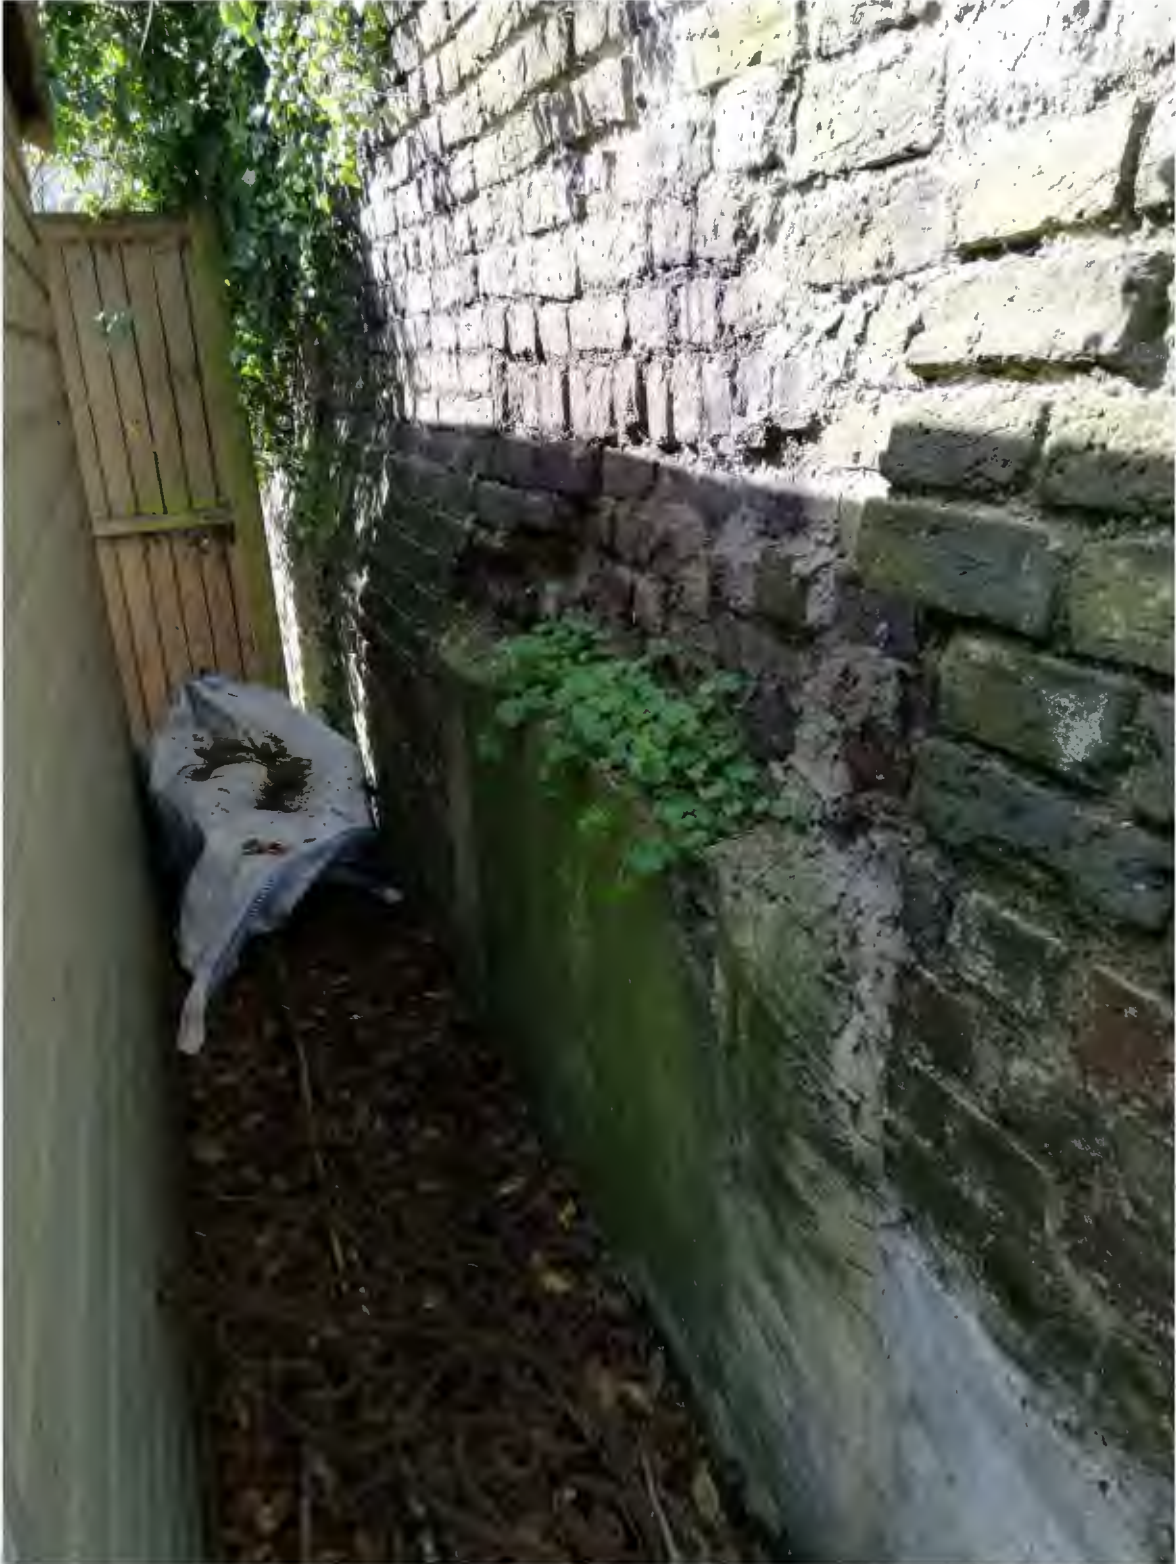
Photo 2, Southern section of wall behind existing shed

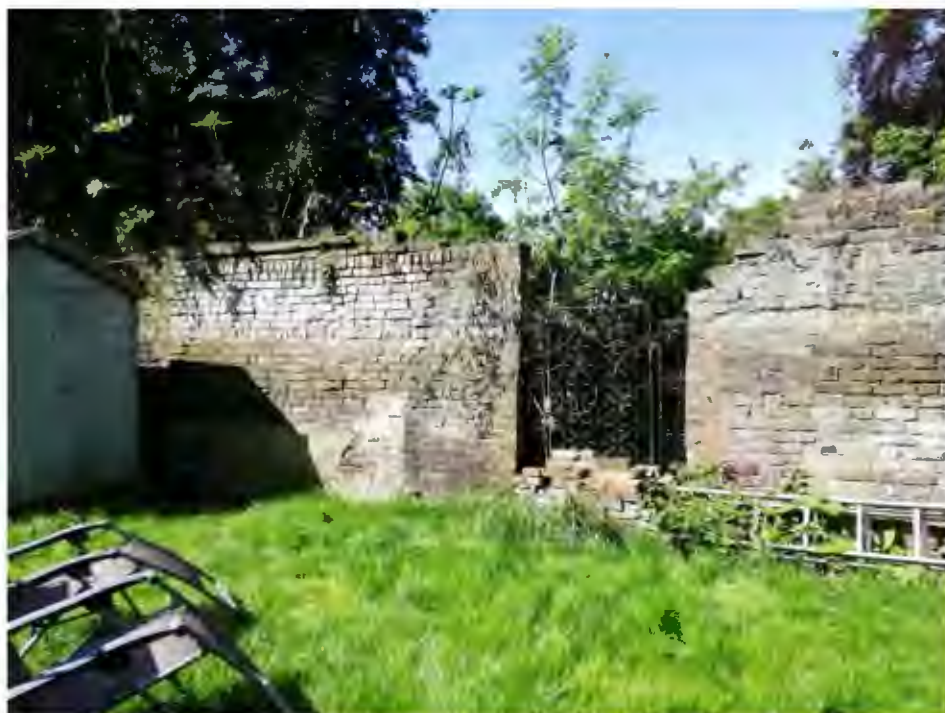
The right-hand section of the wall on this elevation has two openings (refer to Photograph 3 & 4). These openings provide access between the two properties. On review the openings do not look to be of a similar age as the wall construction as new brickwork and cement mortar is visible, refer to photograph 5.

The brickwork at high level surrounding the openings is in poor condition and a number of courses are missing locally from the upper section of the wall.

Photo 3, Opening 1, Full height

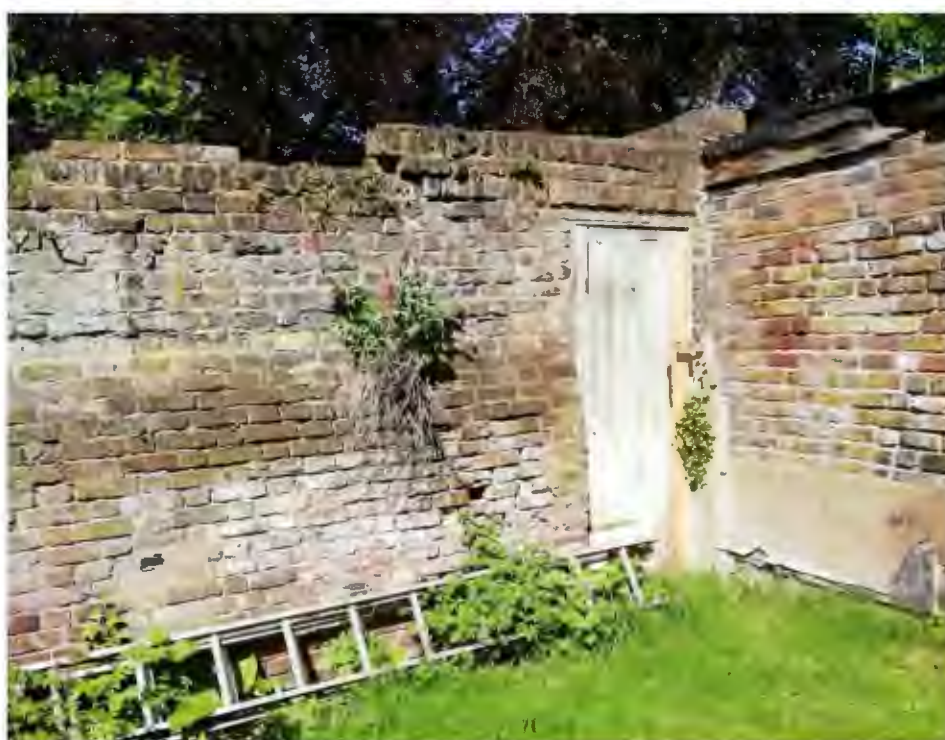
Photo 4, Opening 2

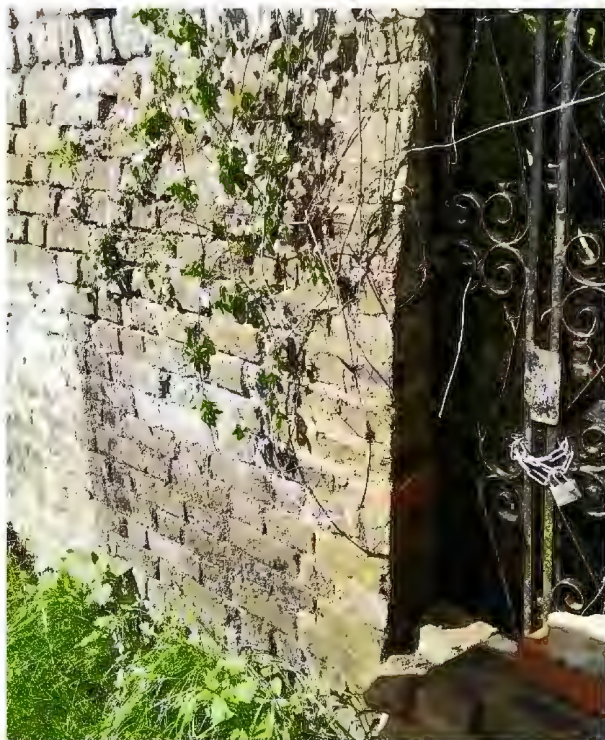
Photo 5, new/old brickwork at opening reveal

Photographs 5 & 6 show the composition of the wall itself. At its base it is a brick & a half thick reducing to one brick thick for the upper section. To achieve the change in thickness the wall corbels at approximately 1000mm above the current ground level. The Wall is approximately 2.3m high from 20 Perrins Walk side.

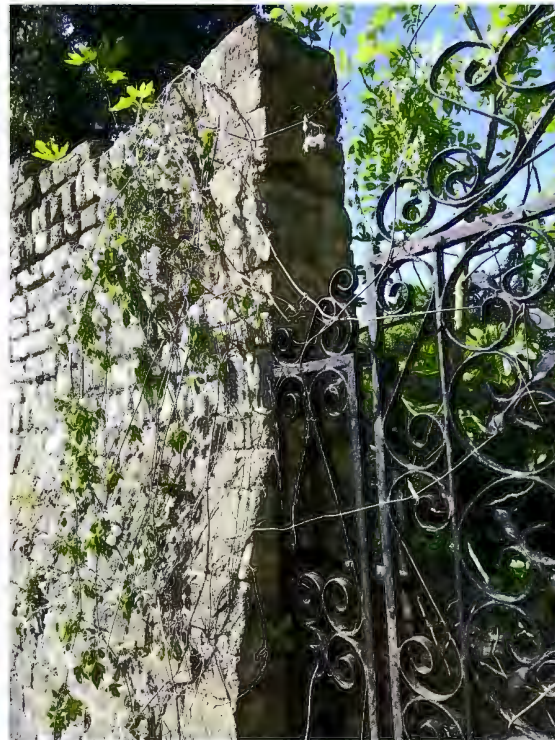
Photo 6, Corbel detail

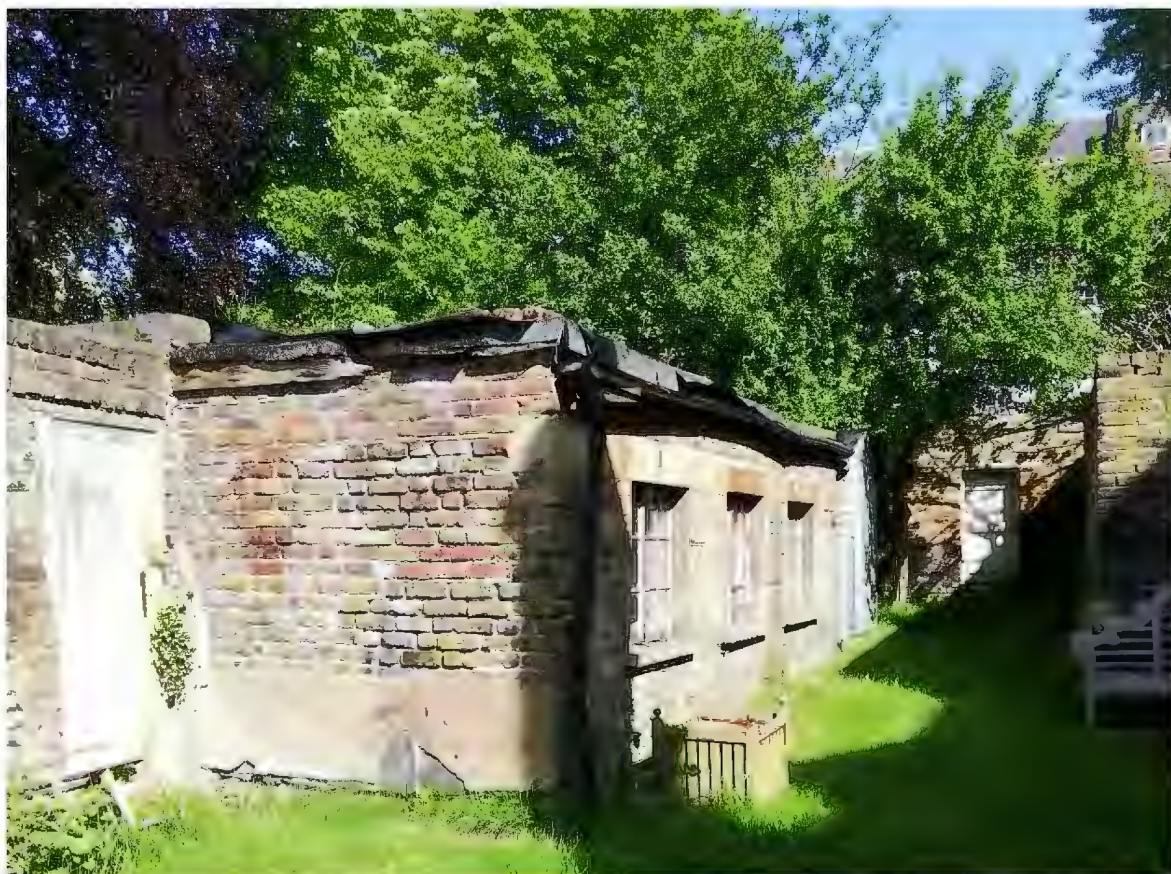
Photo 7, Outbuilding on 20 Perrins Cottage Side

The outbuilding is centrally located along the length of the wall and steps its footprint straddles the two properties. The construction of the outbuilding looks to be of London stock brick and no structural defects of concern in the masonry were seen during the site visit on the 11th May, although sections do require re-pointing. An anchor plate is evident on the top right-hand side corner of its east elevation.

The roof to the outbuilding was noted to be in disrepair.

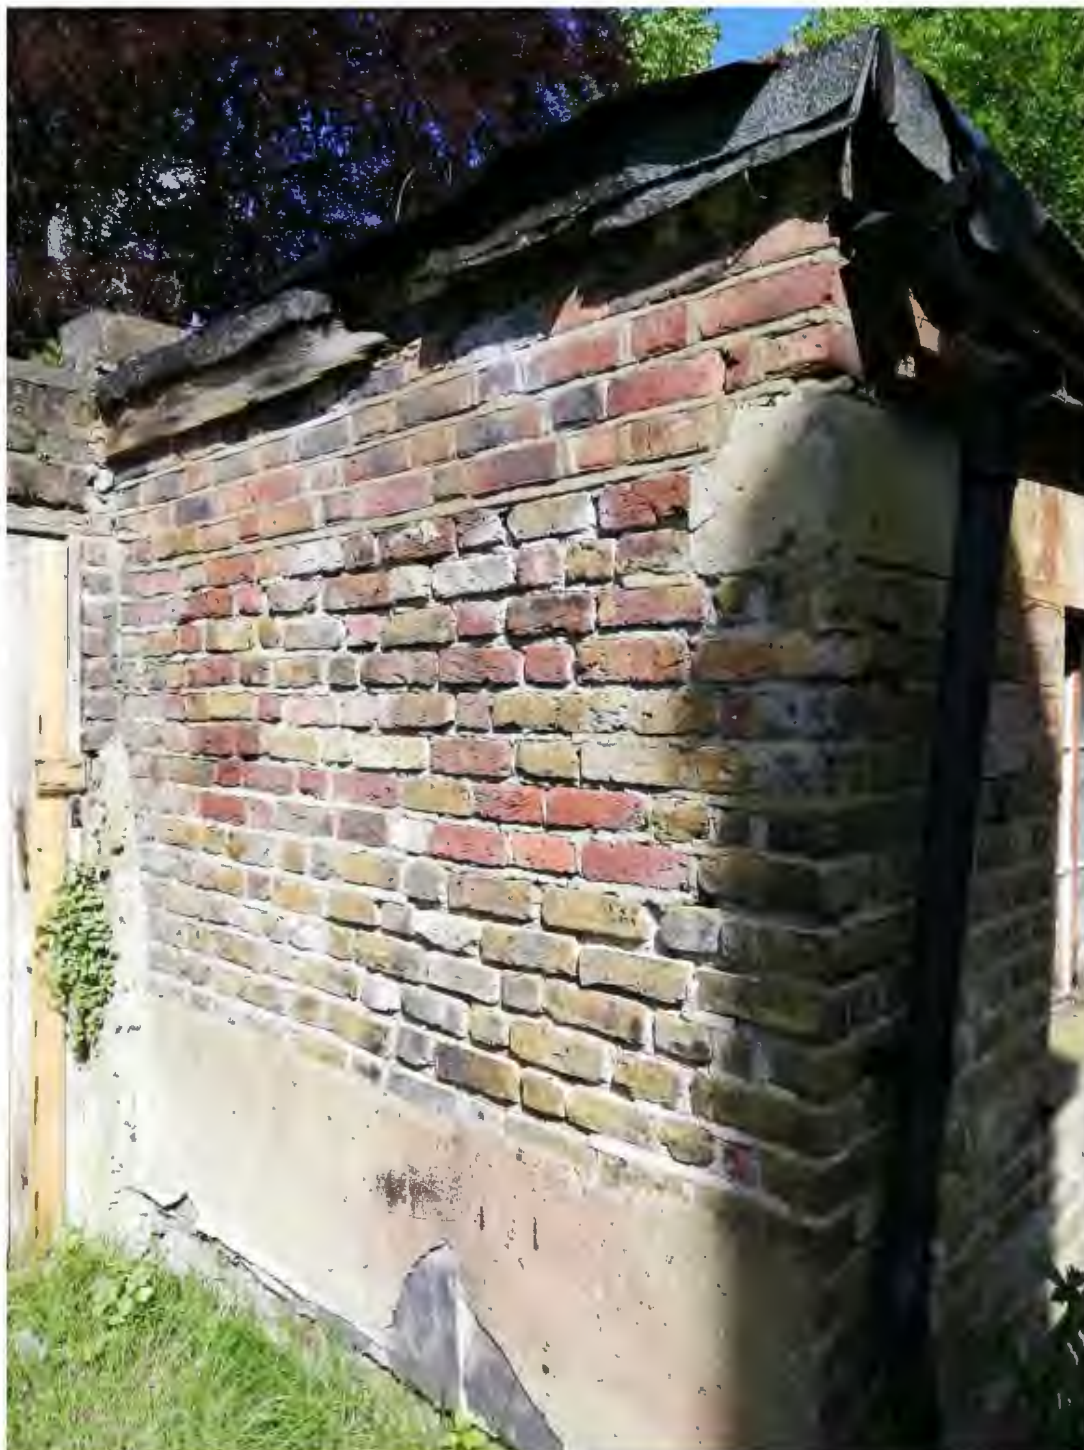
Photo 8, View of Outbuilding Masonry

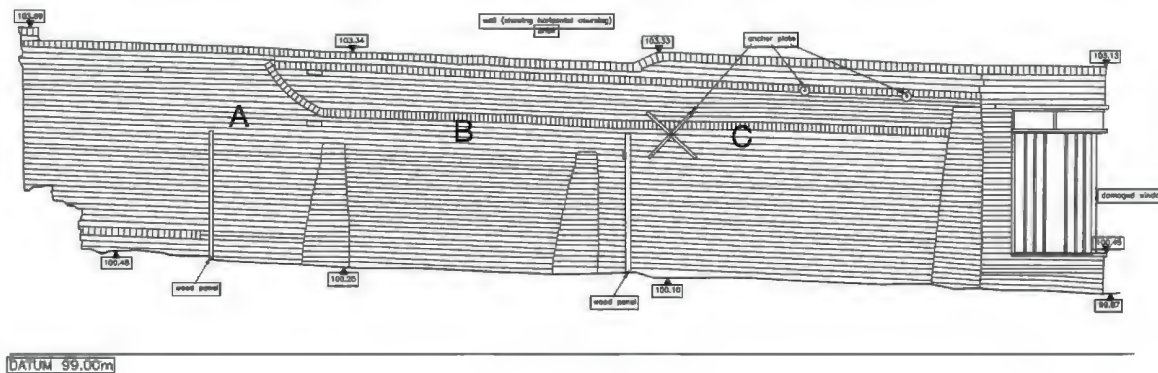
Elevation 2, Matrix Surveys

Elevation 2, below, shows the northern part of the curtilage wall. This elevation forms part of the outbuilding façade (from its right-hand extent to the crossed anchor plate).

There are buttresses located on this elevation which are all of a raked masonry brickwork construction and taper towards their top. The right-hand side, taller pier looks to be constructed in the same brick as the remainder of the wall. The two smaller piers, to the left-hand side and centre, are obviously of recent construction and are likely to be an attempt to strengthen the wall against the obvious bow at approximately 2.3m above ground level. The bonding of the new buttresses does not match that of the wall, and they do not look to be properly keyed into the existing wall.

It should be noted that there is an level change between the two properties along this wall, with a retained height of approximately 860mm to the 20 Perrins Walk side the neighbouring property.

Measurements taken on site of the lean to the wall were measured at 48mm, 131mm and 144mm and correspond to the locations A, B & C in Elevation 2, above.

Location A on Elevation 2 & D on Elevation 4 have a centre of gravity that still falls within the middle third of the wall base and no added stability measures are required. However, at locations B and C on Elevation 2, and location E on Elevation 4, the wall is potentially unstable in the long term.

Separately, we have also investigated the structural capacity of the retaining section of the wall, Elevation 2. This wall is not satisfactory to support the required applied wind loads and retaining forces from the neighbouring property when checked using current codes of practice.

Finally, we have investigated the structural design of the 2.3m high freestanding wall with piers at a maximum of 5.0m centres as a standalone item. Location C on Elevation 2, where the wall spans 5.0m between piers is not satisfactory. The maximum allowable spacing of piers for the wall to be compliant with current codes is 4.6m. This is achieved at Locations A and B on Elevation 2, although as noted earlier, this section of wall fails once the retaining forces are taken into account in any event.

We would therefore recommend that Elevation 2 & 4 are either strengthened or taken down and rebuilt to modern codes of practice.

Three new buttresses would be introduced to Elevation 2 at central locations between the existing buttresses, and the existing buttresses should also be rebuilt. These piers will have new footings and be properly tied into the existing wall to ensure they work together structurally.

The existing masonry would be carefully taken down and a new concrete retaining wall built to the base of Elevation 2. This retaining wall will be faced with existing bricks so that it matched the current visual appearance of the wall.

Elevation 4 & the upper section of Elevation 2 would then be reinstated with concealed wind posts to provide the required structural capacity.

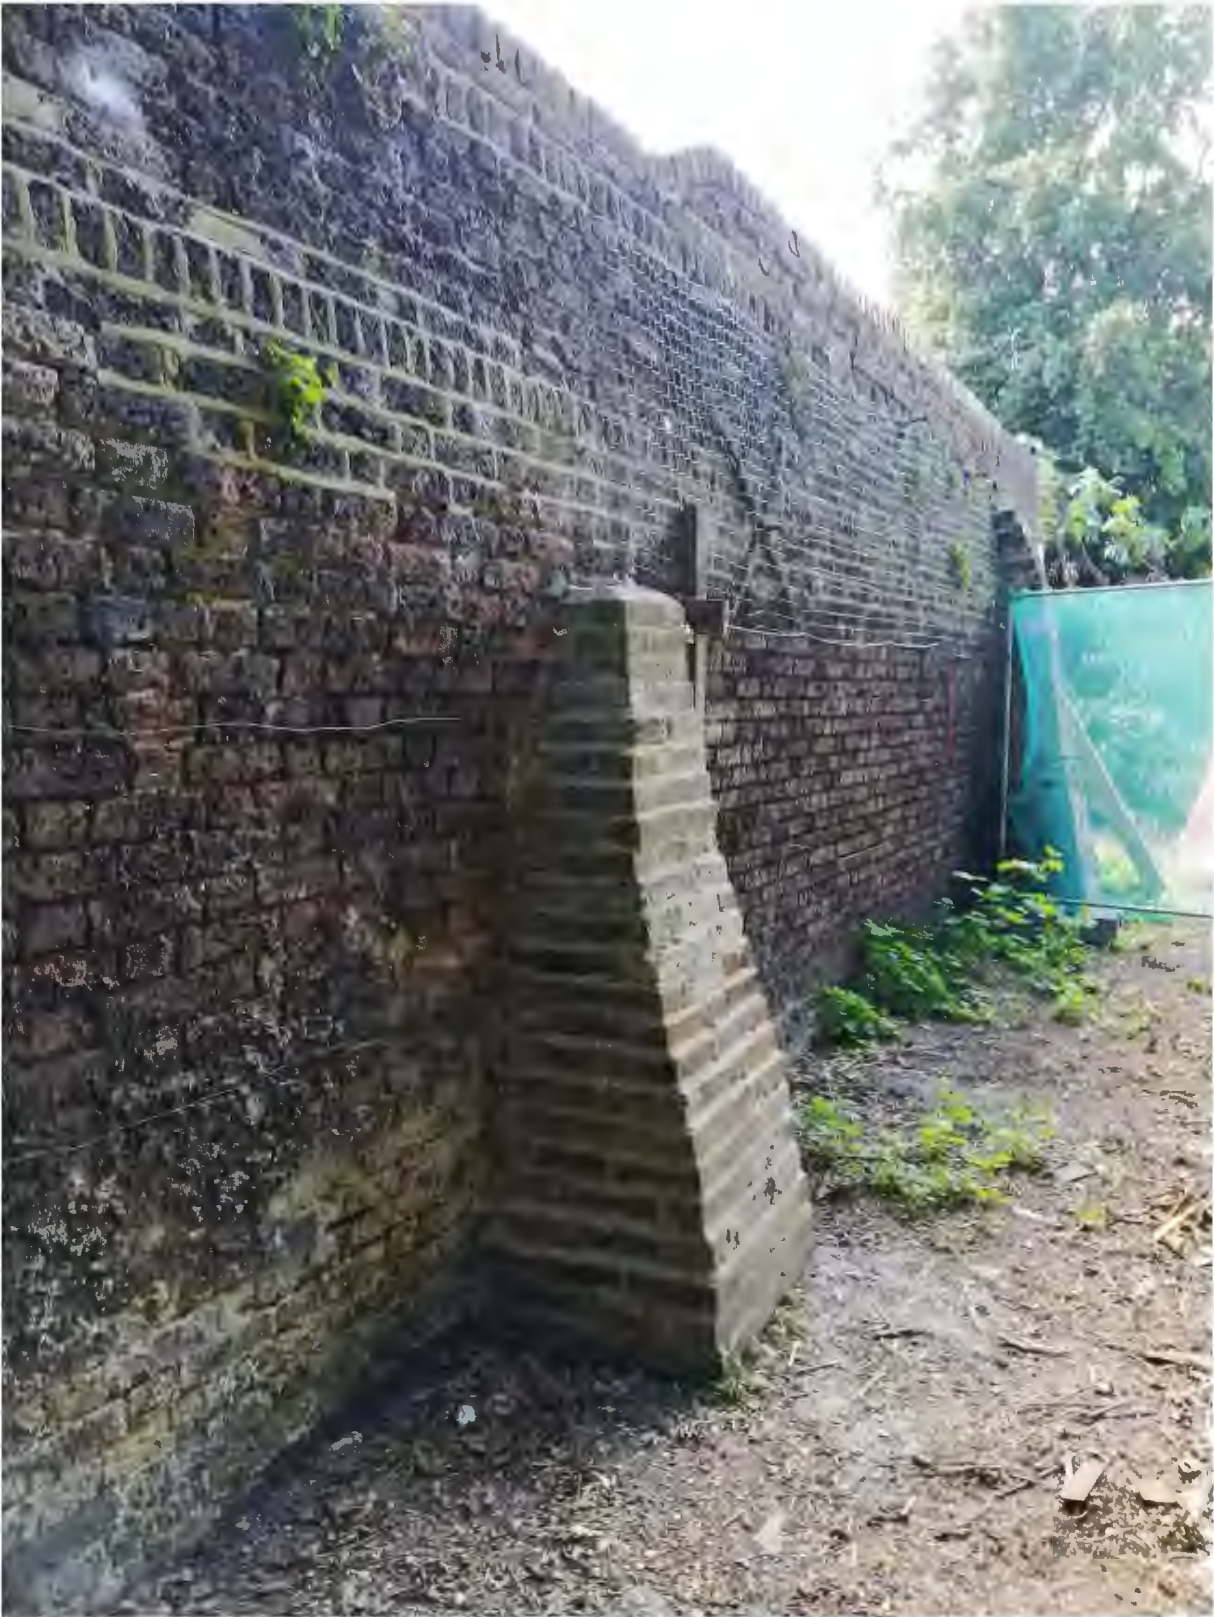
Photo 9, North section of wall and viewing toward the into Outbuilding entrance

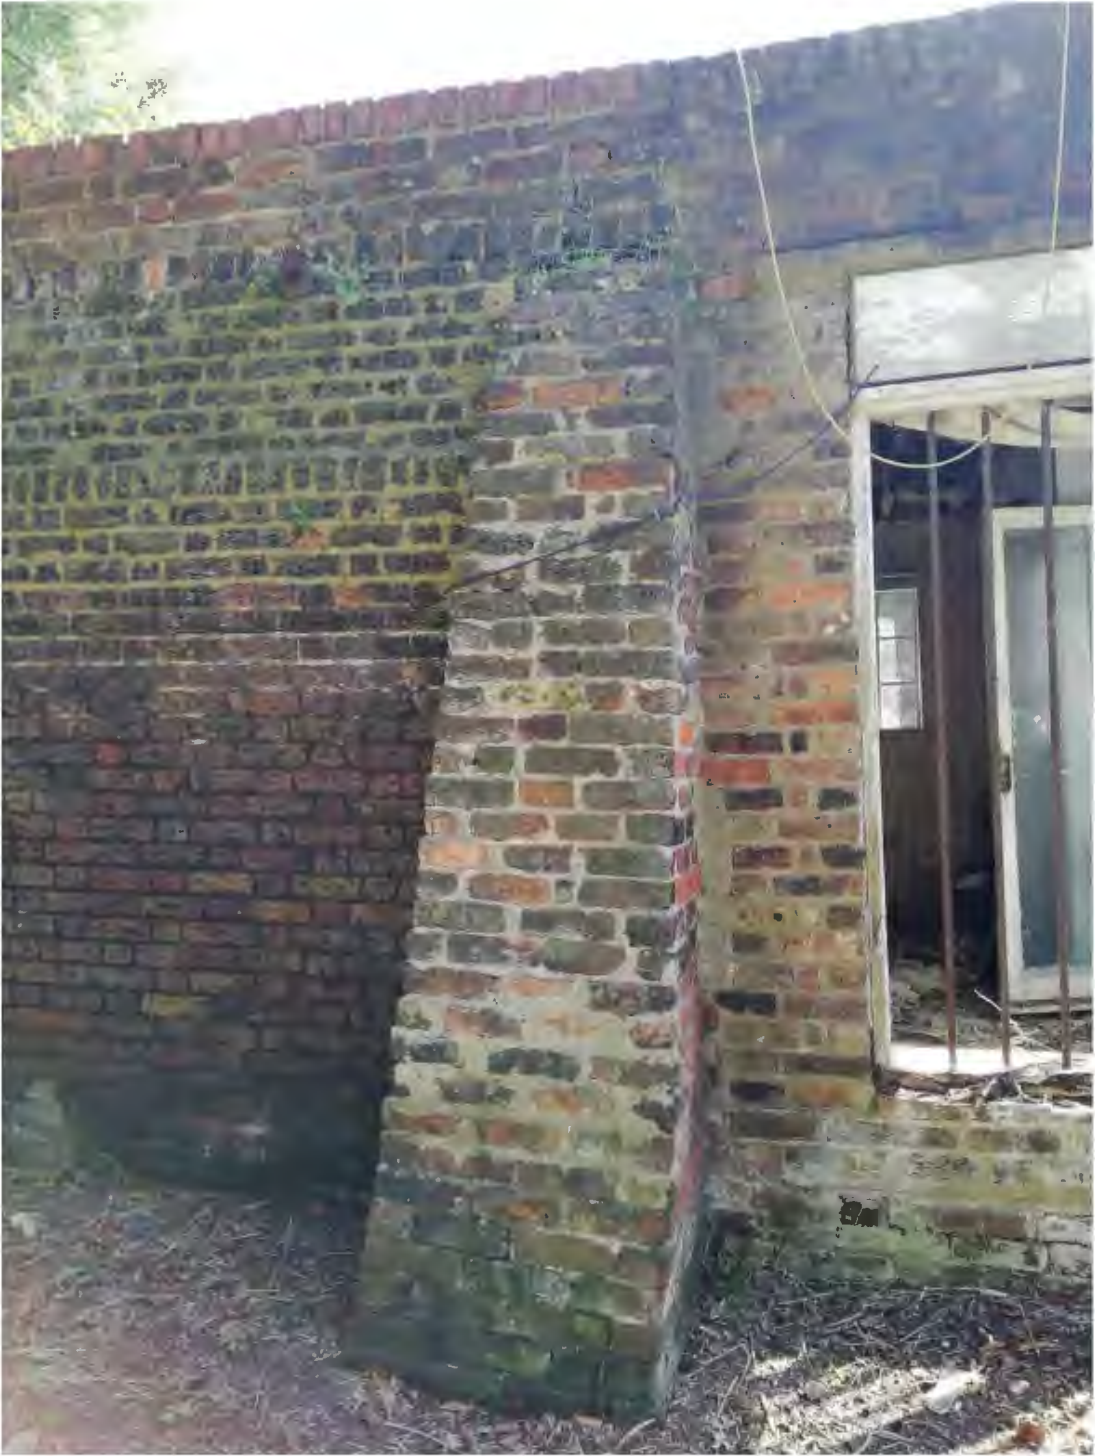
Photo 10, Right-hand side masonry pier to Outbuilding

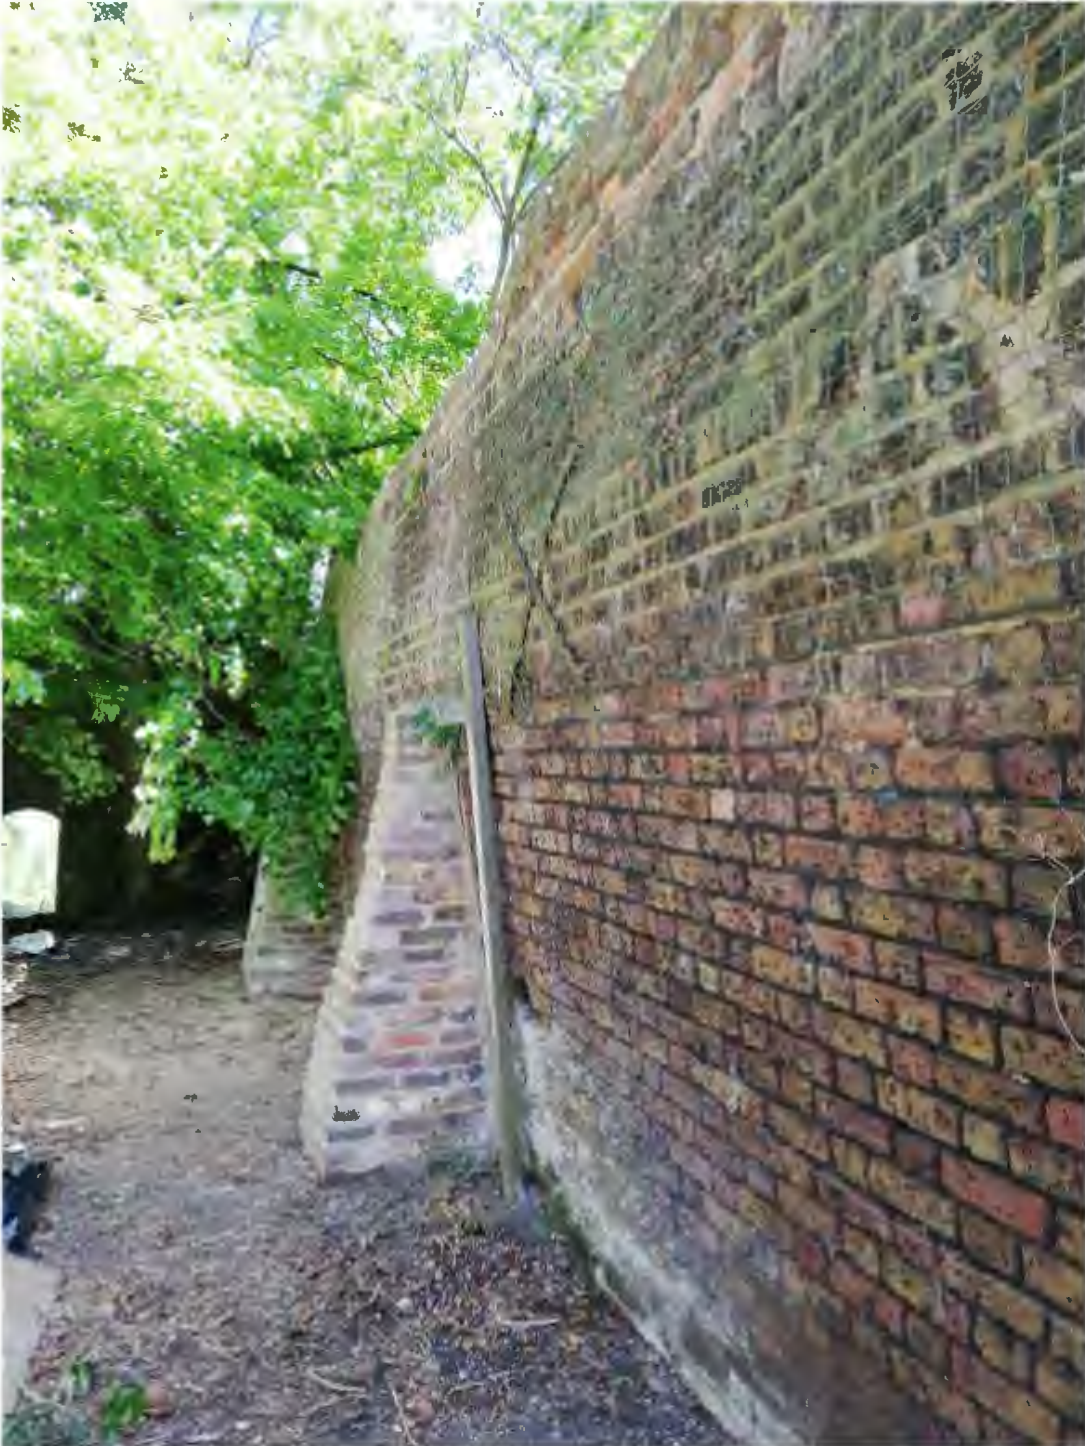
Photo 11, North Section of Wall showing newer piers and bow at the top of the elevation. Also evident is the anchor plate situated in front of the nearest pier.

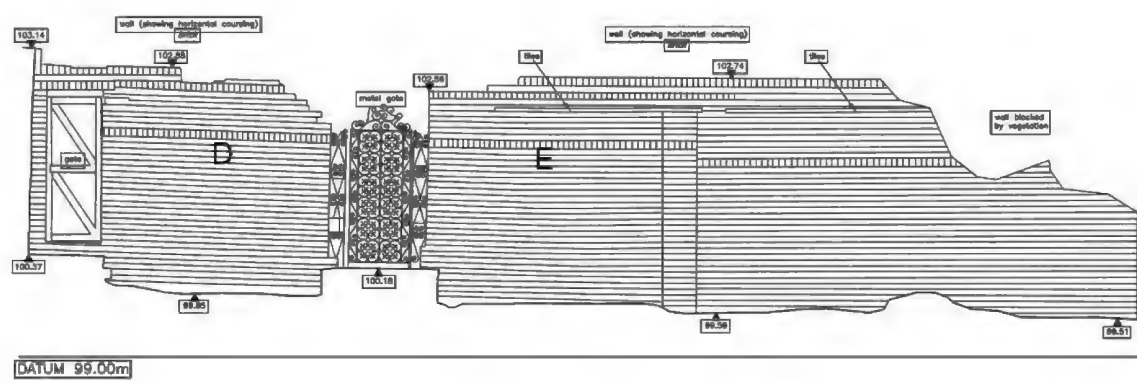
Elevation 4, Matrix Surveys

Once the vegetation had been removed from this section of the wall we were able to see the condition of the masonry. The new brickwork and cement mortar is more visible on this side of the wall and, similar to the northern section, there is a slight bow to the wall at approximately 2.3m above ground level.

Measurements taken on site of the lean to the wall were measured at 51mm and 110mm which correspond to the locations D & E on Elevation 4.

There is also a level change of approximately 400mm between the two properties in this location. Unlike the northern section of wall, due to its thickness of 325mm at its base, the wall is not acting as a retaining wall as the spread of load at 45 degrees will transfer directly into the soil on the lower side.

We also recommend introducing two new piers either side of Opening 1 to strengthen this wall panel and repair the upper courses of masonry.

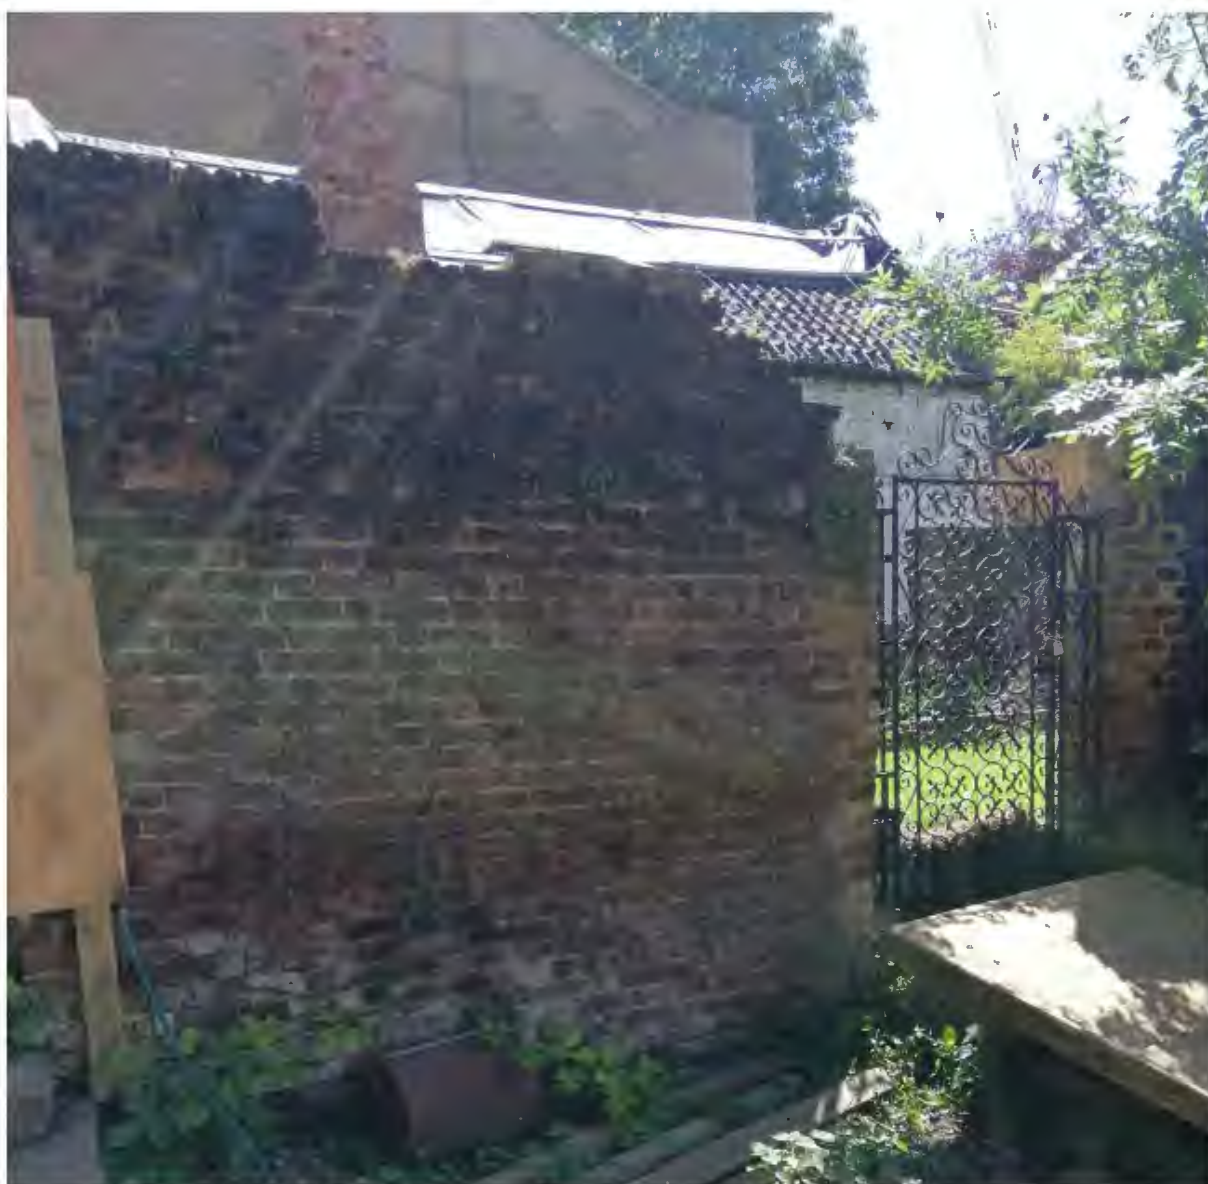
Photo 12, Elevation 4, LHS of opening 1 on 22 Frognal Way side

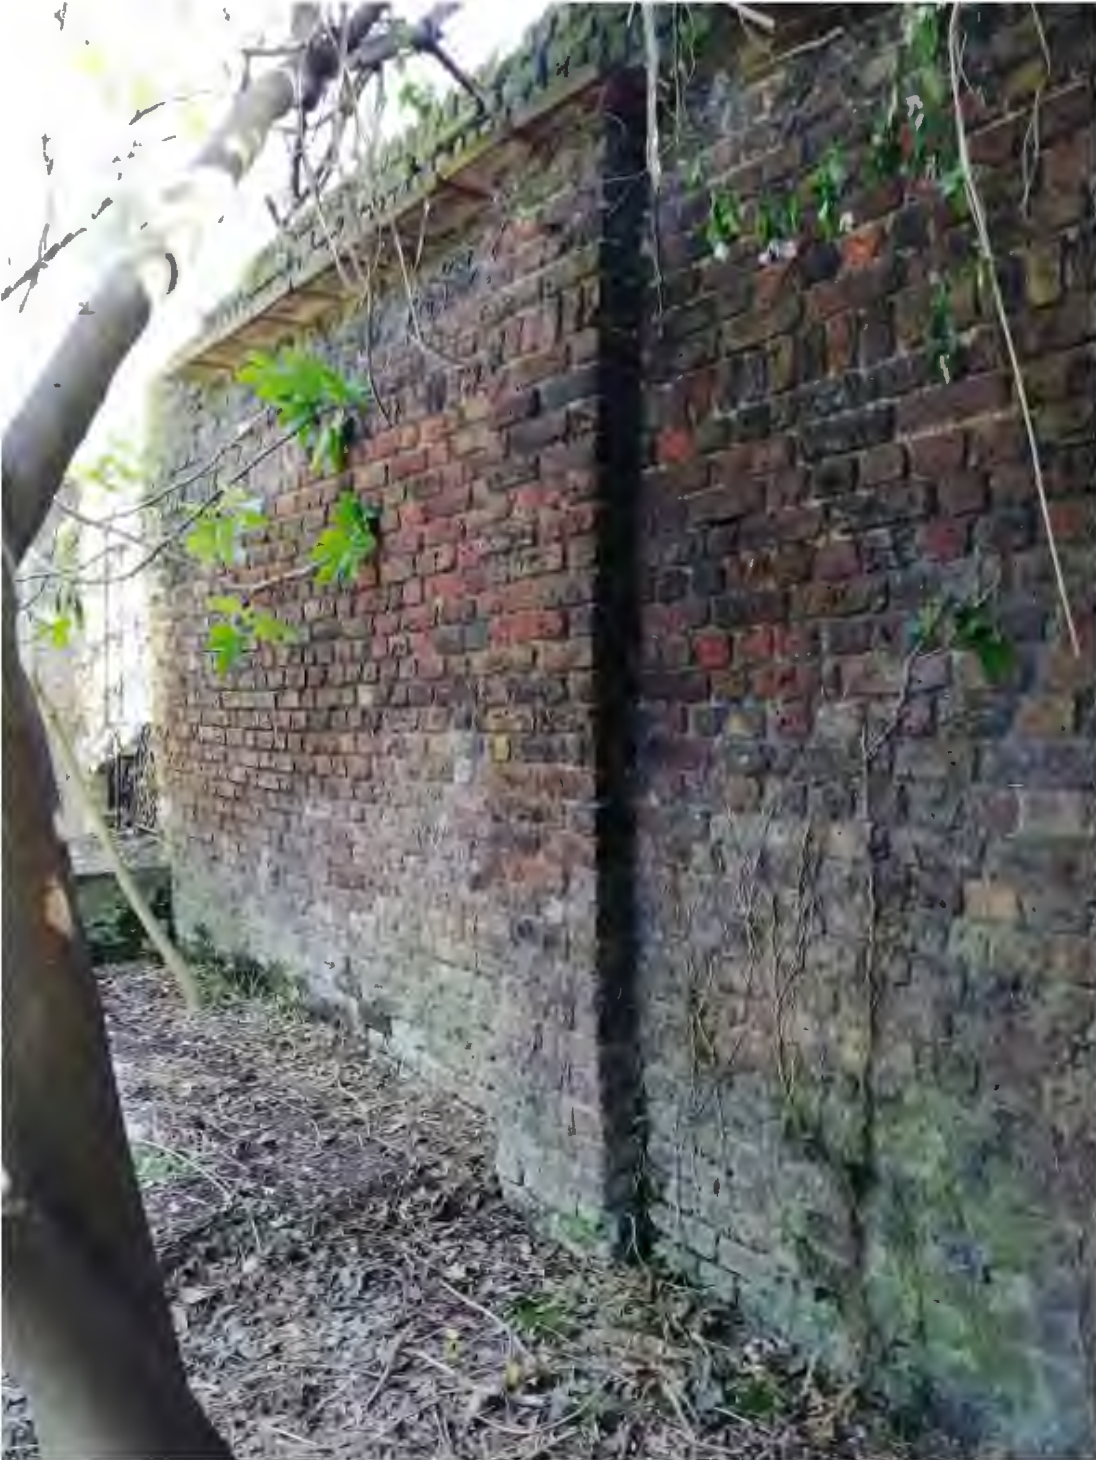
Photo 13, Elevation 4, RHS of opening on 22 Frognal Way side

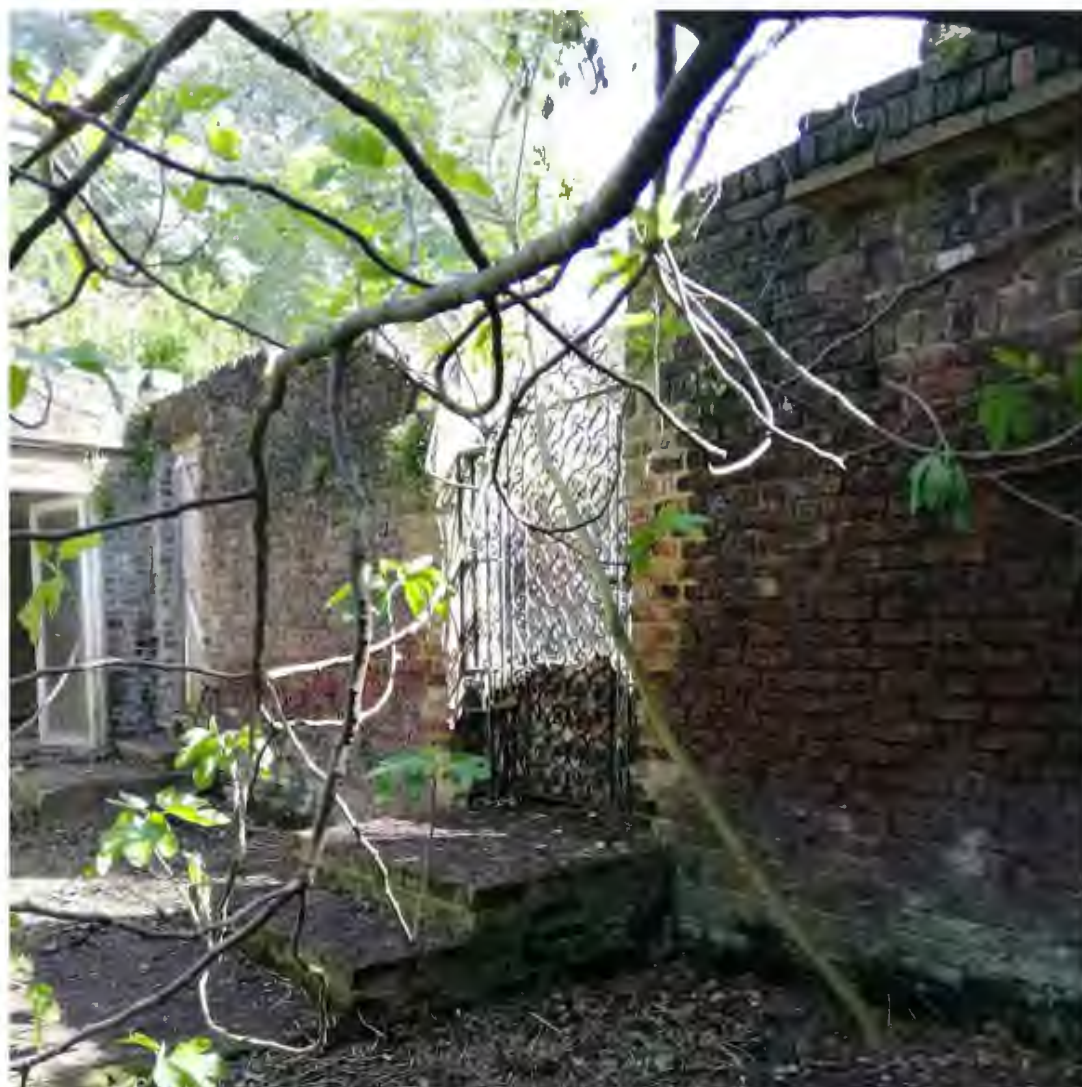
Photo 14, Opening 1 in foreground with Opening 2 & Outbuilding in background

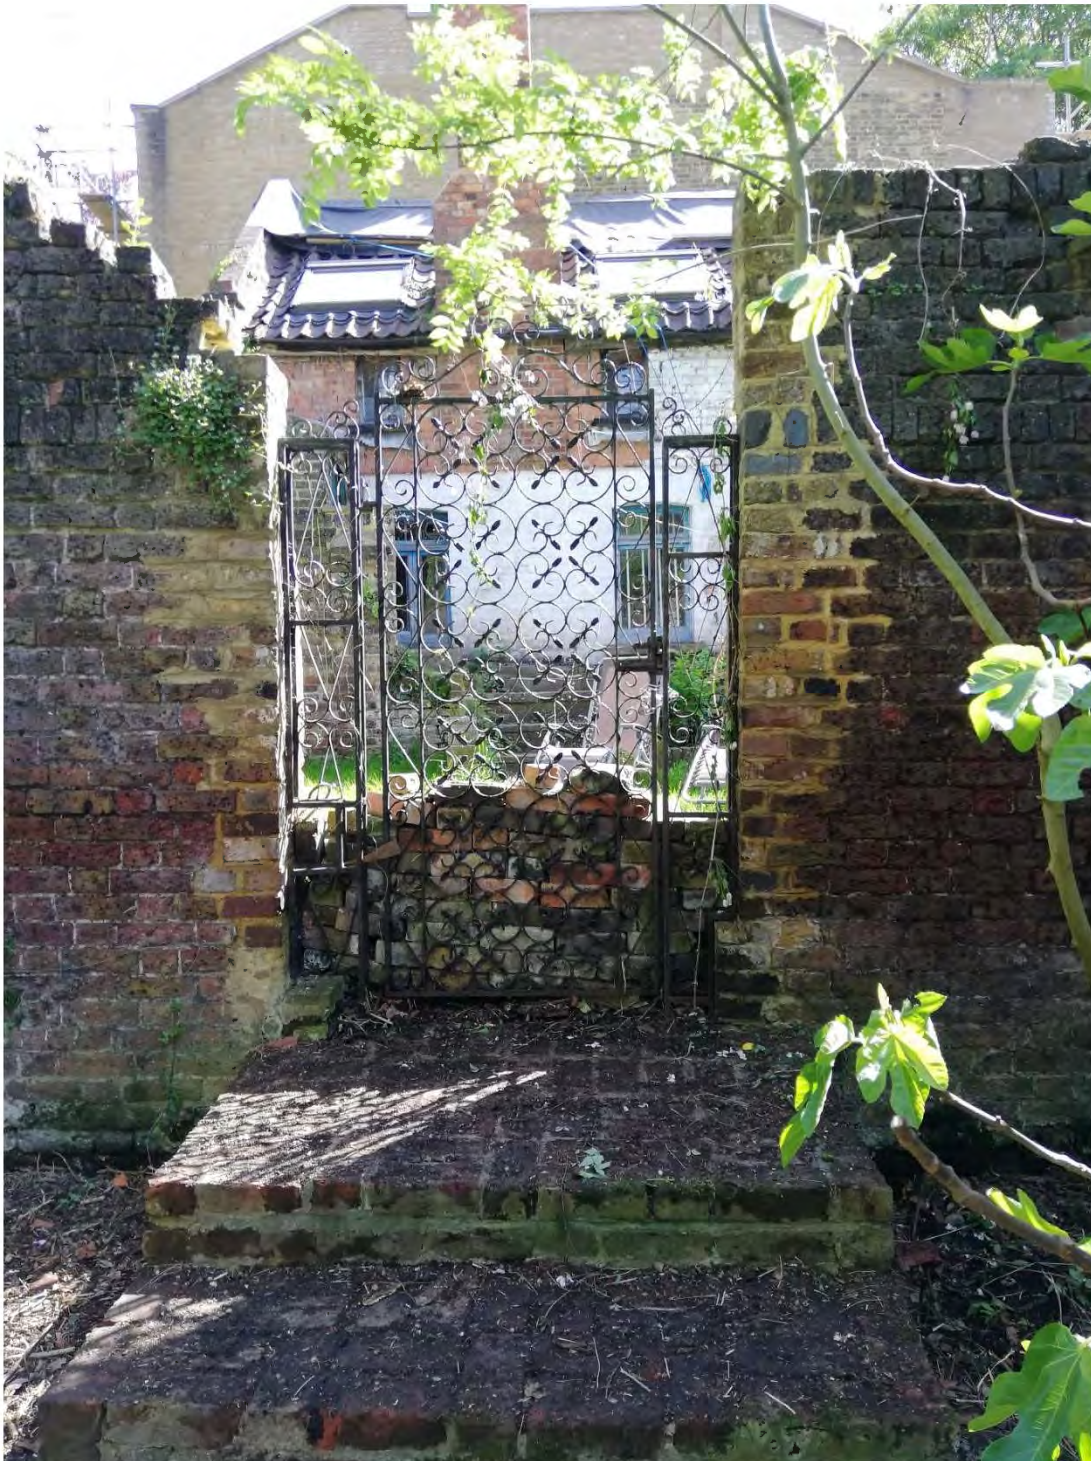
Photo 15, Opening 1 with new brickwork evident

As with observations from the 20 Perrins Walk side, the top masonry courses are noted to be in poor condition.

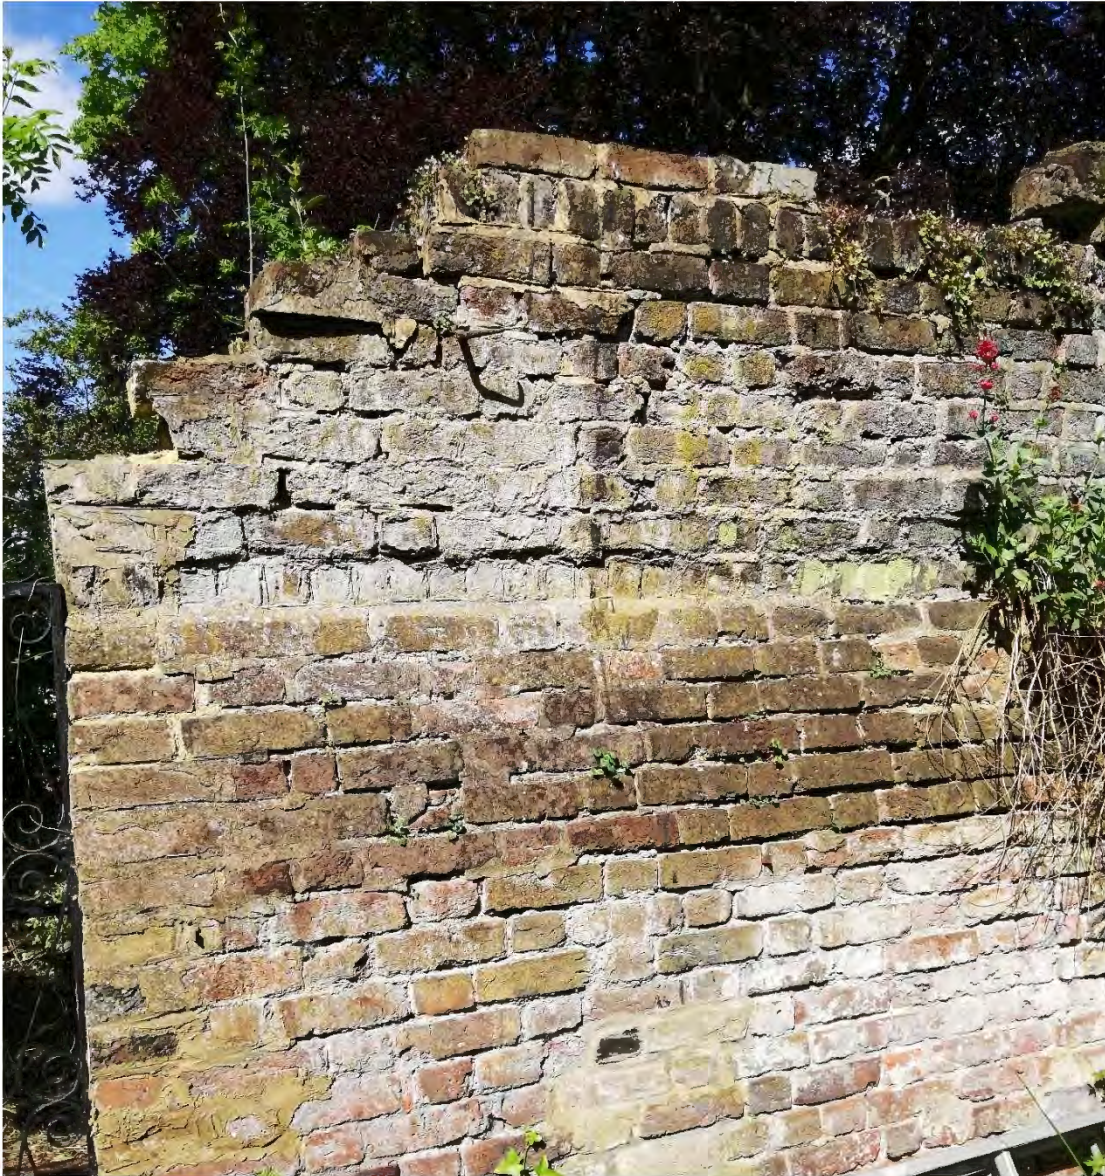
Generally the masonry on the 20 Perrins Cottage elevation looks to be in worst condition. This is probably due to increased exposure from its orientation. If the wall is strengthened rather than rebuilt, both elevations would require repointing.

Photo 16, Disrepair at the top of the wall adjacent to Opening 1

Where possible all masonry should be reused or new to match existing, and any re-pointing should be done with a suitable lime mortar by Limetec or similar in accordance with our specification.
