TECHNICAL REPORT ON A SUBSIDENCE CLAIM

[REDACTED]
[REDACTED]
**22 Daleham Gardens
London
NW3 5DA**

[REDACTED]
[REDACTED]
SUBSIDENCE CLAIM

DATE 07 November 2018

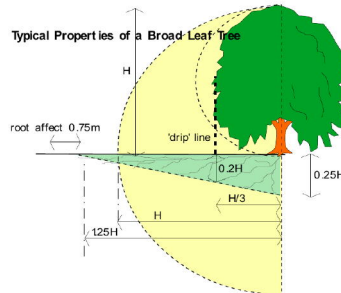
Typical proportions of a Beech tree. Note the potential root zone.

The beech grows at a rate of 300mm a year to reach heights of between 20 - 28mtrs depending on soil and climate etc. It is regarded as having weak root activity⁴.

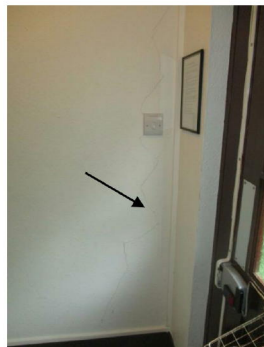
Cracking in communal hall

Communal Hall, Stairs and Landing - Hairline - 1mm diagonal cracking below front windows on 1st floor and 2nd floor levels, 1mm diagonal crack to right hand partition by front door, front was sticking and has been adjusted.

The pattern and nature of the cracking to the communal hallway and right hand front bay area is indicative of an episode of subsidence. The cause of movement appears to be clay shrinkage.

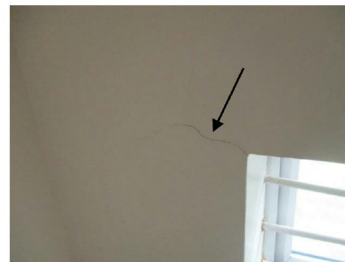
Cracking in communal stairway

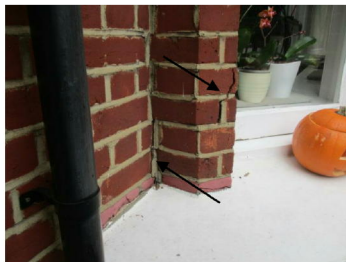
Cracking to right hand bay

Right Hand Bay - 7mm vertical tapering cracking to left hand side bay junction at upper ground floor cill level, 1mm vertical crack to right hand splay at basement level above window, 3mm vertical tapering crack to right hand side junction at upper ground floor cill level.

In structural terms the damage falls into Category 3 of Table 1, Building Research Establishment⁵ Digest 251, which describes it as "moderate".

Although the cause of the movement needs to be dealt with, we note the vegetation is subject to a Preservation Order. Unfortunately, current legislation requires certain investigations to be carried out to support an application for the tree works.

Typically, these investigations would involve trial pit(s) to determine the depth and type of footings, boreholes to determine the nature of the subsoil/influence of any roots and monitoring to establish the rate and pattern of movement. The monitoring data provided must be sufficient to show a pattern of movement consistent with the influence of the vegetation and therefore it may be necessary to carry out the monitoring for up to a 12 month period.

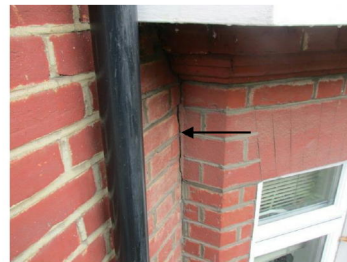
Cracking to right hand bay

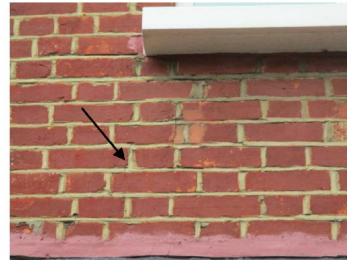
Front Elevation - 1mm stepped crack below left hand side of 1st floor communal landing window.

Cracking to front elevation

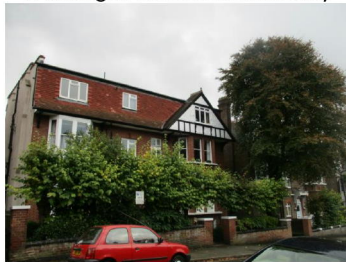
Type	Height	Distance	Ownership
Beech	16 m	4 m	20 Daleham Gdns

Beech, (*Fagus sylvatica*) is a large growing deciduous species. Water demand is low, but its size can lead to problems. It will tolerate pruning when young and can be a useful hedge species. However mature and older trees will not stand heavy pruning and can be killed by it. Lifespan is typically up to about 200 years after which they often decline rapidly.

View of third party beech tree

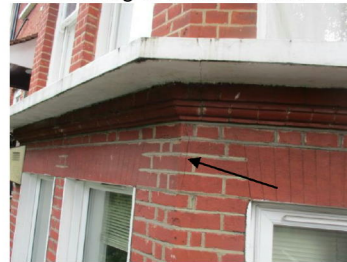
Cracking to right hand bay
