Proposed Demolition following destruction by fire

31 Daleham Gardens
London
NW3 5BU

Statement of Justification

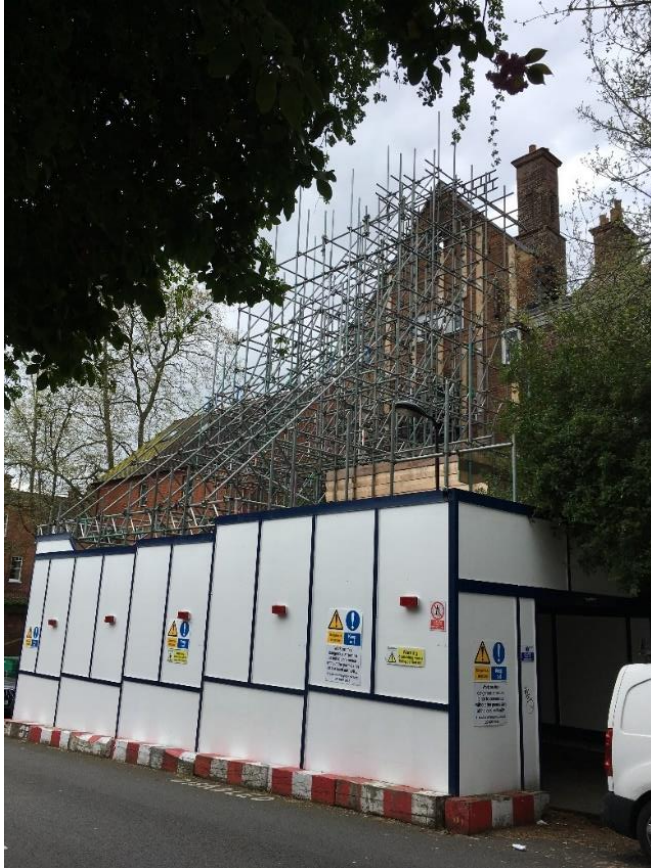
View from
Daleham Gardens

- 4.4 The fire destroyed the main roof with the internal structure severely damaged.
- 4.5 Whilst much of the external masonry shell remains, but it is structurally compromised with extensive cracks and distortion.

- 4.6 Lateral support to the upper masonry elements has been lost owing to the destruction of timbers floor and roof members.
- 4.7 The internal load-bearing masonry structure is showing signs of exposure to high temperatures and attendant fire-fighting activities, extinguishing water and removal to control spread. Widespread damage has therefore resulted.

- 5.1 The original build was an important part of the Conservation Area even though not a listed building.
- 5.2 The significance of the building and its contribution to the Character of Conservation Area is now lost because of the extensive fire damage.
- 5.3 Its reinstatement would be a new building where its character and any contribution would be judged through the Planning Process as Full Planning Permission would be required.
- 5.4 The extent of damage, current condition of the building and concerns over public safety require that the building is demolished completely without delay, pending proposals for its replacement.

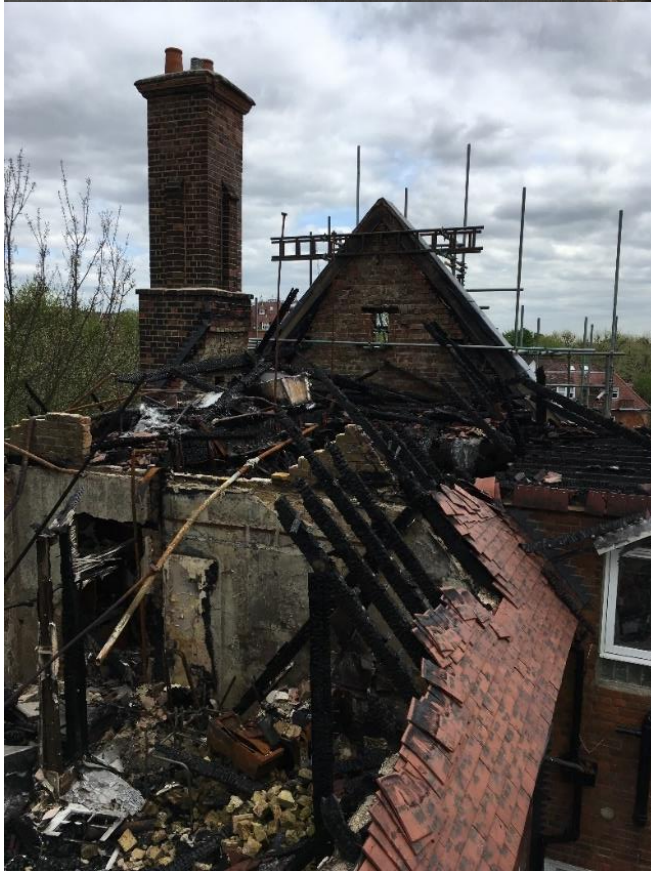
View from Roof
Level

- 4.8 There are no timber of internal joinery elements remaining or capable of repair.
- 4.9 Significant water damage has occurred together with the accumulated collapsed structure and debris from upper levels and roof.
